BRIDGE WATERPROOFING DETAILS

Submitted to the Graduate Faculty of
Swanson School of Engineering in partial fulfillment
of the requirements for the degree of
Master of Science

University of Pittsburgh

The objective of this research is to improve the safety margin and redundancy of current waterproofing details used for bridge substructures in PennDOT practice. Based on a literature review, inspection reports, and field visits, the key components of the waterproofing system are studied. Using software analysis and experimental tests, their strength and robustness is analyzed and evaluated based on the damage development and failure mode. The inadequacy in the key components of current waterproofing system is substantiated and remedies to mitigate water leakage are proposed. Executable recommendations are suggested to strengthen the waterproofing details at critical locations and to provide ease of construction and inspection.

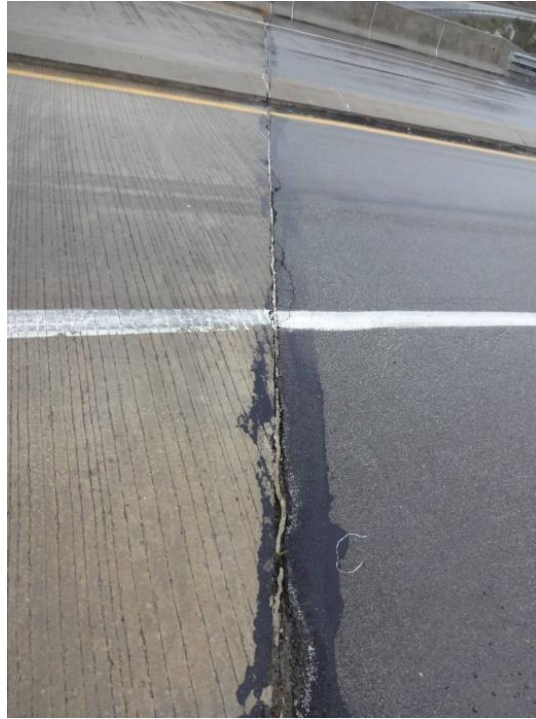
Figure 4.4: Cracking and erosion of joint edges

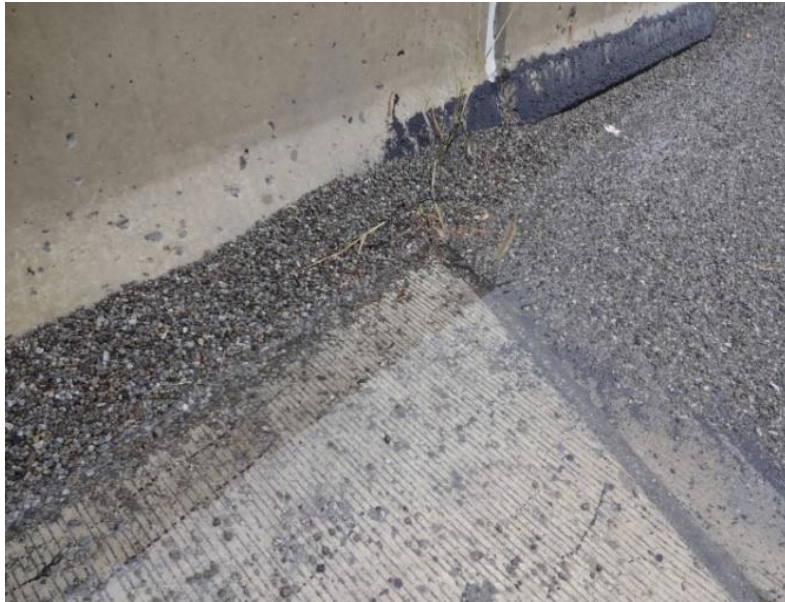
Figure 4.16: Debris accumulation causing water ponding – Prospect #1 Bridge

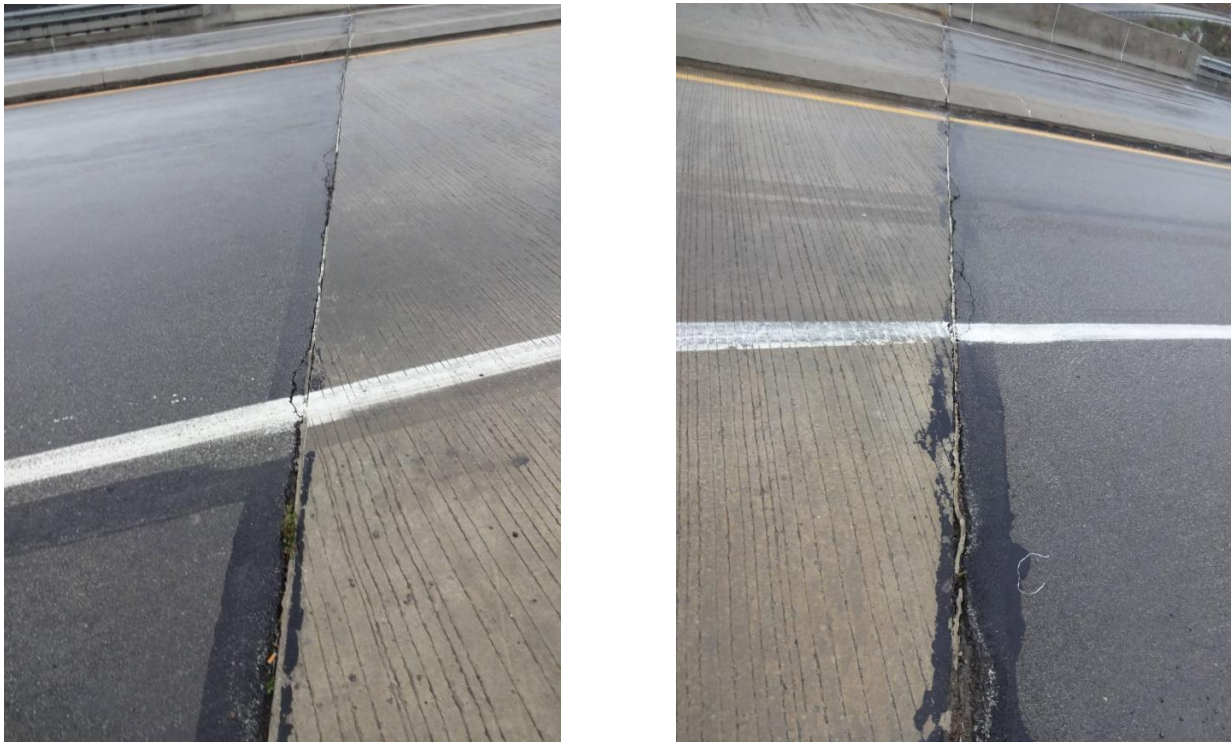
Figure C68: Cracking and erosion of edges in contact with sealant

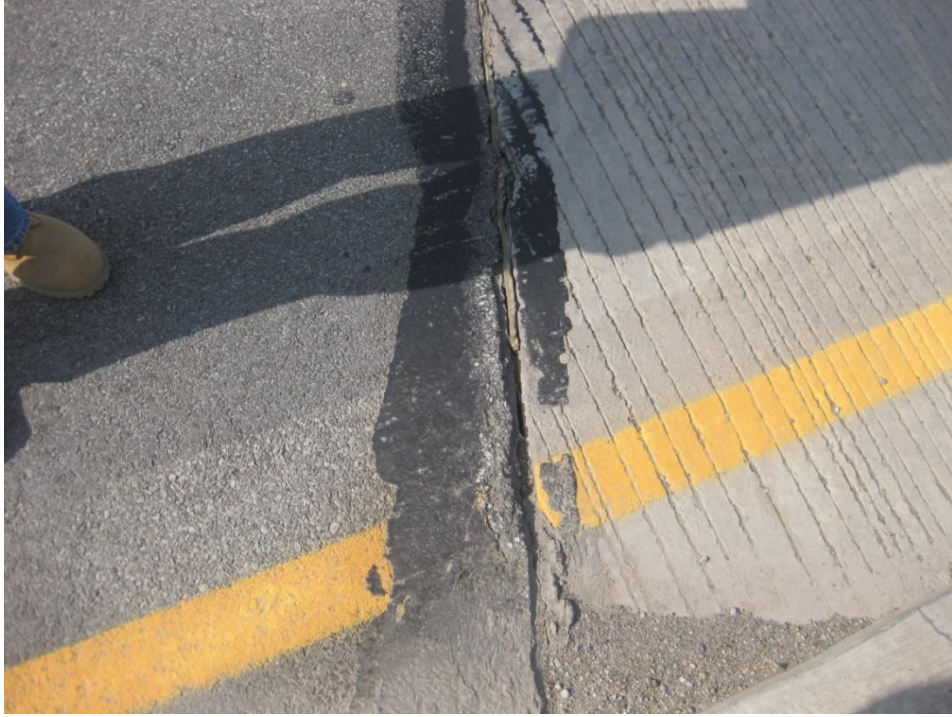
Figure C69: Damaged Silicone sealant seal

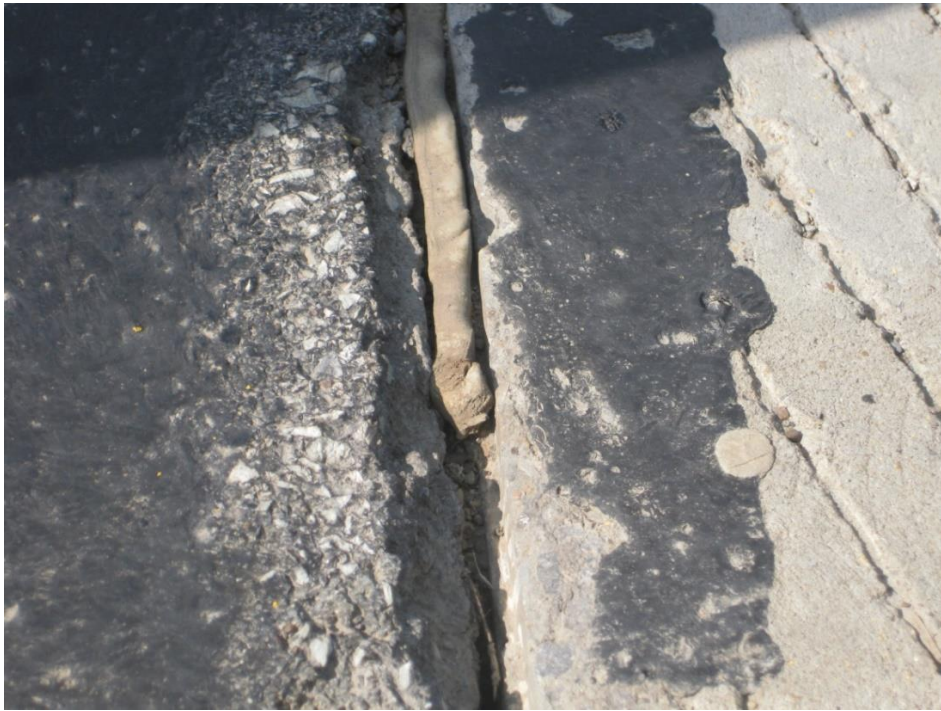
Figure C70: Close-up of damaged seal in figure C68

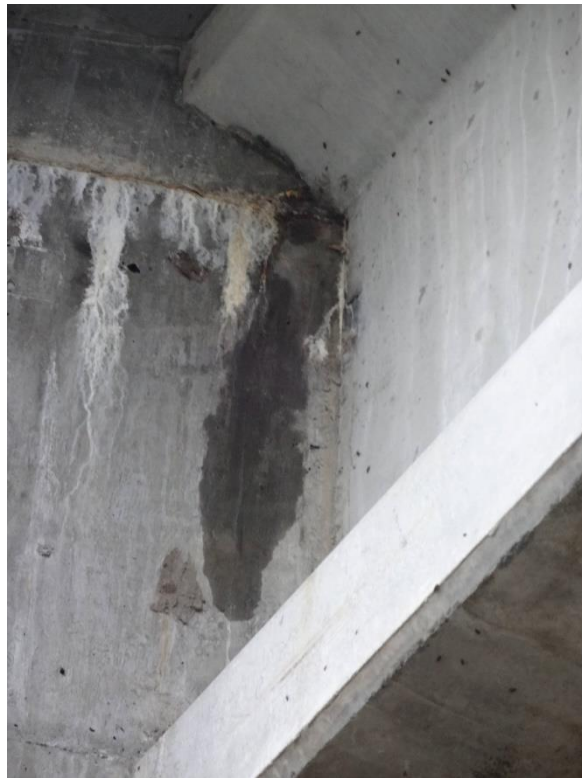
Figure C72: Leakage at interface of abutment backwall and beam

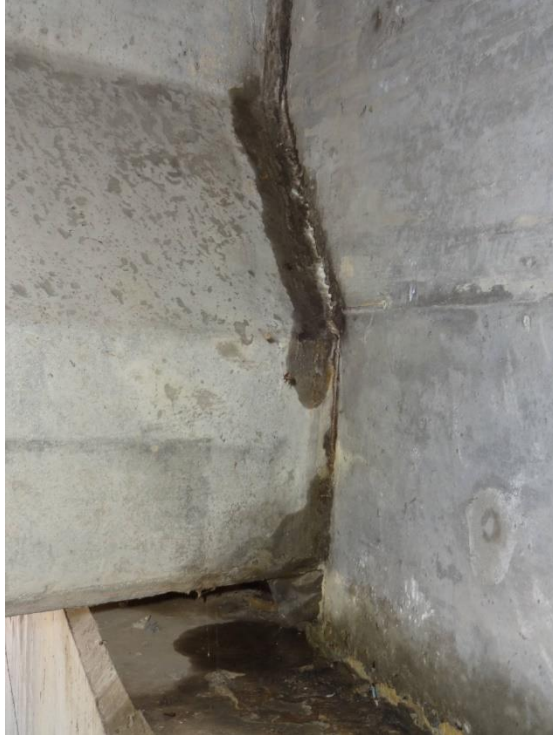
Figure C73: Leakage at interface of abutment backwall and beam

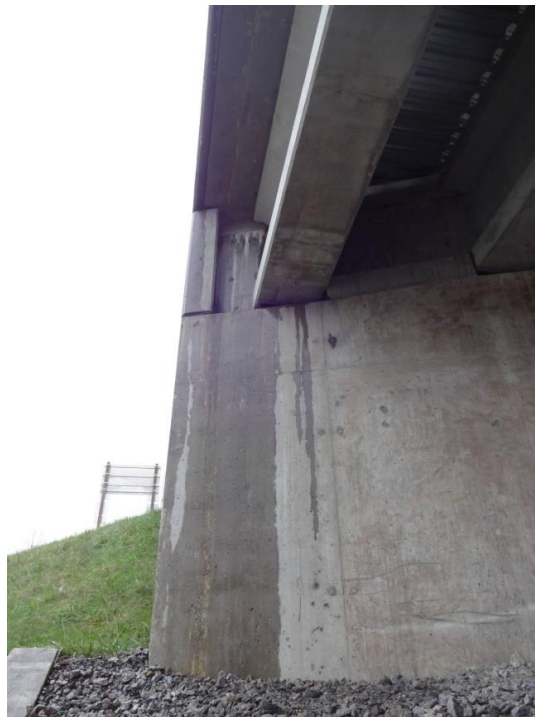
Figure C74: Leakage at edge of abutment

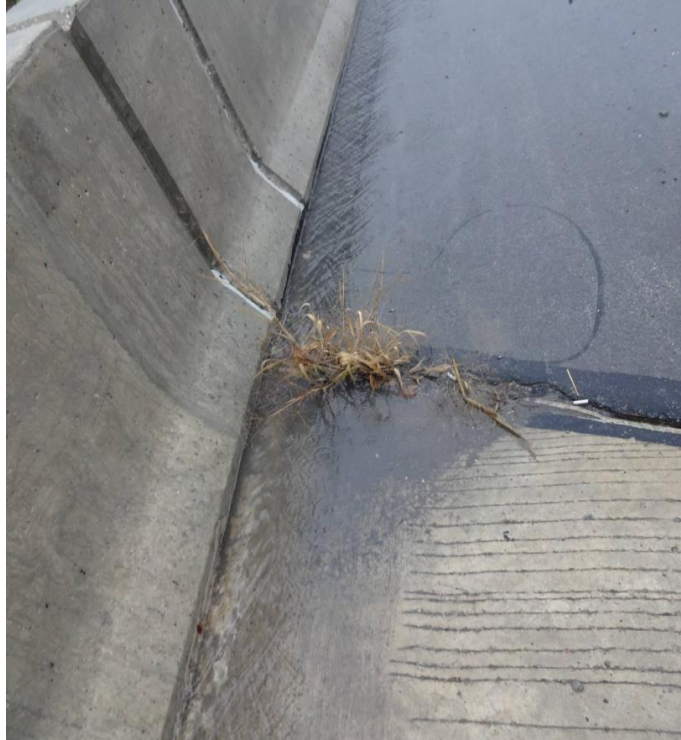
Figure C75: Detour of part of discharge into joint

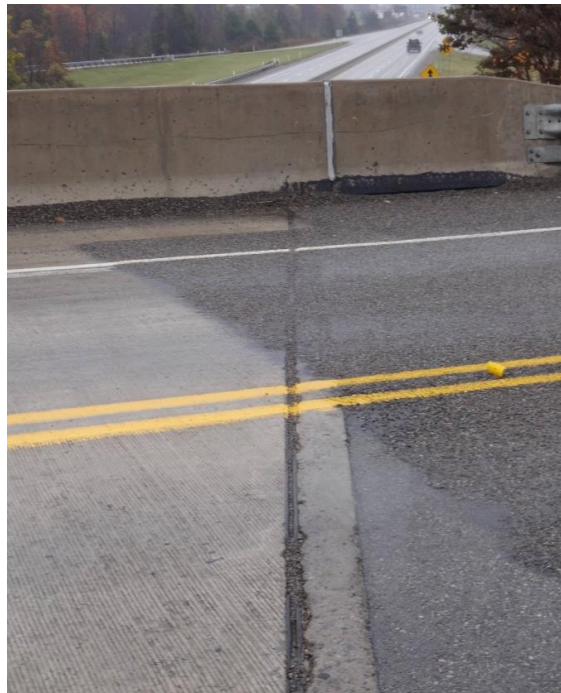
Figure C82: Maintenance works overlapping on expansion joint and deterioration of concrete edges

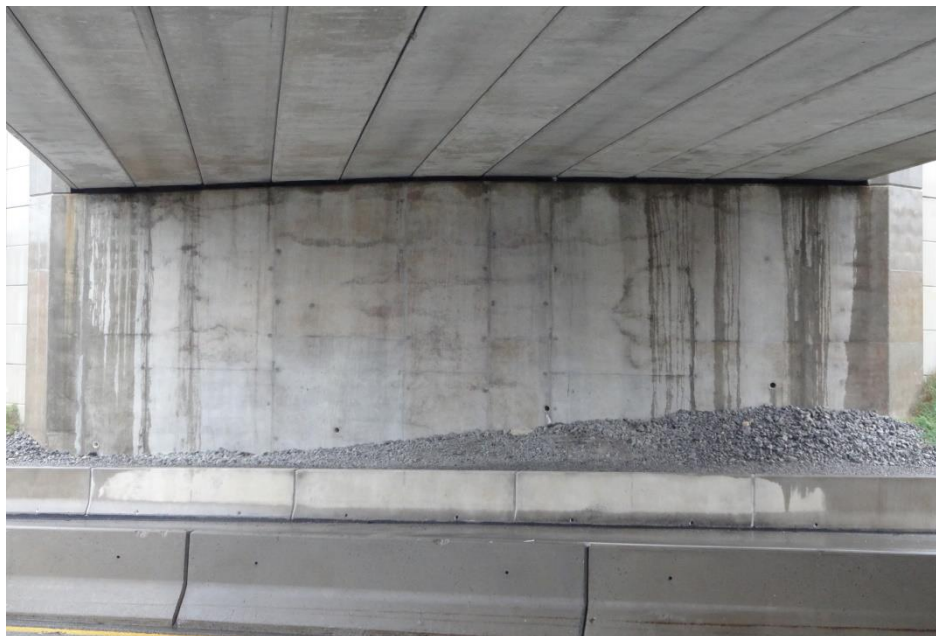
Figure C83: Water staining on abutment

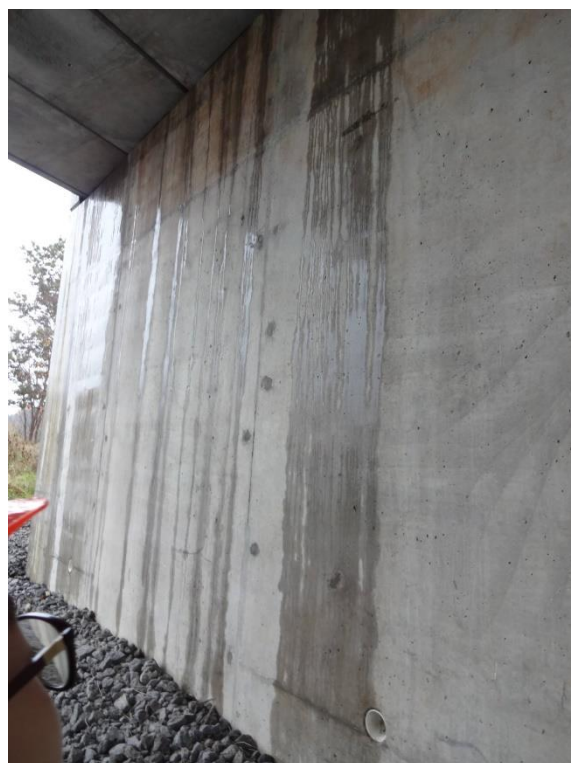
Figure C84: Severe water staining on edge of abutment wall

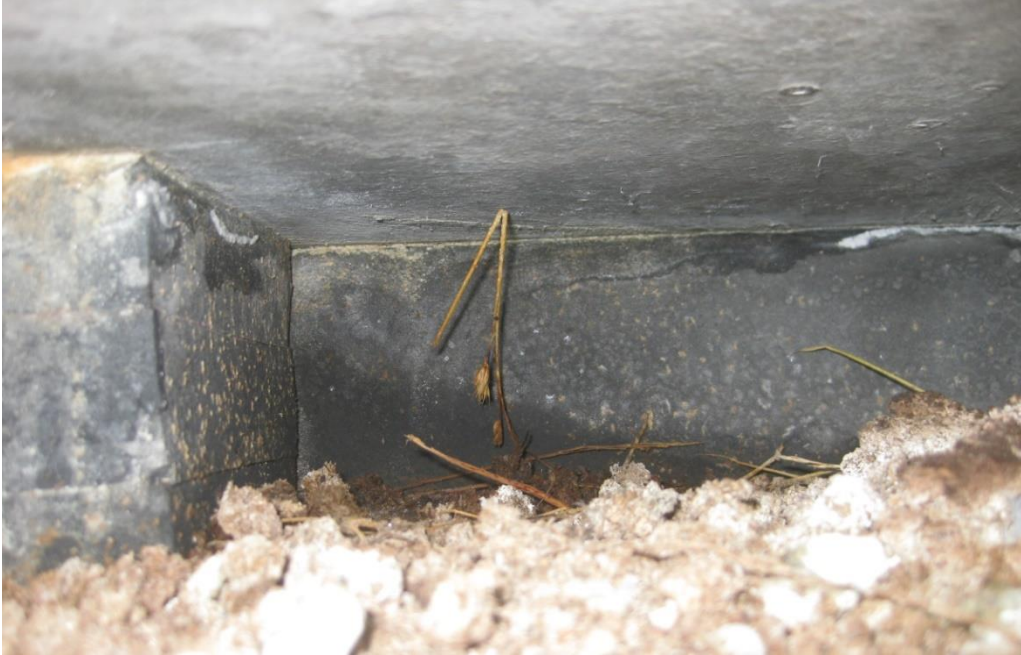
Figure C85: Water staining on top and bottom of back wall on abutment seat

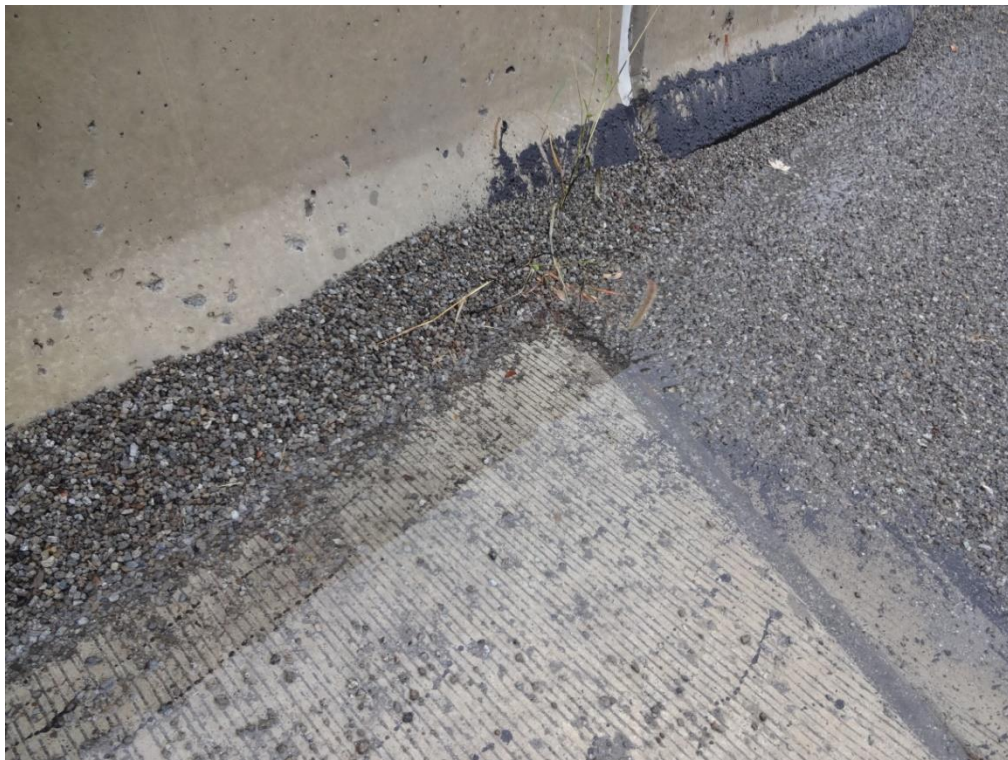
Figure C86: Water ponding at the edge of the deck near the expansion joint

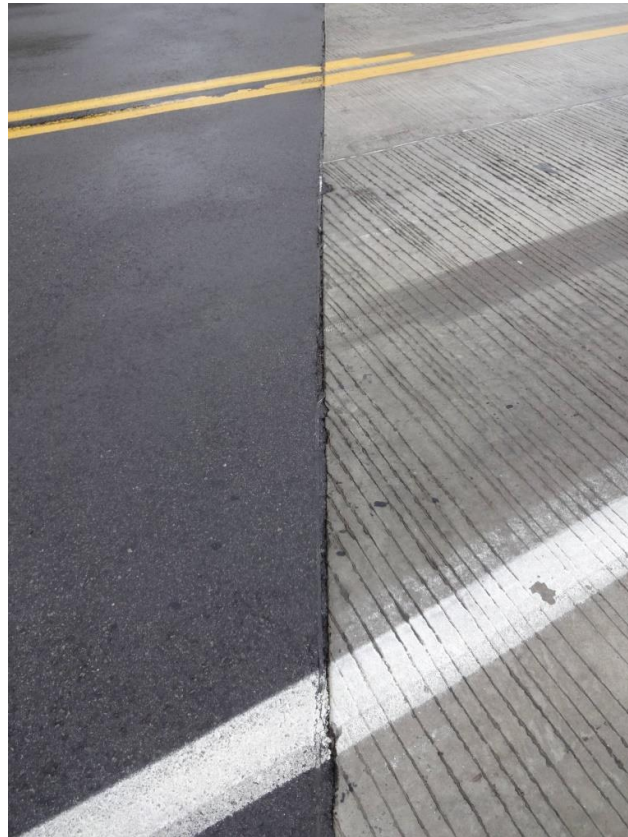
Figure C91: Minor deterioration of edges along joint

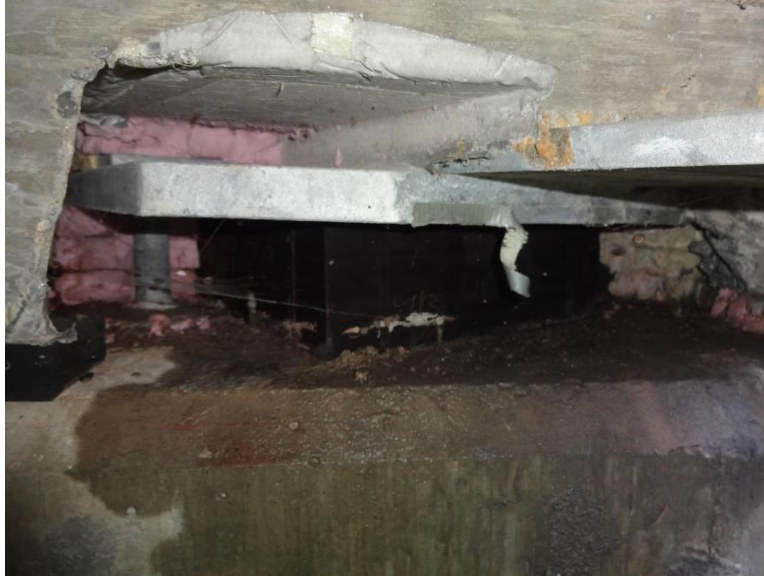
Figure C92: Leakage in bridge abutment seat

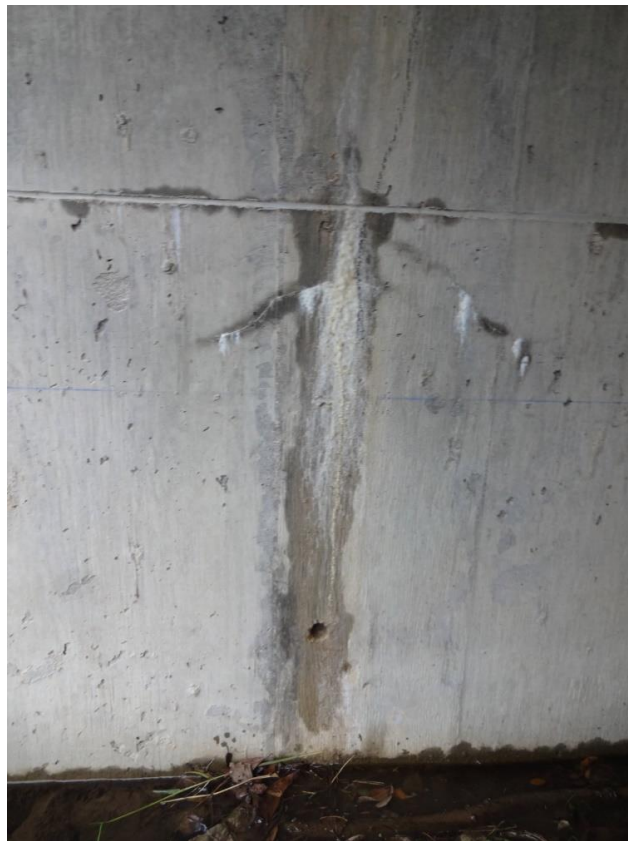
Figure C93: Leakage in cracks propagating from the abutment stem and header interface

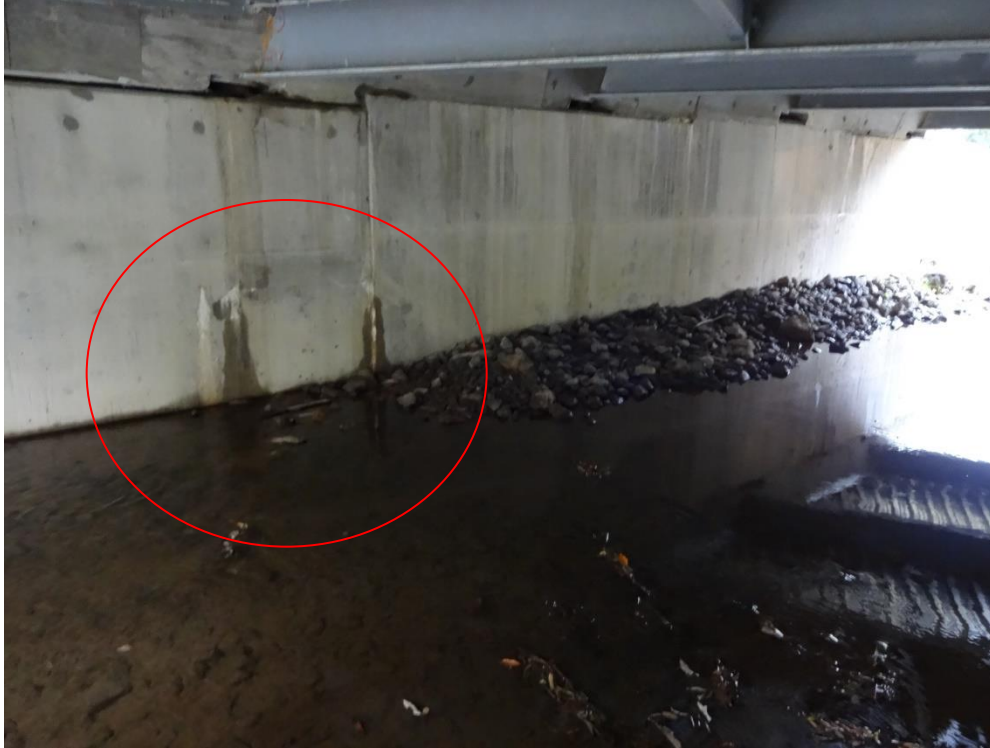
Figure C94: Leakage through cracks with efflorescence

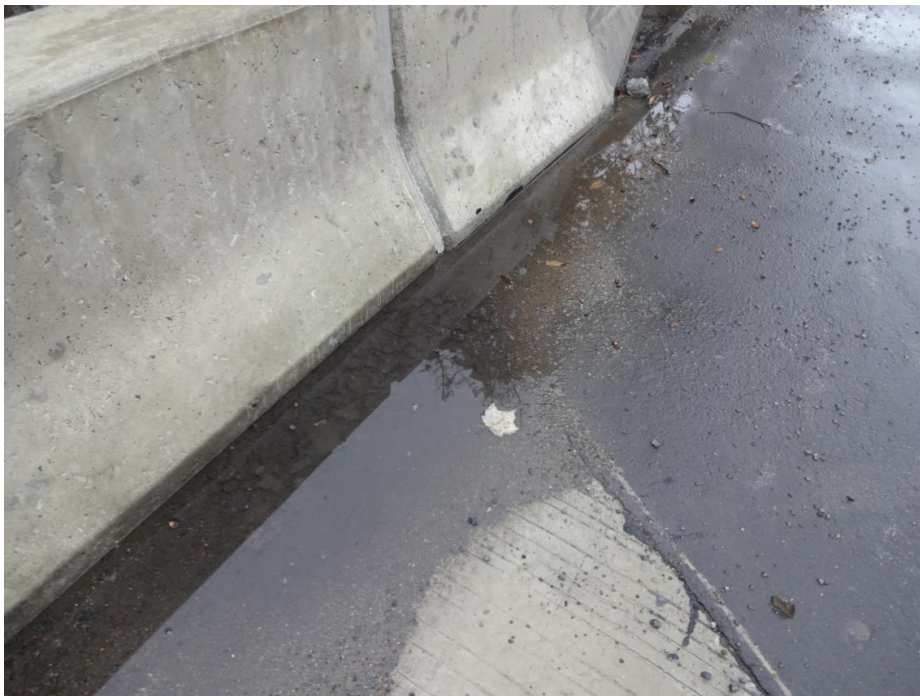
Figure C95: Silt deposition with lack of flow of water along deck edge

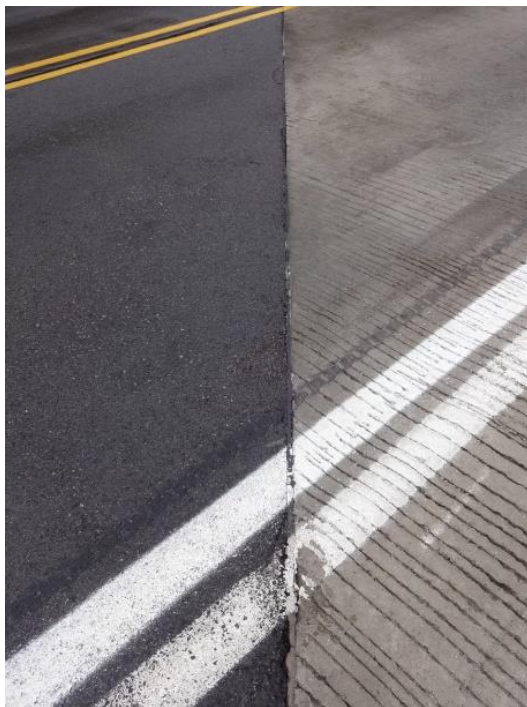
Figure C101: Slight deterioration of HMA surface adjacent to joint

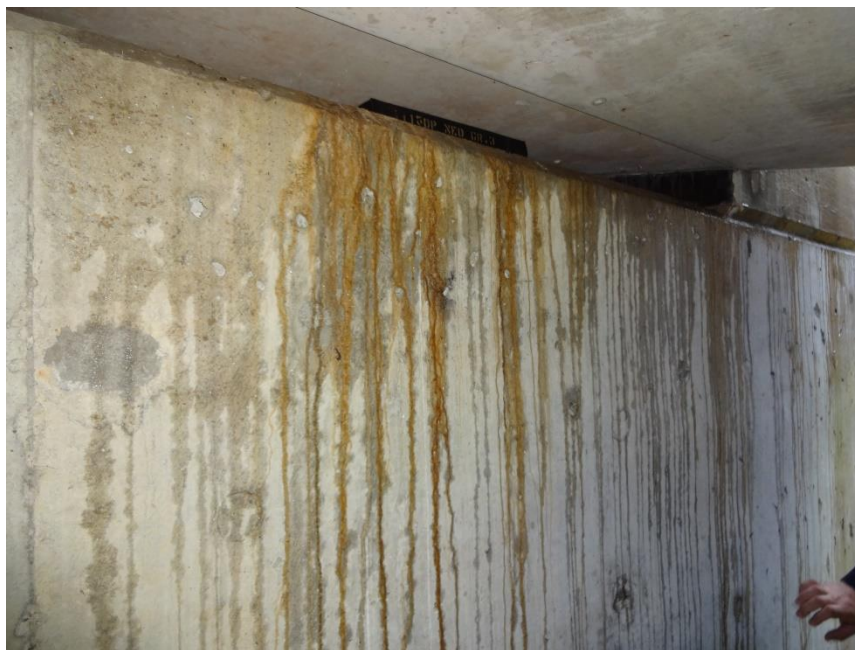
Figure C102: Severe water staining on abutment wall

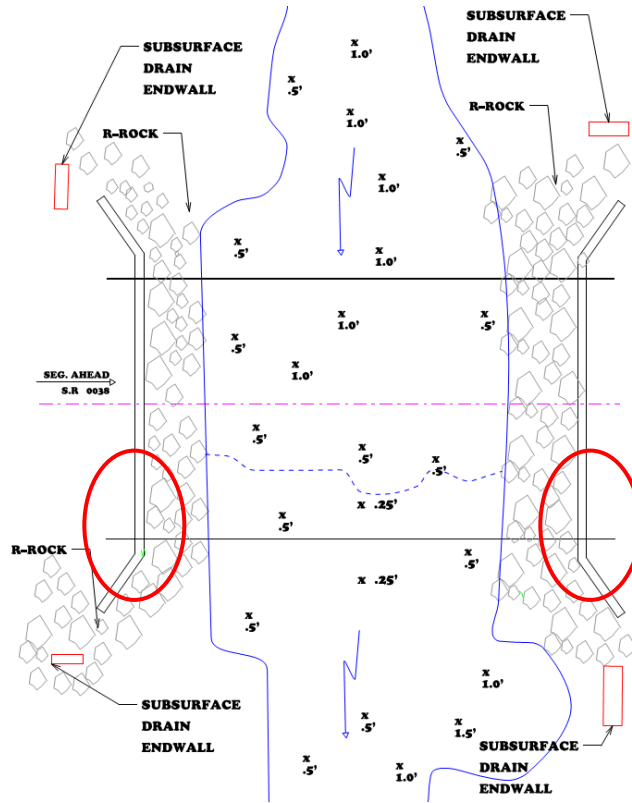
Figure C103: Locations of severe water staining (circled areas)

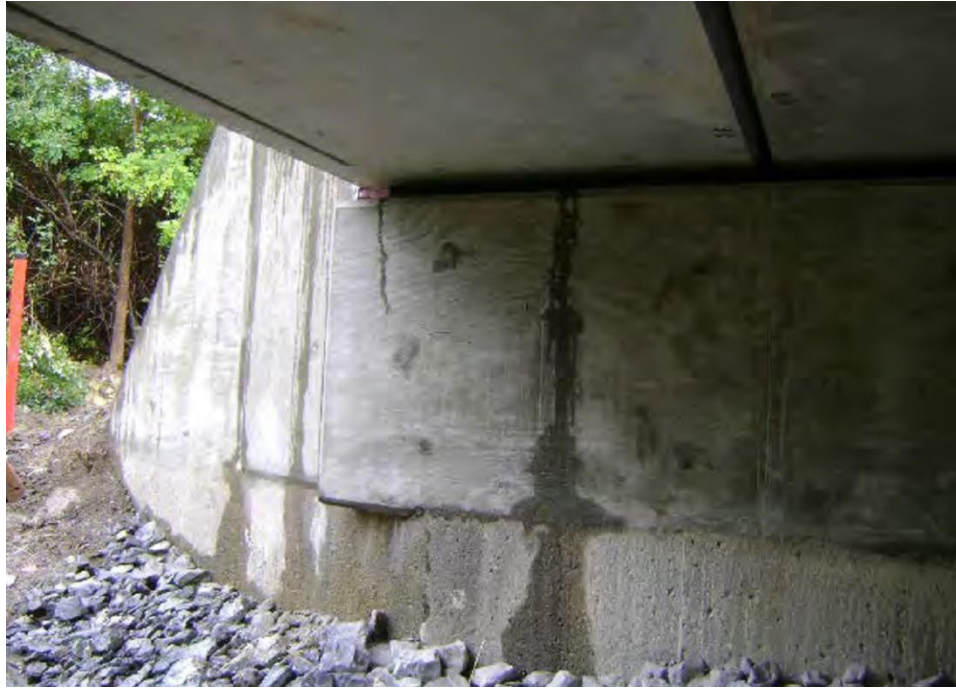
Figure C112: Staining of abutment wall observed by PennDOT inspectors

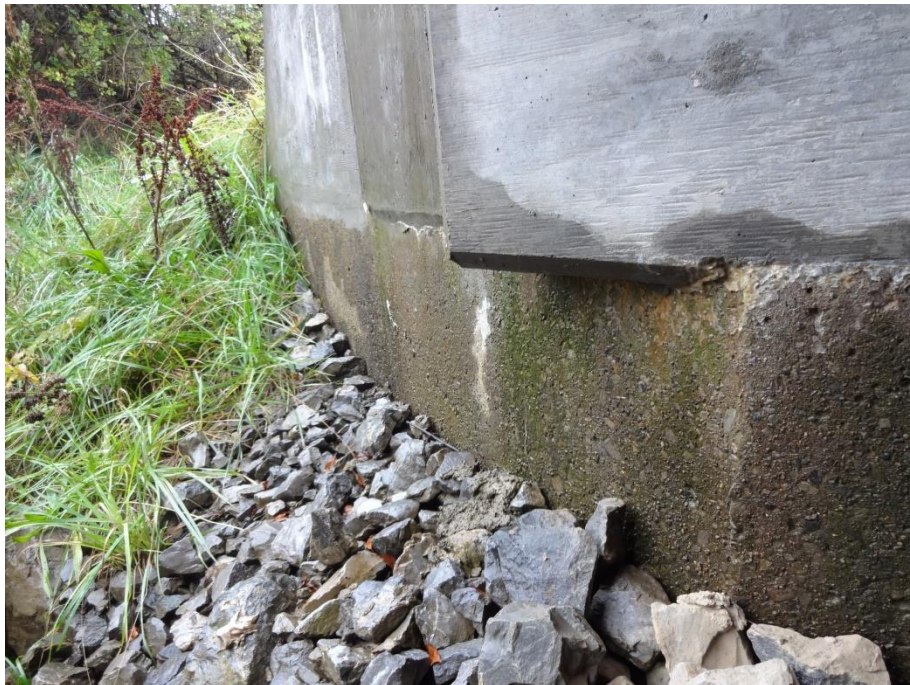
Figure C113: Severe leakage from interface of new and old abutment sections

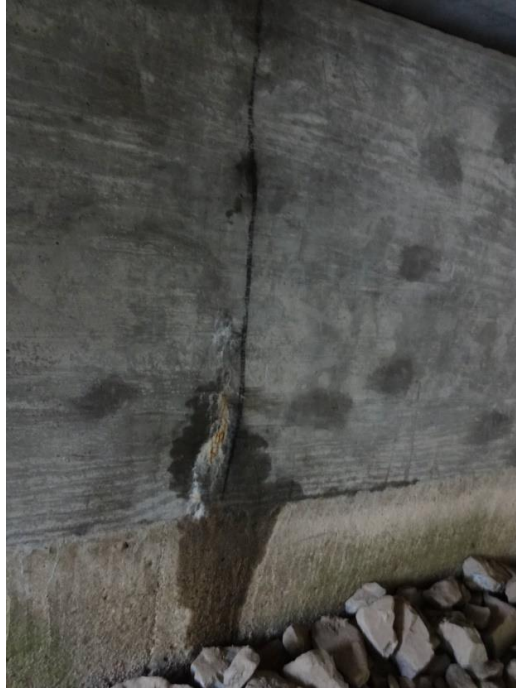
Figure C114: Leakage at cracks originating from interface of new and old abutment sections
