**ON THE REPAIR OF IMPACT-DAMAGED PRESTRESSED CONCRETE  
BRIDGE GIRDERS**

Jarret Lee Kasan

Submitted to the Graduate Faculty of  
Swanson School of Engineering in partial fulfillment  
of the requirements for the degree of  
Doctor of Philosophy

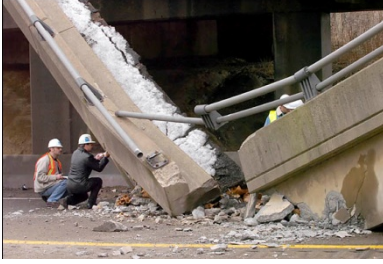
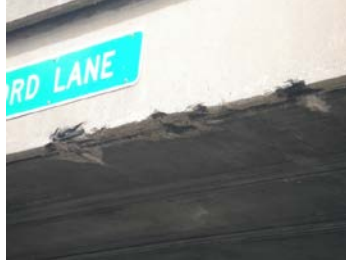
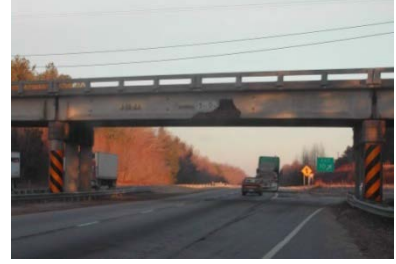
**Figure 1-1** Examples of damage associated with vehicle impact.

a) Lake View Drive collapse onto I-70. Impact damage led to significant strand loss, subsequent corrosion and eventual collapse under girder self-weight. [Pittsburgh Post-Gazette]

b) Impact damage to fascia beam of Crawford Lane over I-70. [Kasan]

c) Bridge over I-26 north of Columbia SC showing evidence of significant vehicle impact. [Harries]

Collisions between over-height vehicles and bridges are becoming more commonplace (Fig. 1). Recent catastrophic collapses including Lake View Drive onto I-70 in Washington PA (Fig. 1a) and the McIlvaine Road vehicle collision only 8 miles east of Lake View Drive (Fig. 1b) have led to a re-evaluation of the condition of many prestressed structures resulting in new postings and in some cases emergency decommissioning of structures. Collision damage, however, is generally far from catastrophic (Fig. 1c) although sound repair techniques are critical if additional damage (typically related to corrosion) is to be mitigated

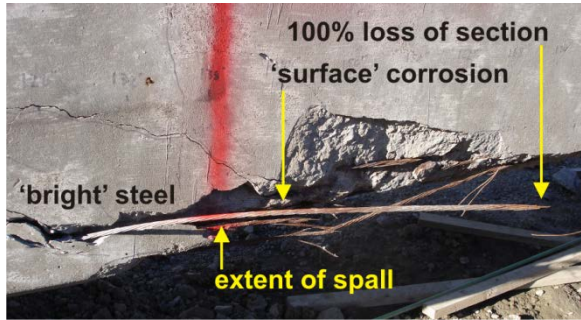
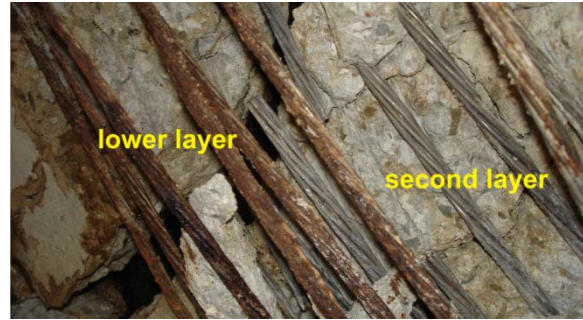
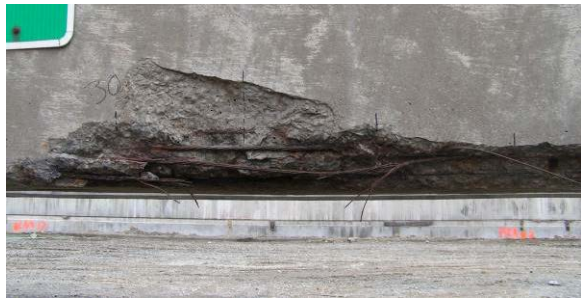
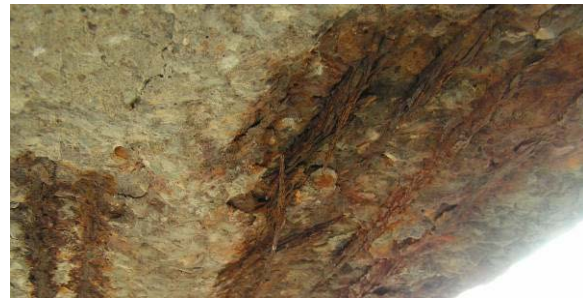
**Figure 2-1** *In situ* corrosion of prestressing strand.

a) Progression of strand corrosion as strand is de-passivated due to loss of concrete cover. Cracking at left of image is associated with load test (Harries 2009).

b) Corrosion of lower layer of strands in box girder while second layer remains bright. Strand ruptures near center of image associated with load test (Harries 2009).

c) Typical damage to strand resulting from recent vehicle impact.

d) Typical corrosion of strands resulting in significant loss of section at soffit of box girder.

The deteriorating condition of the nation's bridge infrastructure cannot be overstated. PC bridges, however, generally contradict this trend. These, often newer, structures have thus far demonstrated exceptional durability and represent only a small fraction of deficient bridges in the nation (FHWA 2007). Nonetheless, PC bridges are susceptible to potentially catastrophic damage; the extent of which is often difficult to assess until it has progressed to the point of collapse (Harries 2009). Deterioration of PC bridges usually results from corrosion of the strand in a region where the concrete has been damaged, often by vehicle impact (Harries et al. 2009). An example of such damage is shown in Figures 2-1c and d. Due to its refined chemistry and typically small diameter, prestressing steel is particularly susceptible to corrosion (ACI 222 2001). Provided sound cover concrete is present to ensuring resistance to chloride attack, the passivating layer on the prestressing strand is maintained and corrosion is mitigated. Examples of this are shown in Figure 2-1 which shows observed damage from the collapsed Lake View Drive Bridge reported by Harries (2009). In Figure 2-1a, a 3/8 in. (9.5 mm) diameter strand is entirely corroded at the location of an older vehicle impact; the steel crumbled to the touch. A short distance away, where the strand re-enters sound concrete, the corrosion is only 'surface' corrosion. Finally, at the location at which the strand was again encased in sound concrete, only 'bright' steel is found. A similar situation is seen in Figure 2-1b, showing the soffit of a box

girder following testing to failure (Harries 2009). In this case, the lowest layer of strands in the box, having a clear cover of only 1.25 in. (32 mm) and partially exposed due to spalling likely resulting from vehicle impacts, exhibits marked corrosion. The second layer of steel, 1.5 in. (38 mm) above the lower layer remains 'bright'.

Figures 2-1c and d show representative damage to prestressed box girders (Harries 2009). The damage shown in Figure 2-1c was almost certainly initiated by a recent vehicle impact and does not exhibit significant corrosion yet. Left unpatched, the damage in Figure 2-1c is likely to progress to that shown in Figure 2-1a. Figure 2-1d shows relatively typical soffit corrosion. In this case, the initial cause of the damage is less clear although the corrosion is most certainly accelerated by salt-spray from the road below. In the structure shown, the vertical clearance to the Interstate carriageway below was only 14.5 ft (4.42 m) making both vehicle impact and salt spray problematic (Harries 2009).

Damage such as that seen in Figure 2-1 clearly affects the capacity of the individual girder and therefore the bridge. Furthermore, when damage is caused by vehicle impact, it will often be located in the critical middle third of the flexural span. When rating a girder exhibiting such damage, typically a sections approach will be used and the contribution of the severed and corroded strands will be neglected. While this is an adequate approach at the affected section, it is conservative elsewhere along the span assuming fully bonded strands are used. The severed or corroded strand, once it re-enters sound concrete, continues to be bonded to the concrete; thus stress transfer between the concrete and strand is possible. If this is the case, the strand may be 'redeveloped' (in the sense of 'development length') by bond transfer at a distance from the damage location. By the same argument, the prestress force in a bonded strand is not lost at a distance from the damage, since it too may be 'redeveloped'. If the beneficial effects of

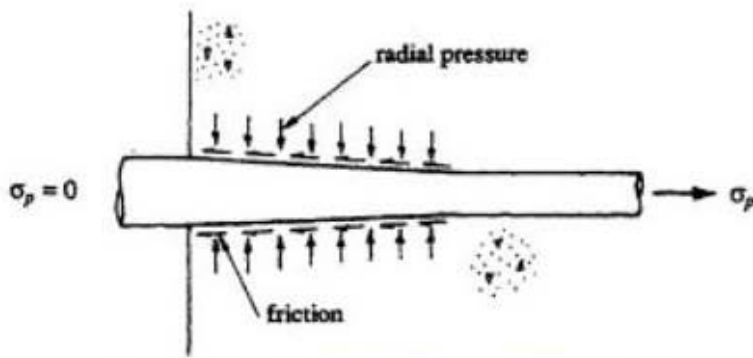
**Figure 2-2** Radial Forces developed by the wire as described by the Hoyer Effect (Gilbert and Mickleborough 1990).

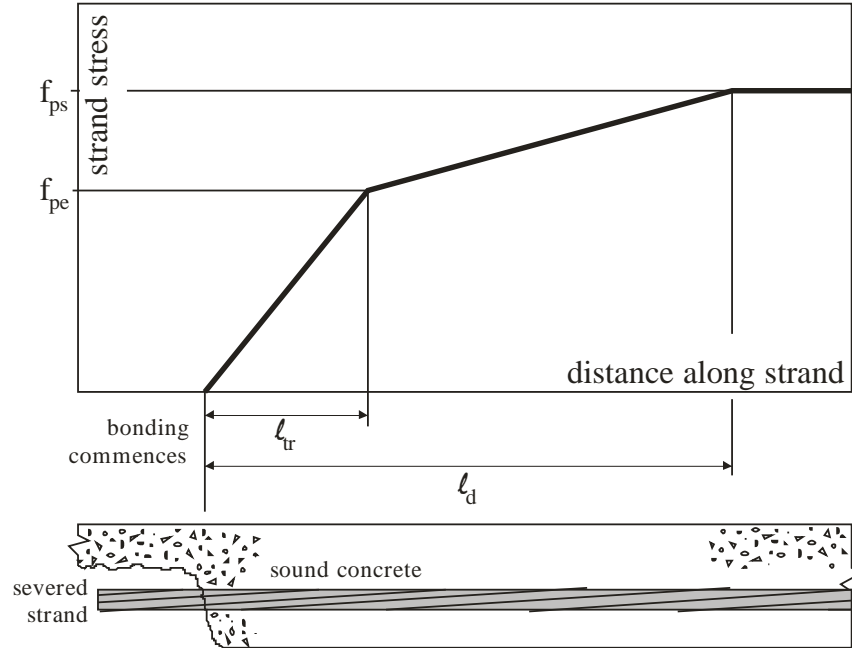
Figure 2-3: Idealized transfer and development lengths.

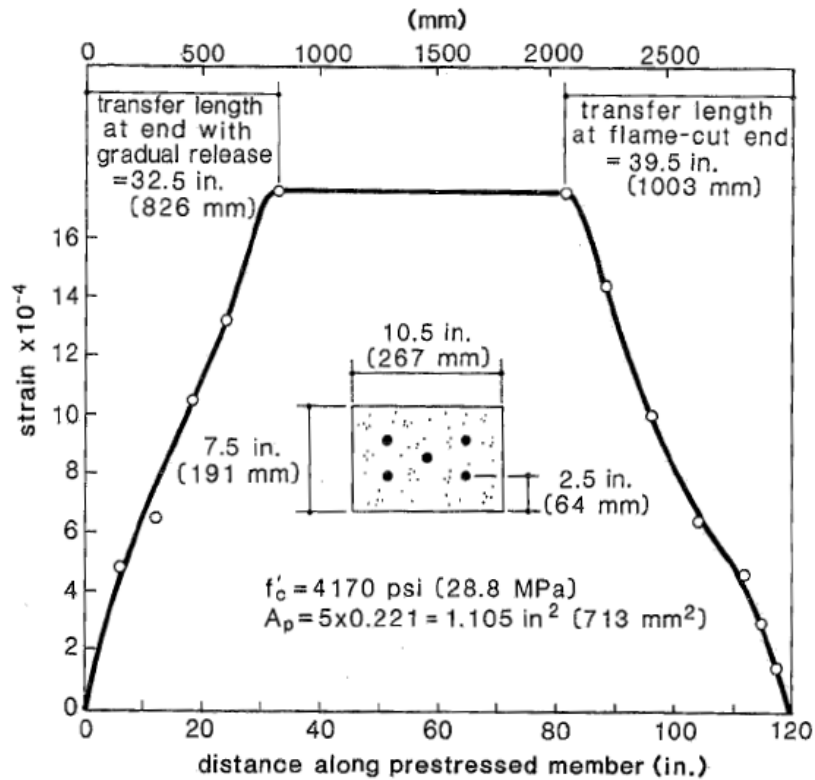
Figure 2-4 Transfer length of a 0.6 in. diameter strand in a 10 ft member illustrating different transfer lengths based on method of prestress force release (Kaar et al. 1963).

Strand transfer lengths have also been found to increase with a more rapid prestressing force release rate (Kaar et al. 1963 and Steinberg et al. 2001). Kaar has shown that the transfer length for flame cut ends (which is the release method used at most precasting plants) is greater than for a more gradual release, as is evident in Figure 2-4. Another study conducted by Steinberg et al. (2001), cut strands in a manner which resulted in the release of prestressing force to be faster than flame cutting. Steinberg et al. (2001) used two methods to determine strand transfer length; 1) a manual method which analyzed strains taken from gages mounted on the member’s surface before and after prestress release; and 2) LVDT readings which provided strand end slip values. Strain readings taken from gages embedded in the members verified strand transfer lengths determined from the other two methods. Regardless of the method used, all three determinations of strand transfer length resulted in values greater than that calculated based on contemporary PCI, ACI and AASHTO code provisions. The importance of the greater transfer lengths observed in test specimens subject to rapid prestressing force release rates is important in this study since a) impact damage may result in very rapid strand ruptures; and b) the technique used to cut strands in this study resulted in relatively rapid force release.

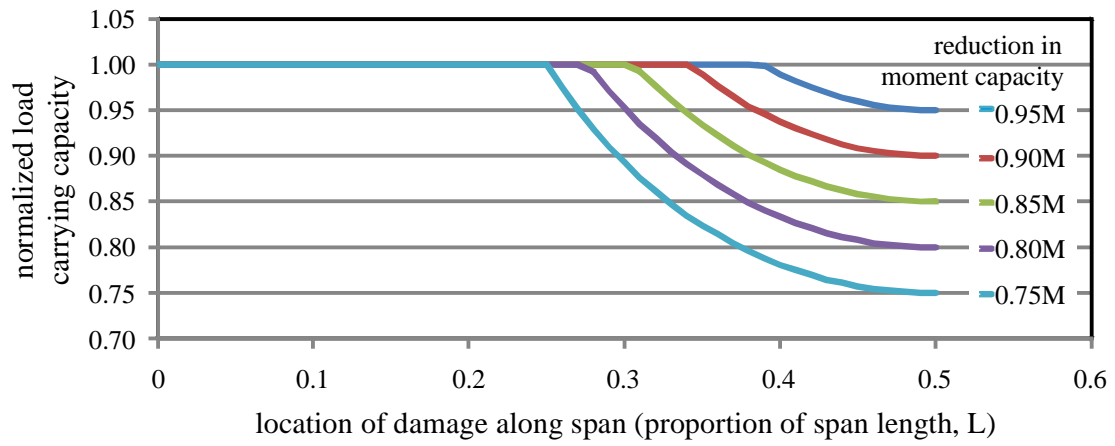
**Figure 2-5** Capacity of uniformly loaded simple span girder accounting for damage.

At a distance greater than  $\ell_d$  from observed strand damage, when strand ‘redevelopment’ is assumed, girder capacity is restored since a) the strand is still present in sound concrete and thus is reinforcing the section; and b) the prestress force attributed to the damaged strand is still present. This, however, is not typically taken into account in rating damaged prestressed girders where the common practice is to assume that once a strand is severed it is lost over the entire length of the girder. By accounting for ‘redevelopment’ and considering appropriate sections along a damaged girder, it is possible to significantly increase a girder’s load rating over that obtained for the damaged section or for the entire girder assuming the loss of ruptured strands over the entire girder length.

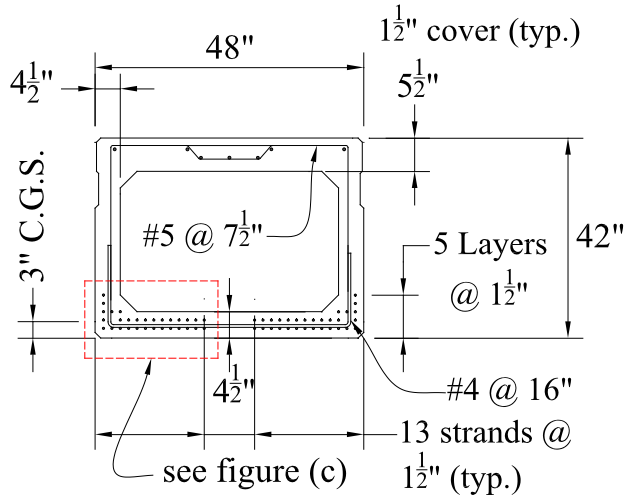
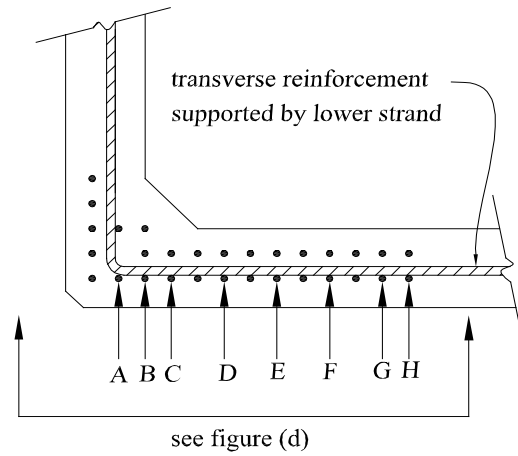
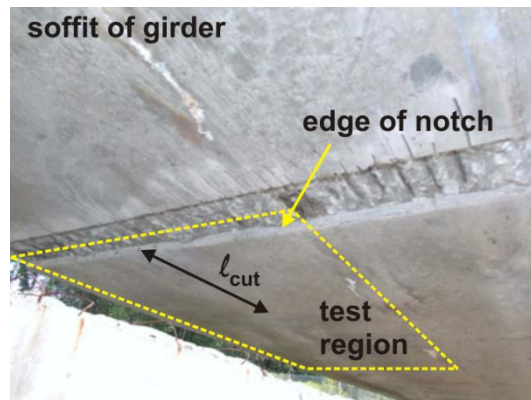
**Figure 2-6** Test and girder details.

a) test girder with support conditions (1 ft = 305 mm).

b) girder cross section (1 in. = 25.4 mm).

c) strand/gage nomenclature.

d) strands with cut location.

e) notch orientation.

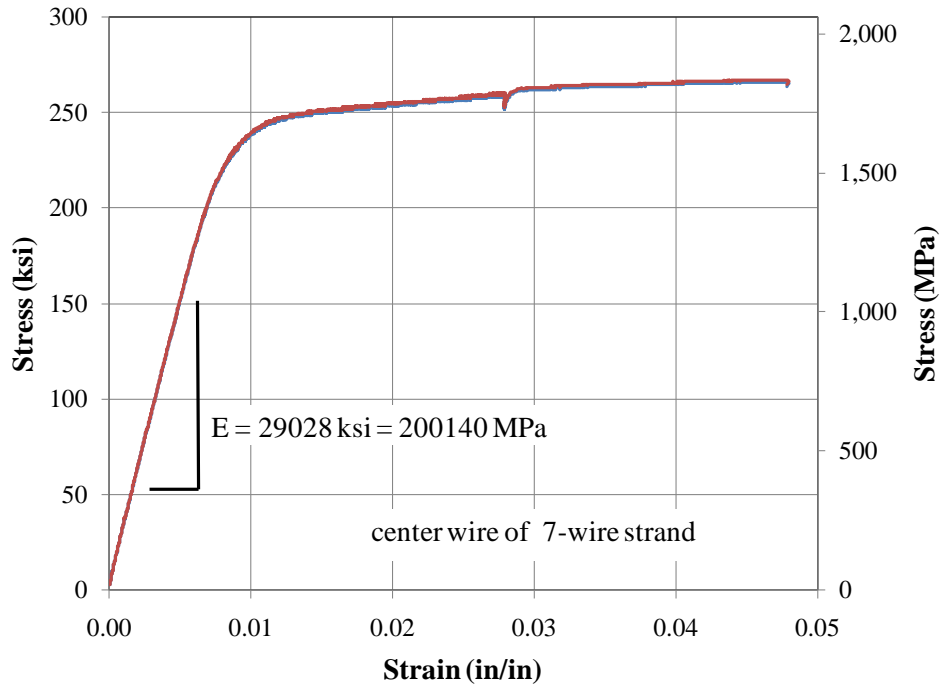
**Figure 2-7** Stress-strain curve obtained from center wire of strand from test girder.

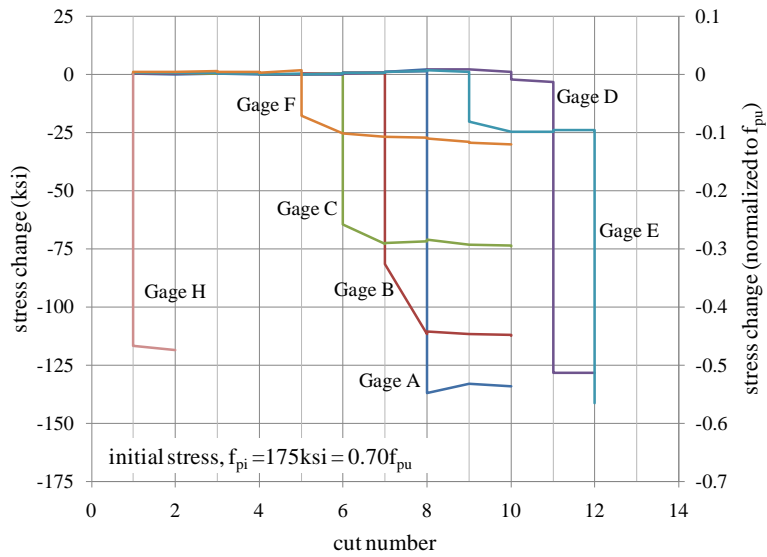
**Figure 2-8** Stress change-cut number history for all gages.

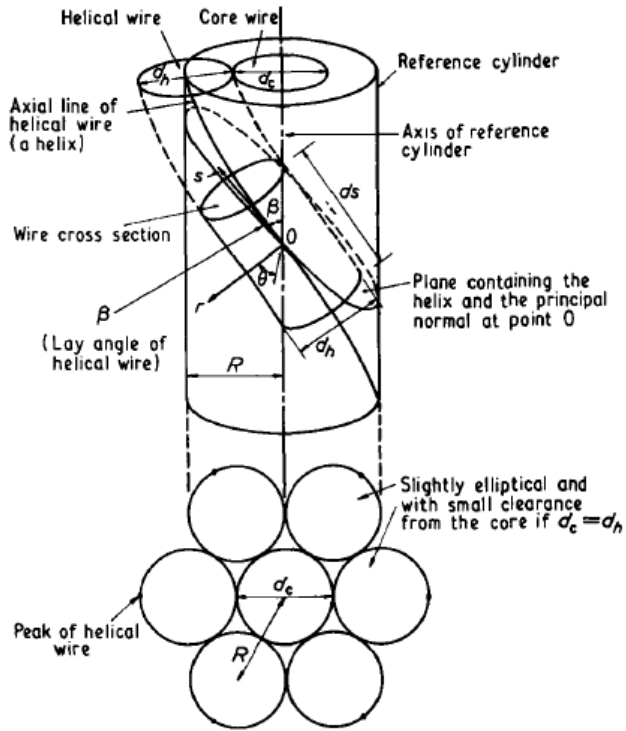
**Figure 2-9** Geometry of a seven-wire strand (Machida and Durelli 1973).

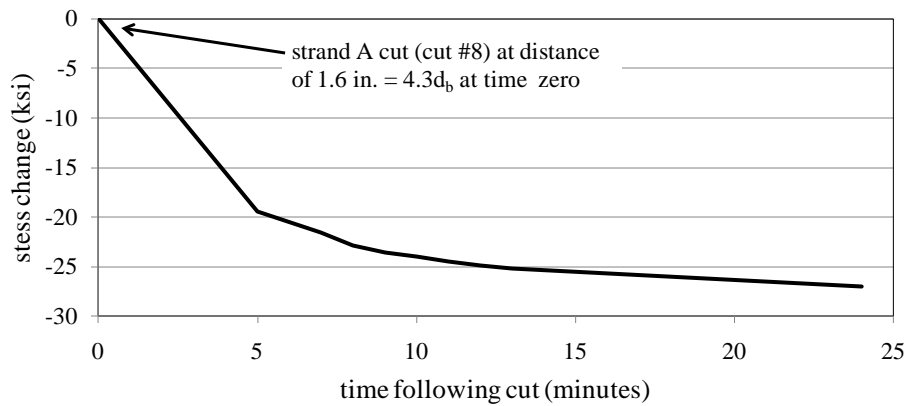
**Figure 2-10** Stress change-time history for strand A following cut #8.

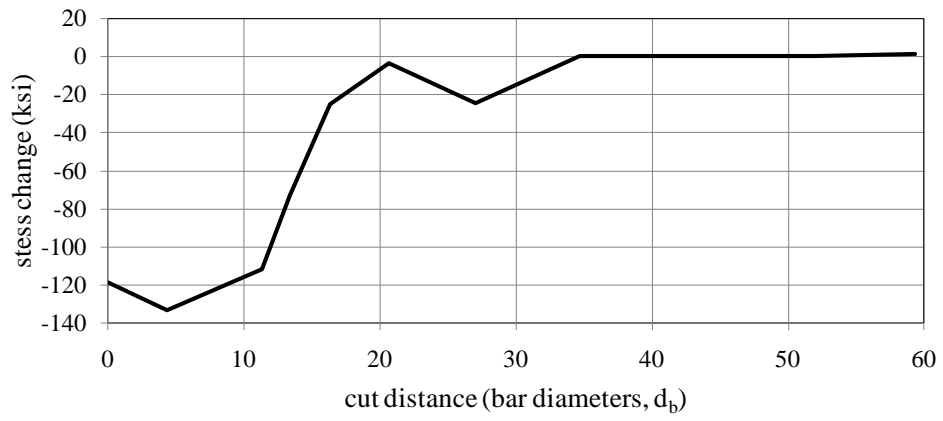
**Figure 2-11** Stress drop versus cut distance.

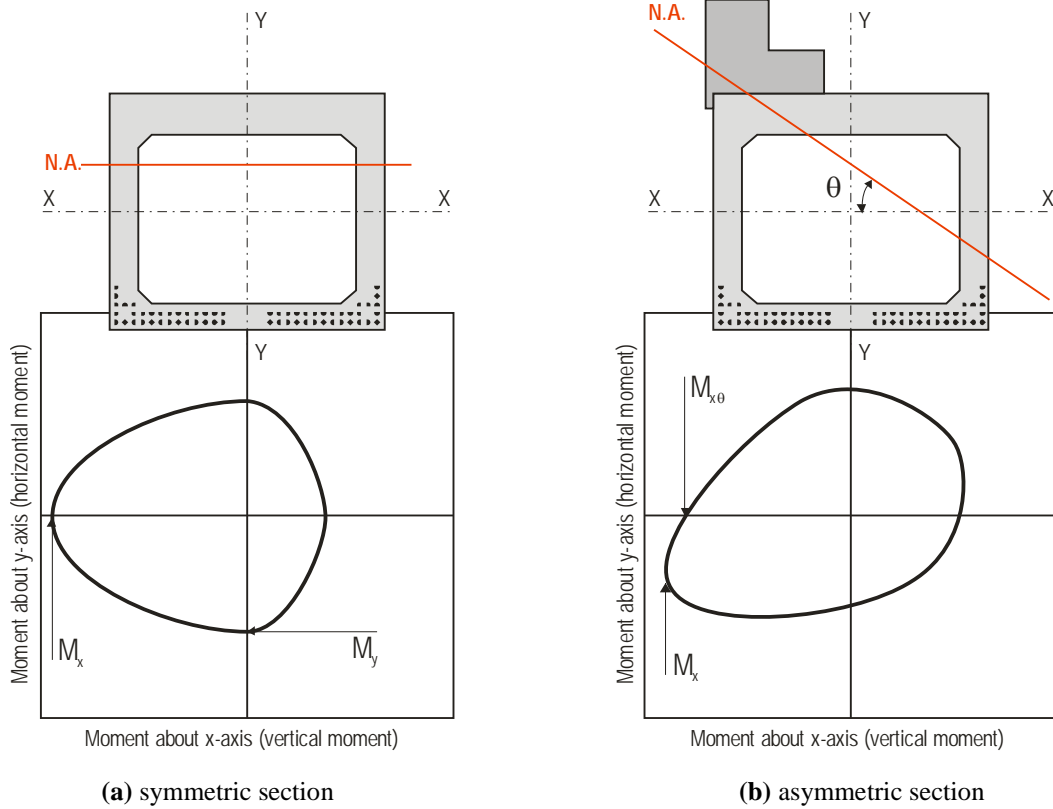
**Figure 3-1** Schematic representation of moment interaction (Harries 2006).

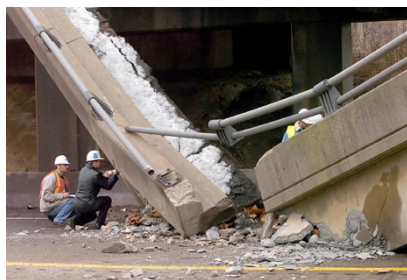
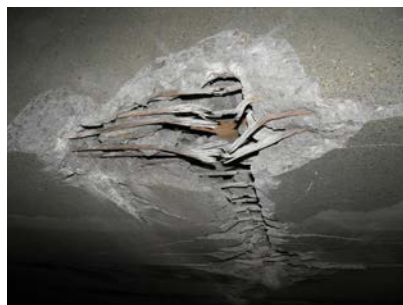
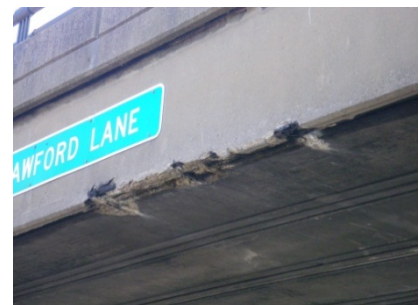
**Figure 3-2** Examples of vehicle impact damage to AB girder bridges along about 22.5 miles of the I-70 corridor in southwestern Pennsylvania.

(a) Lake View Drive bridge collapsed onto I-70 December 26, 2005 (Pittsburgh Post Gazette, 12/29/05)

(b) Soffit and fascia of McIlvaine Road bridge over I-70 damaged by vehicle October 18, 2010 (PennDOT)

(c) Crawford Lane bridge over I-70 damaged by vehicle impact March 15, 2011 (photo by author).

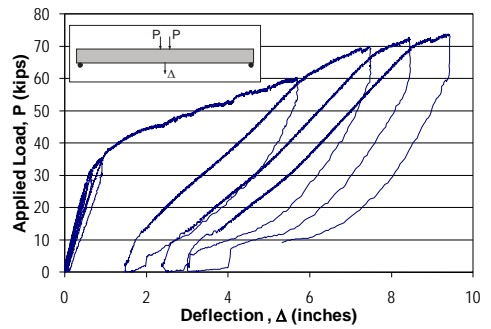
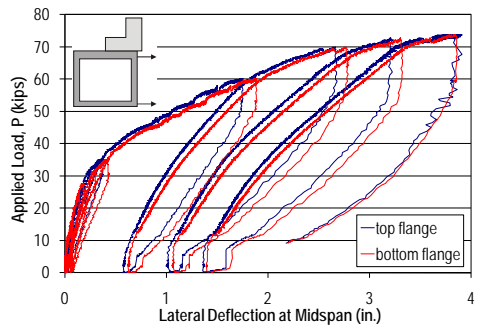
Figure 3-3 EXTERIOR AB girder test (Harries 2009).

(a) Test set-up for asymmetric EXTERIOR girder. Loading is symmetric.

(b) applied load versus vertical deflection

(c) applied load versus lateral deflection

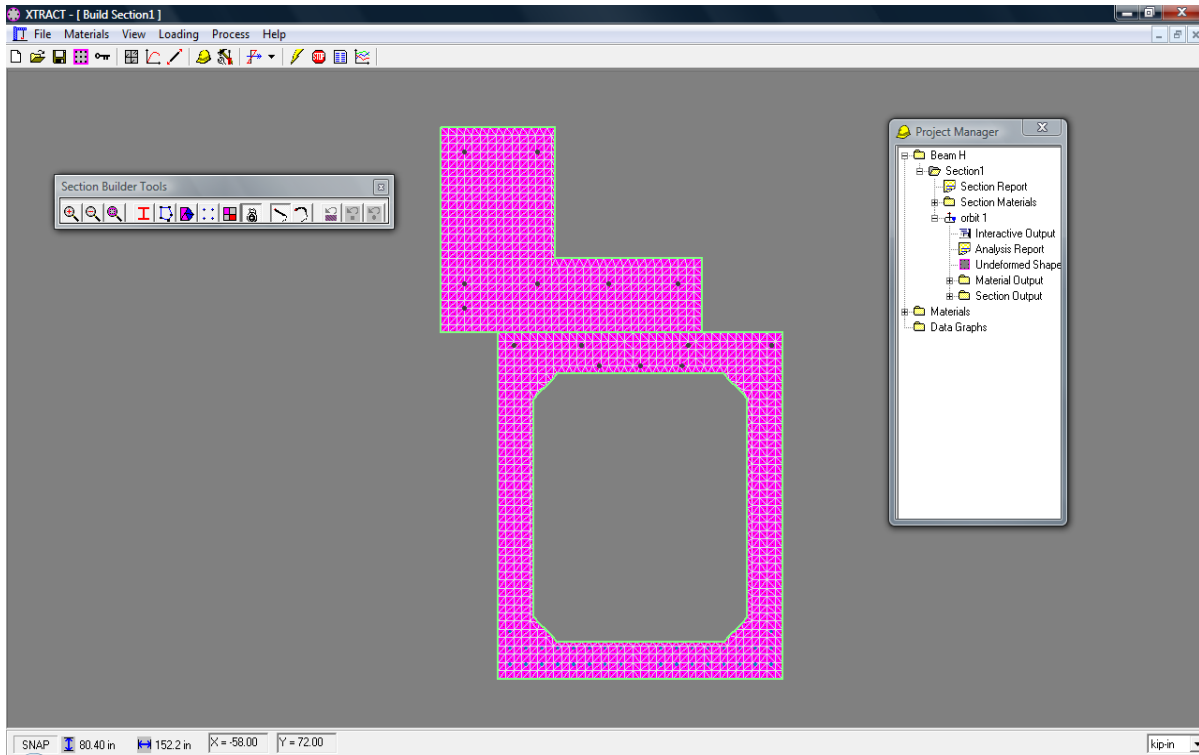
**Figure 3-4** XTRACT screen capture showing Beam H.

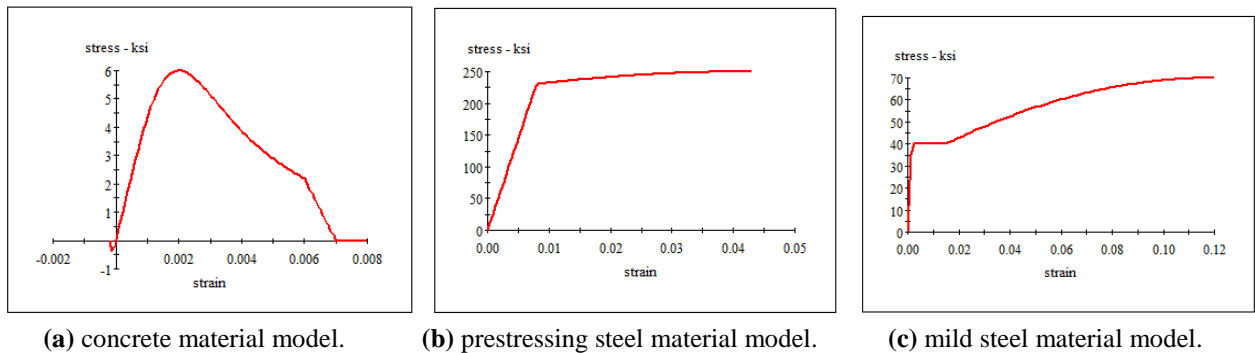
**Figure 3-5** Material models used in XTRACT analyses.

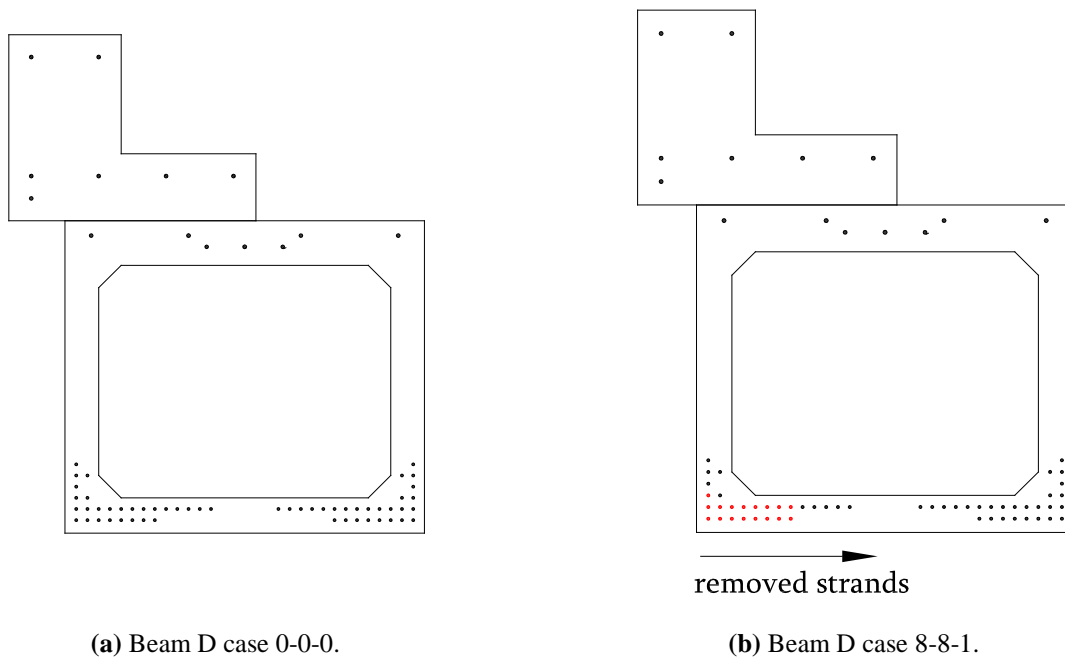
Figure 3-6 Example of damage classification.

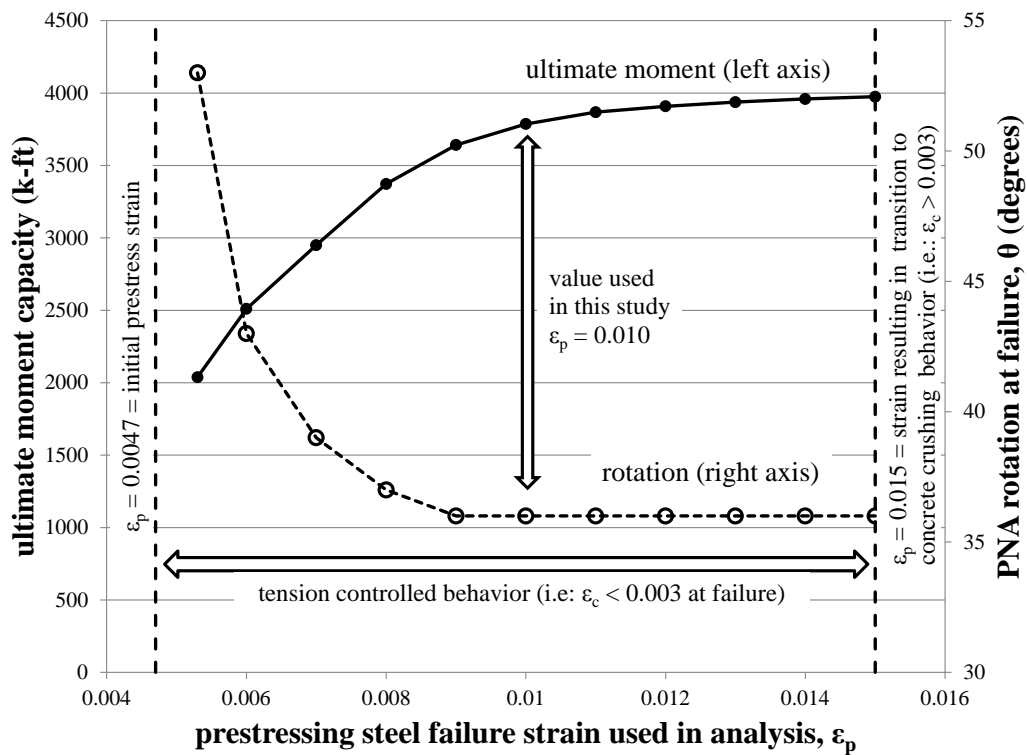
Figure 3-7 Verification of steel failure strain criteria.

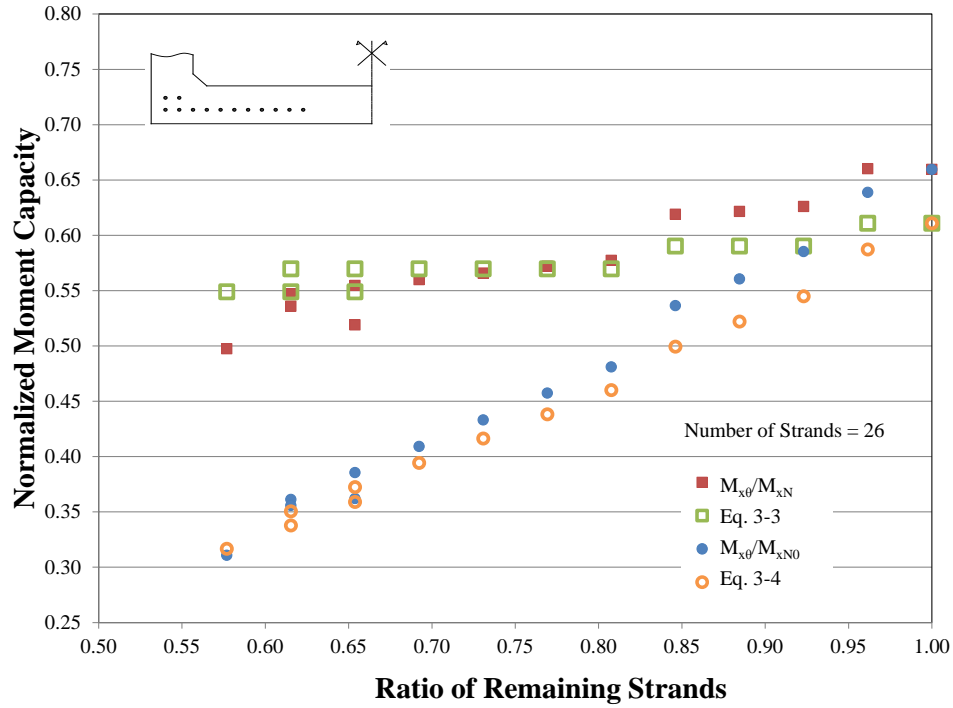
Figure 3-8 Normalized moment capacity vs. number of removed strands – Beam A.

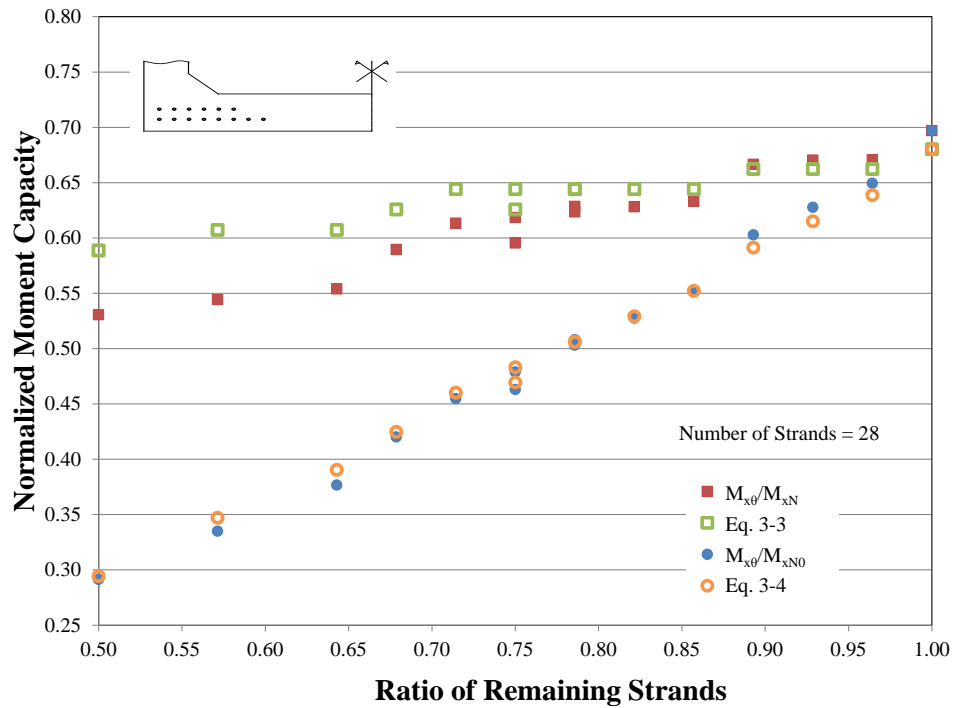
Figure 3-9 Normalized moment capacity vs. number of removed strands – Beam B.

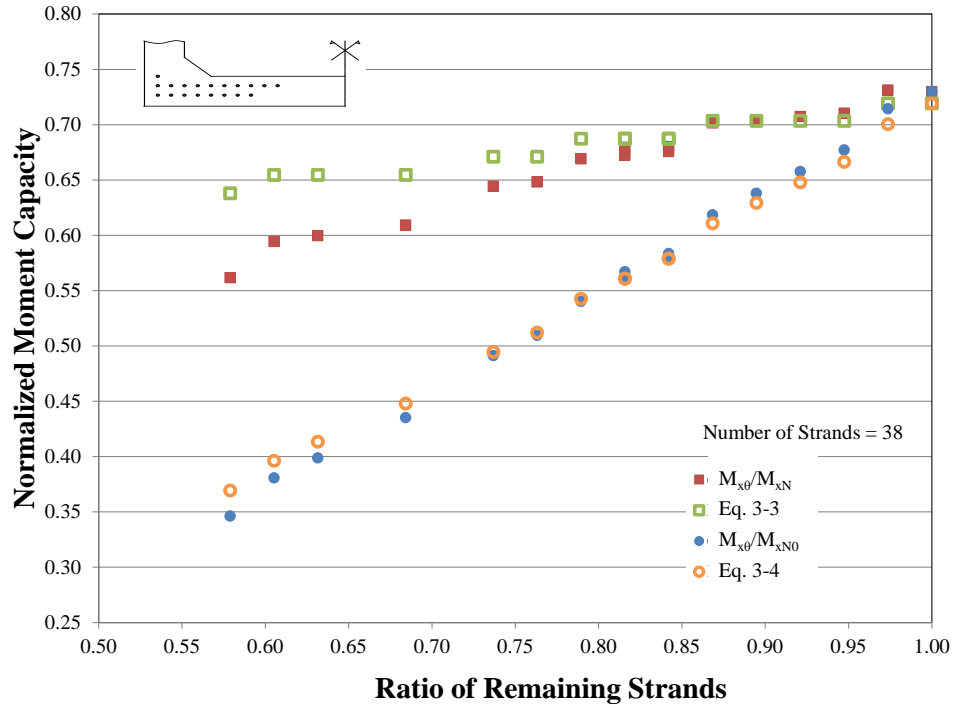
Figure 3-10 Normalized moment capacity vs. number of removed strands – Beam C.

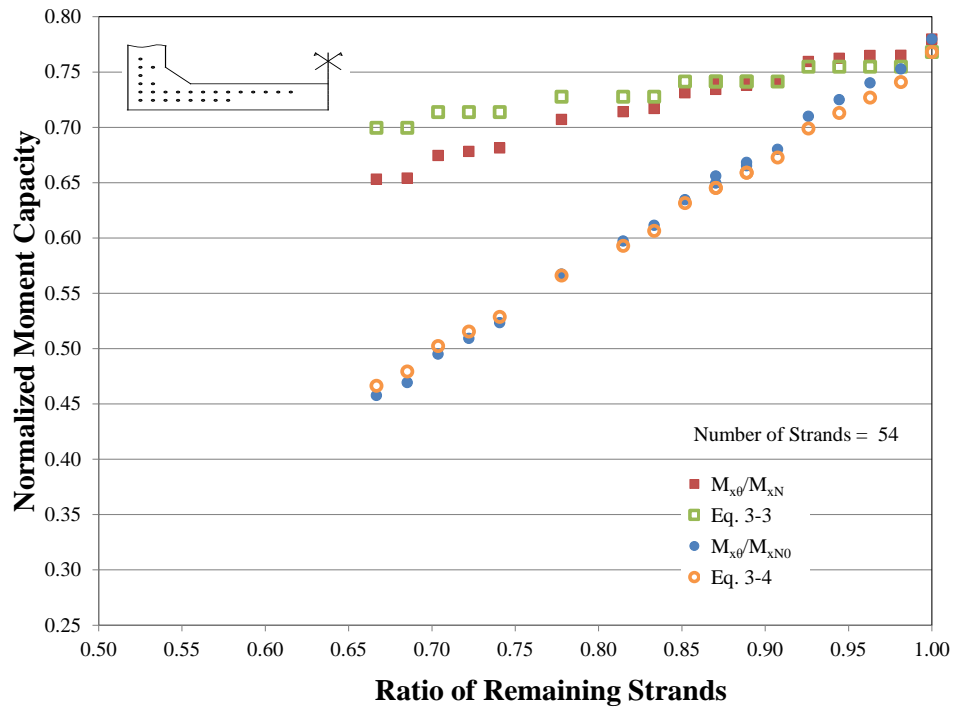
Figure 3-11 Normalized moment capacity vs. number of removed strands – Beam D.

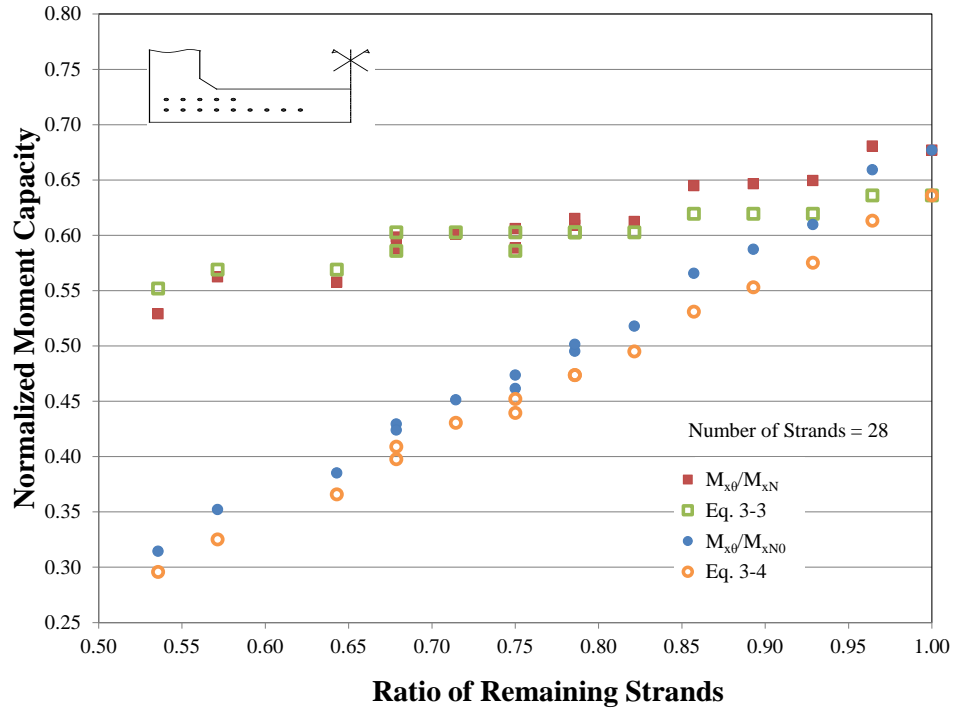
Figure 3-12 Normalized moment capacity vs. number of removed strands – Beam E.

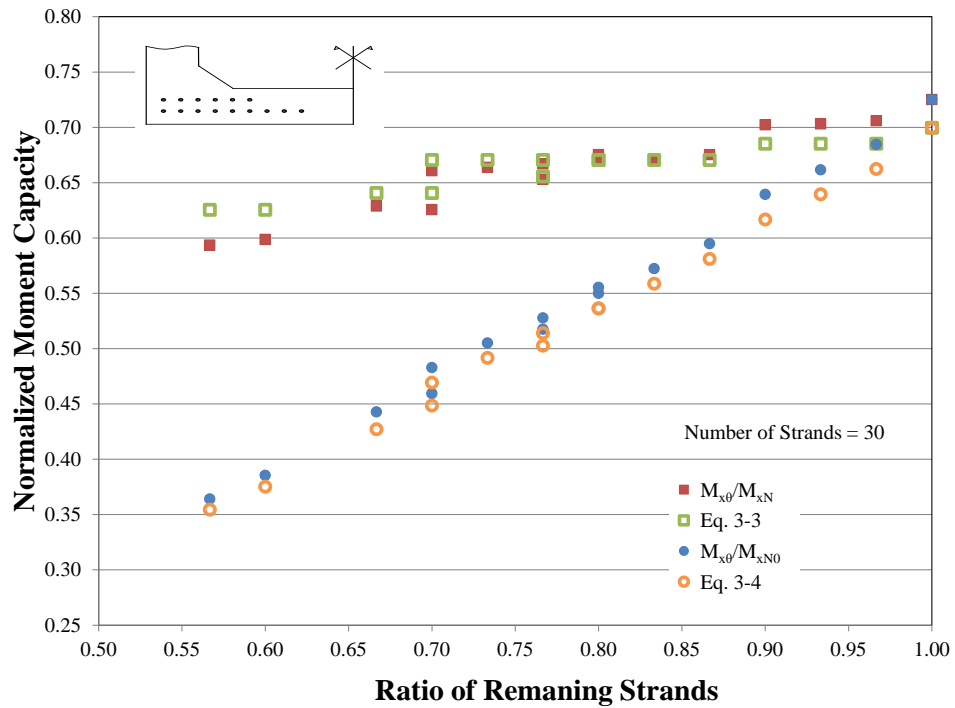
Figure 3-13 Normalized moment capacity vs. number of removed strands – Beam F.

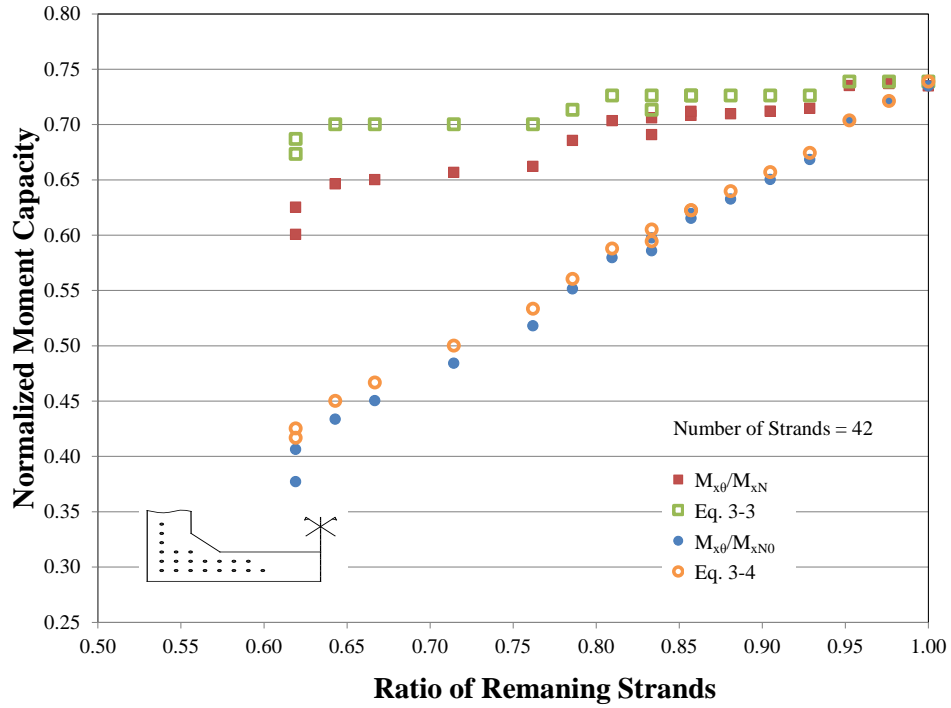
Figure 3-14 Normalized moment capacity vs. number of removed strands – Beam G.

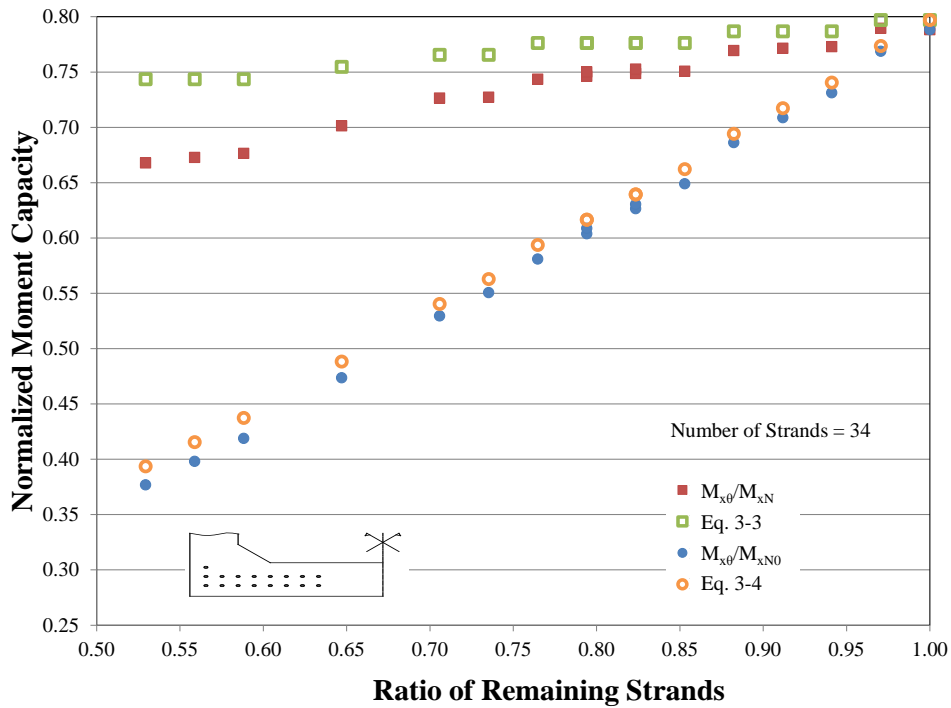
Figure 3-15 Normalized moment capacity vs. number of removed strands – Beam H.

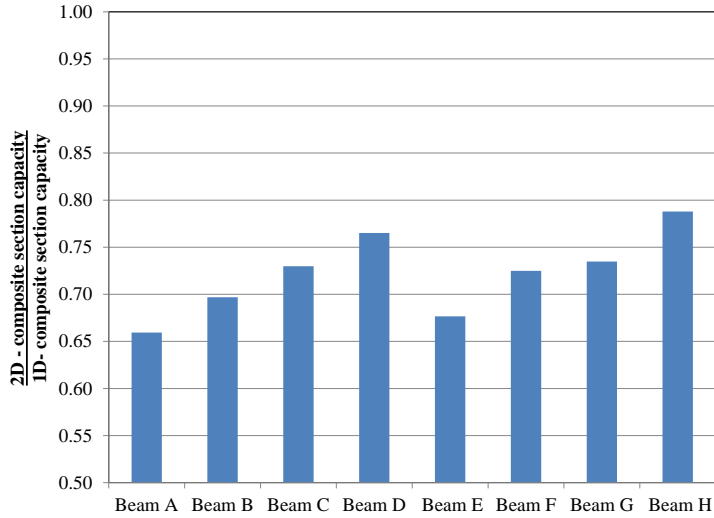
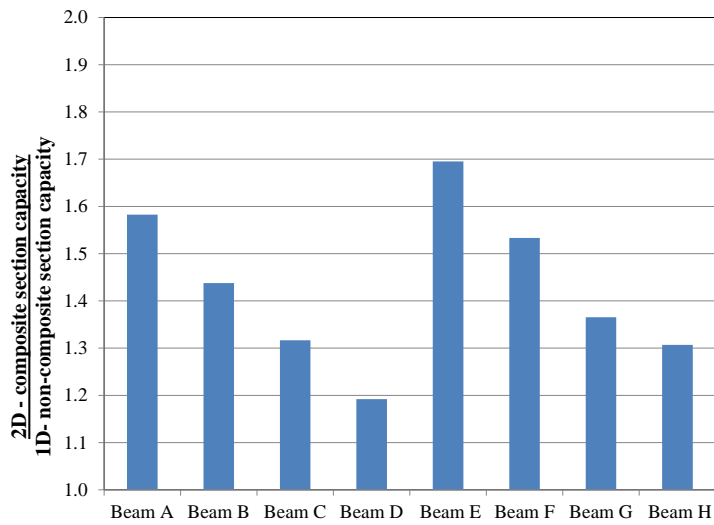
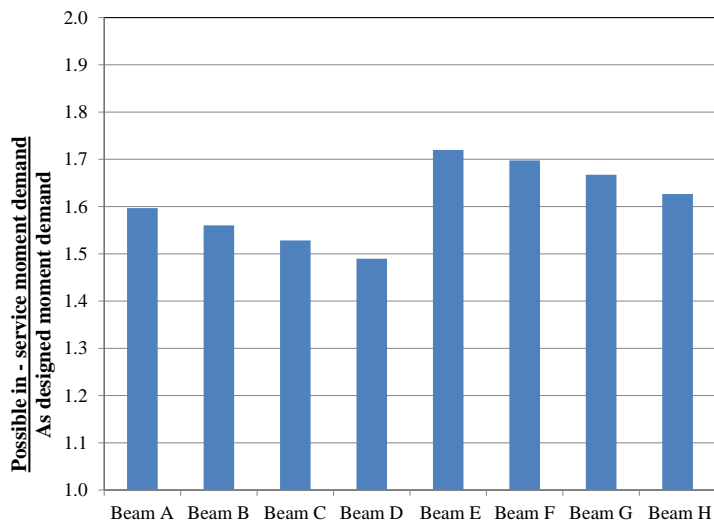
**Figure 3-16** Capacity ratios of undamaged prototype girders.

**a)** ratio capacity of girder with composite barrier wall analyzed considering neutral axis rotation (2D) versus that considering an analysis about the horizontal axis.

**b)** ratio of 2D composite barrier wall girder capacity to non composite capacity.

**c)** ratio of potential nominal load on exterior girder to nominal design load.

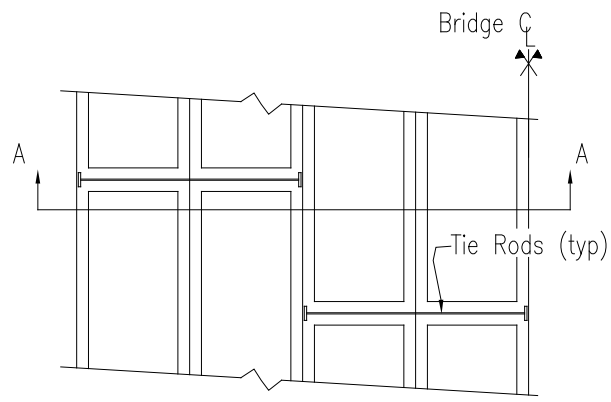
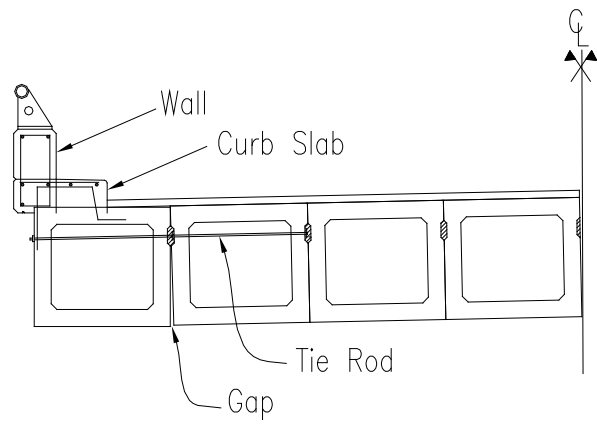
**Figure 3-17** Lake View Drive bridge – a typical AB girder span.

a) Plan View

b) Section AA

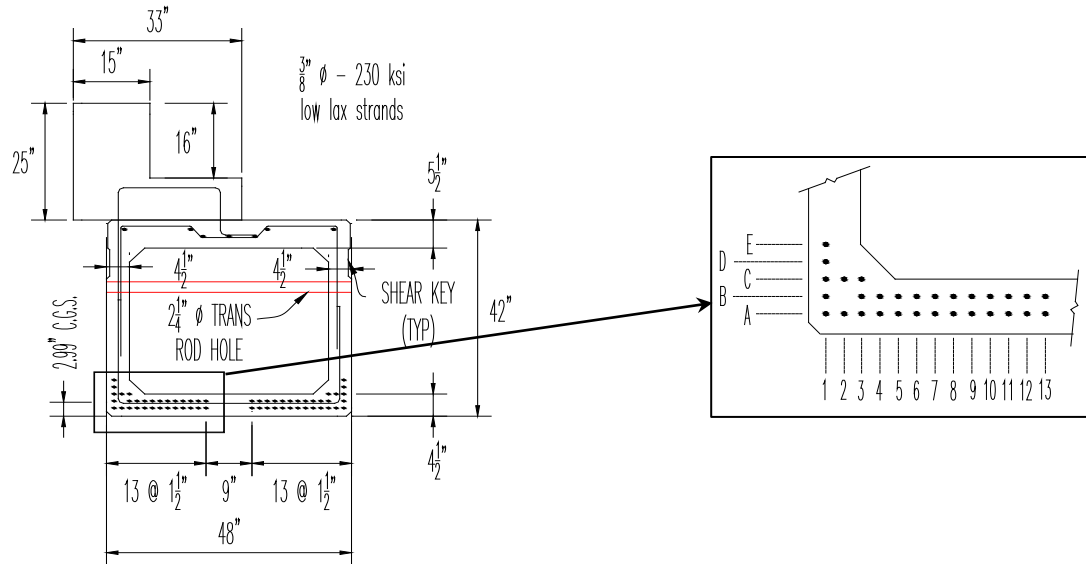
**Figure 4-1** Test girder cross section.

a) Cross section (dimensions in in. unless noted)

b) Strand labelling

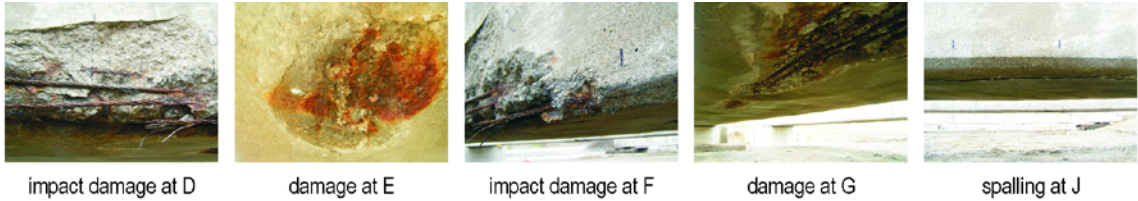
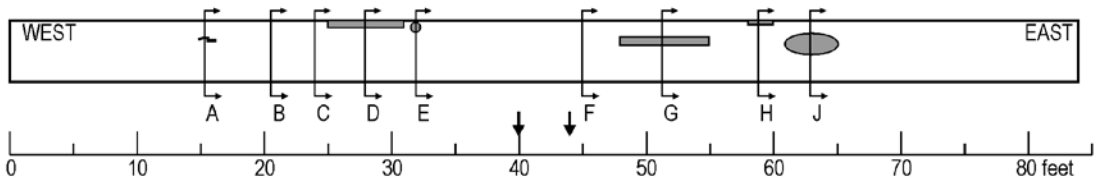
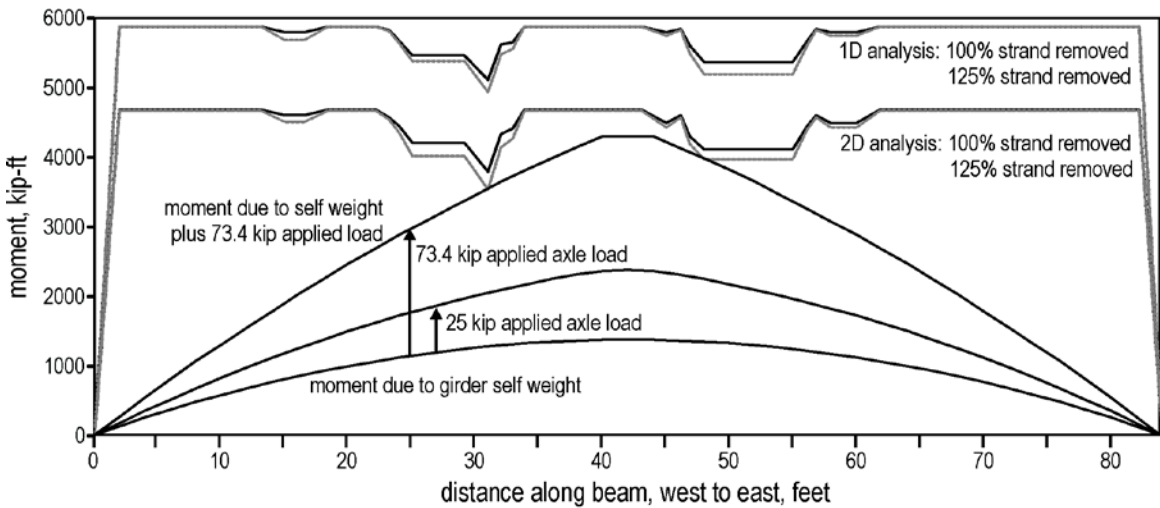
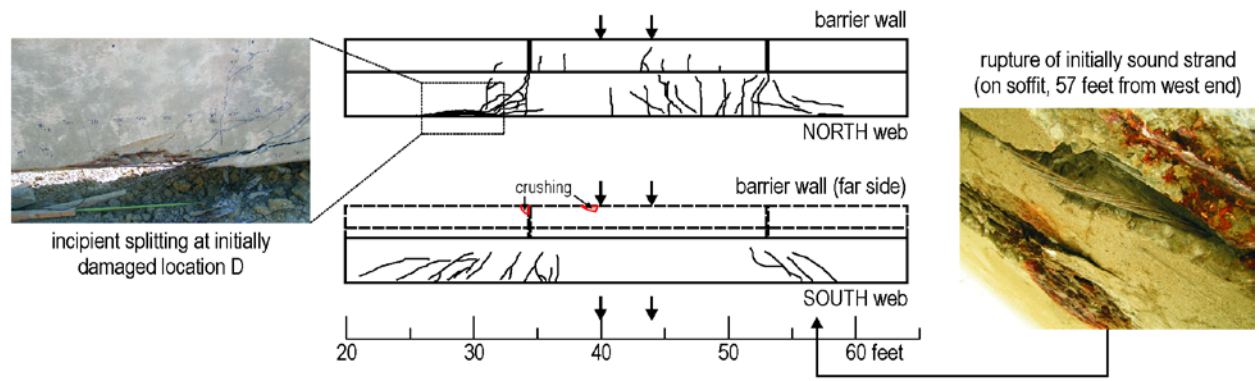
**Figure 4-2** AB test girder initial damage and experimental and predicted behavior.

a) inverted plan showing damage locations along beam soffit

b) moment capacity calculated using 1D and 2D approaches and moment curves due to applied loading

c) observed crack patterns at applied load,  $P = 73.4$  kips

<b>Damage Location</b> (see Figure 4-2a)	<b>Affected Region</b> (stationing from west end of girder, ft)	<b>Damage Description</b>	<b>Affected Strands</b>
A	15 - 16.5	Longitudinal crack	A12
B	@ 20	Shallow spall	none
C	@ 24	Minor impact	A1
D	25 - 31	Major impact	A1, B1, C1, D1 and A2
E	31 - 32	Exposed strands, corrosion	A2, A3, A4, A5, A6
F	@ 45	Minor impact	A1
G	48 - 55	Impact, spall and exposed and corroded strands	A8, A9, A10, A11, A12 and A13
H	68 - 61	Longitudinal crack	A1
J	61 - 64	Shallow spall	none
