**ON THE REPAIR OF IMPACT-DAMAGED PRESTRESSED CONCRETE  
BRIDGE GIRDERS**

Jarret Lee Kasan

Submitted to the Graduate Faculty of  
Swanson School of Engineering in partial fulfillment  
of the requirements for the degree of  
Doctor of Philosophy

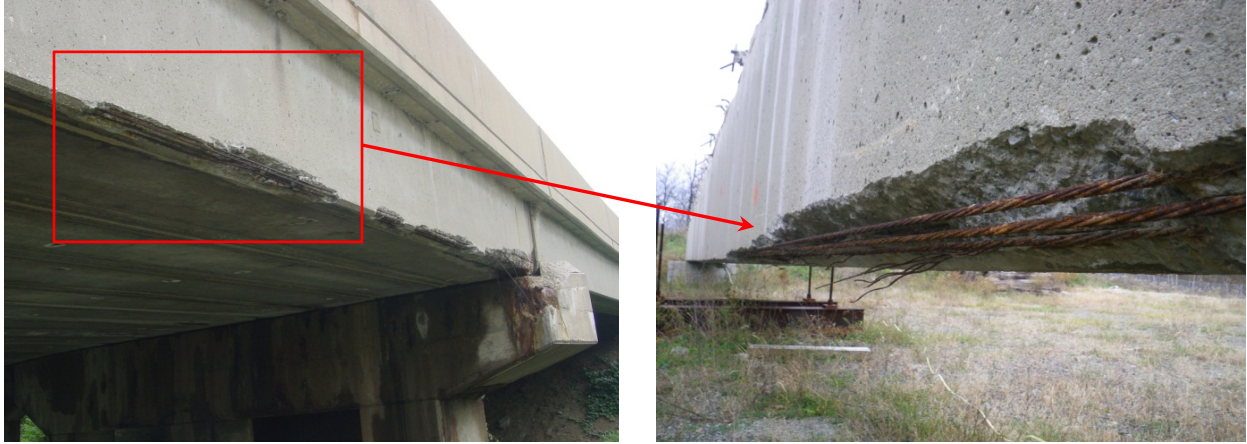
Figure 5-1 Prototype AB Girder.

a) prototype girder *in situ* (photo from PennDOT inspection report dated August 8, 2007).

b) impact damage location, considered in the Appendix A example.

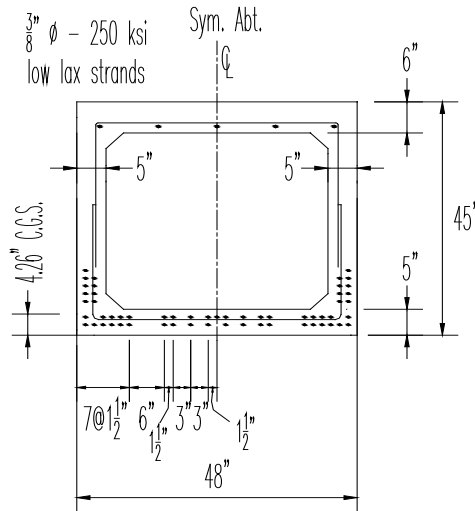
Figure 5-2 Prototype AB Girder Cross Section.

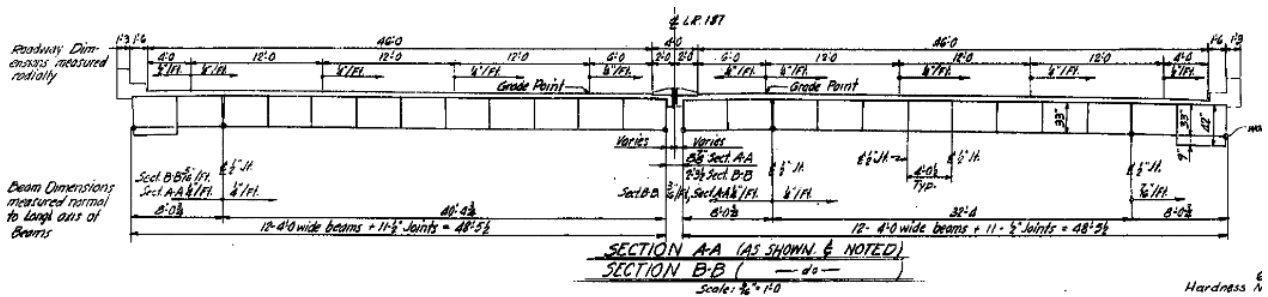
Figure 5-3 Prototype AB Bridge Cross Section.

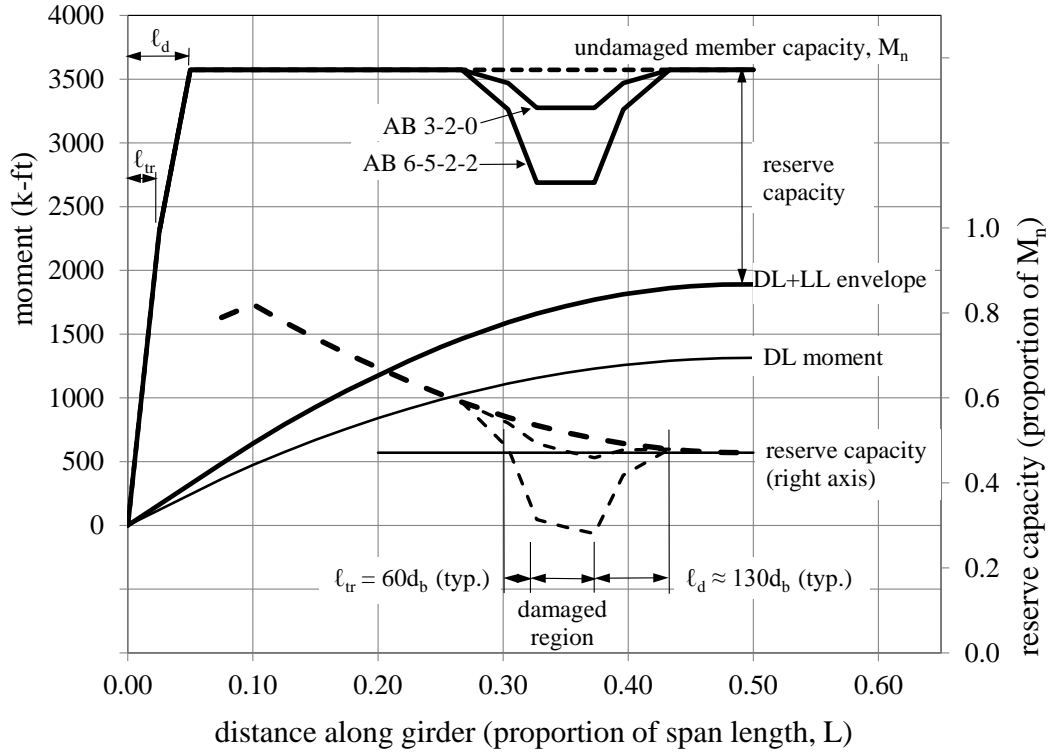
Figure 5-4 Girder Moment Envelopes.

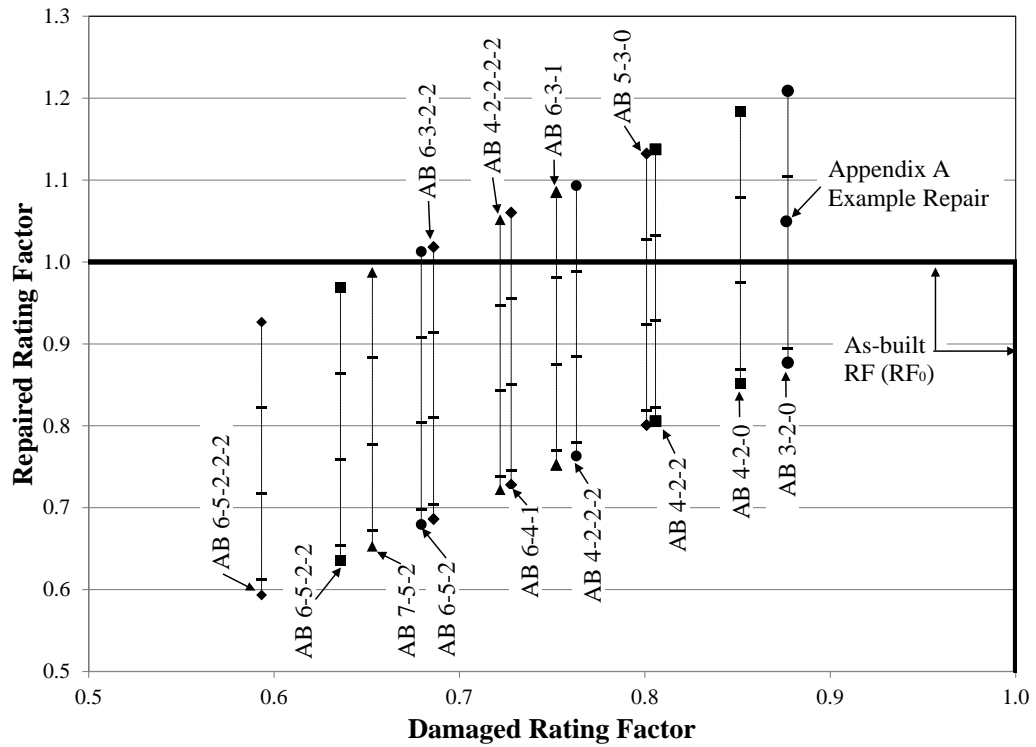
Figure 5-5 Repaired versus Damaged Rating Factor Plot.
