**INVESTIGATION OF THE BEHAVIOR OF EXTERNAL
CFRP-TO-INTERNAL REINFORCING BAR SPLICES**

Submitted to the Graduate Faculty of
The Swanson School of Engineering in partial fulfillment
of the requirements for the degree of
Master of Science

University of Pittsburgh

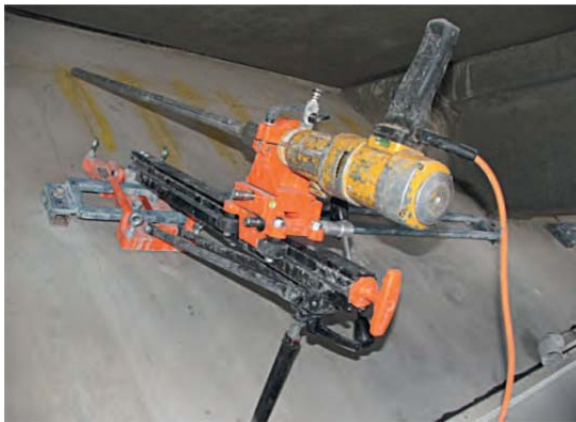
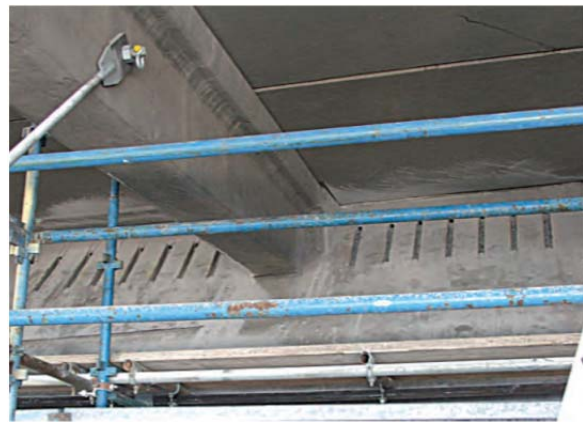
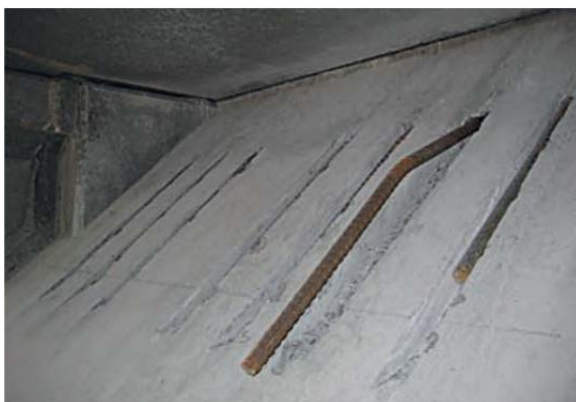
(a) Drilling chase in inclined concrete web.

(b) Completed chases.

(c) 20 mm bar installed in chase.

(d) FRP overlaid chases.

Figure 1.2 Sequence of West Gate FRP anchorage installation (Williams et al., 2011).

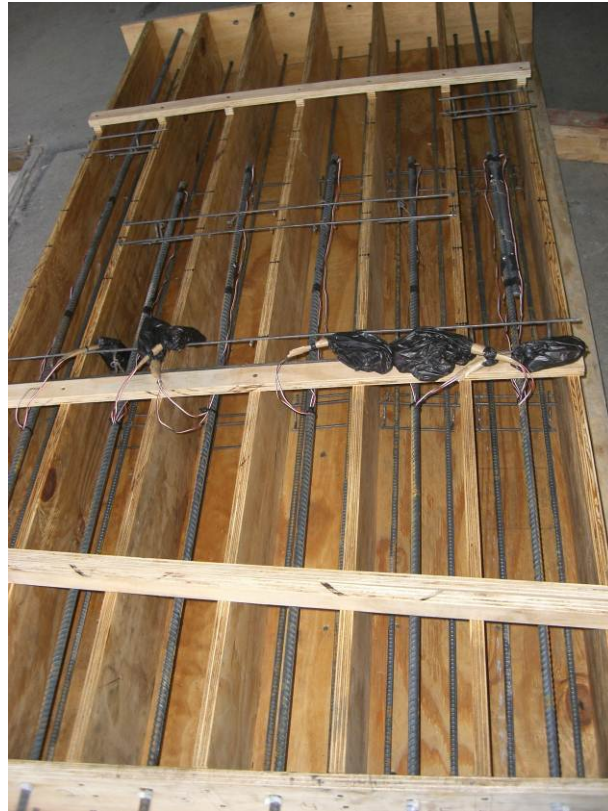
Figure 2.1 Arrangement of forms prior to casting concrete.

in their inverted position (Figure 2.1), and to ensure that the beams would not be damaged during handling, each beam had two #3 bars (9.5 mm) in the compression zone (tension zone in casting position). These bars were provided with 1 in. (25 mm) of concrete cover all around. Each beam had varying primary flexural reinforcement as described below.

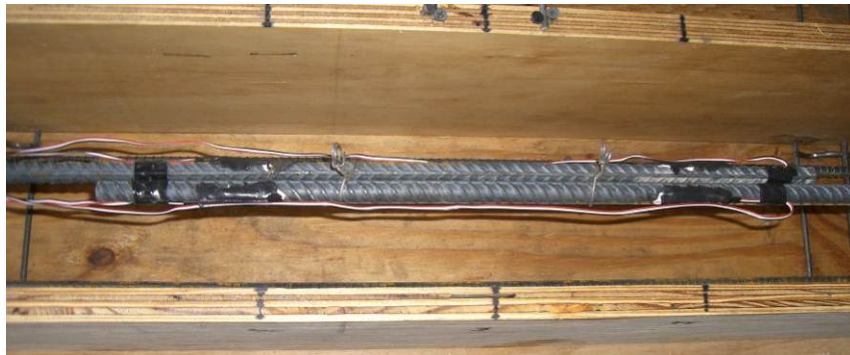
(a) Elevation.

(b) Inverted plan (strain gauges mounted on both bars at locations shown).

(c) Section A-A.

(d) Section B-B.

(e) Photograph of lap splice for Beam C-S-18.

Figure 2.3 Beam C-S-18 having conventional lap splice.

Based on ACI 318 (2011) §12.2.2 development length requirements, the simplified required splice length to develop a 60 ksi (420 MPa) #4 reinforcing bar in 5000 psi (34.4 MPa) concrete is 17 in. (432 mm). Using the more refined ACI 318 §12.2.3 (Eq. 1.8), the required splice length is 7.3 in. (185 mm), although §12.2.1 limits the development length to no less than 12 in. (305 mm). Finally, using AASHTO (2010) §5.11.2.1.1 (Eq. 1.10), the basic required splice length is 12.7 in. (305 mm). Thus, the 18 in. (457 mm) lap splice provided should be more than adequate to fully develop the spliced bars and is compliant with both ACI 318 and AASHTO LRFD requirements. Calculations of required lap lengths are provided in Appendix A.

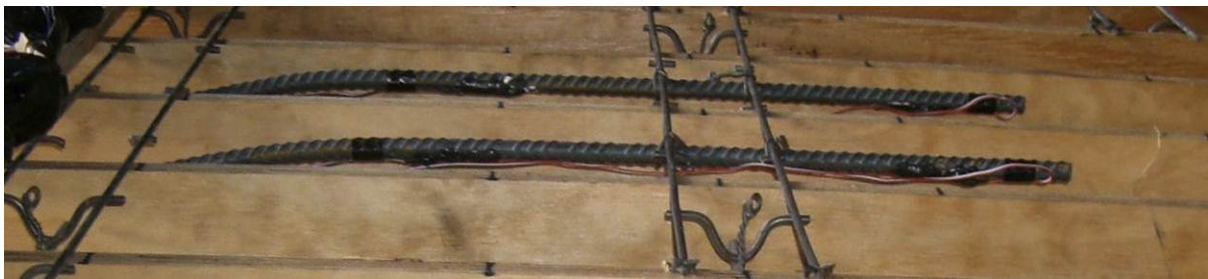
(a) Elevation.

(b) Inverted plan (strain gauges on internal steel and CFRP as shown).

(e) Section E-E.

(f) Photo of cranked bars (S-18-B and S-6-B shown) prior to casting concrete.

Figure 2.5 Beam S-18-B having contact CFRP-rebar splice.

Beam S-18-B was identical to S-18 except that the #4 bar was bent or ‘cranked’ as shown in Figure 2.5 such that the bar was aligned along the surface of the concrete. In this way, the 18 in. (457 mm) long spliced lengths of CFRP and reinforcing steel are in contact.

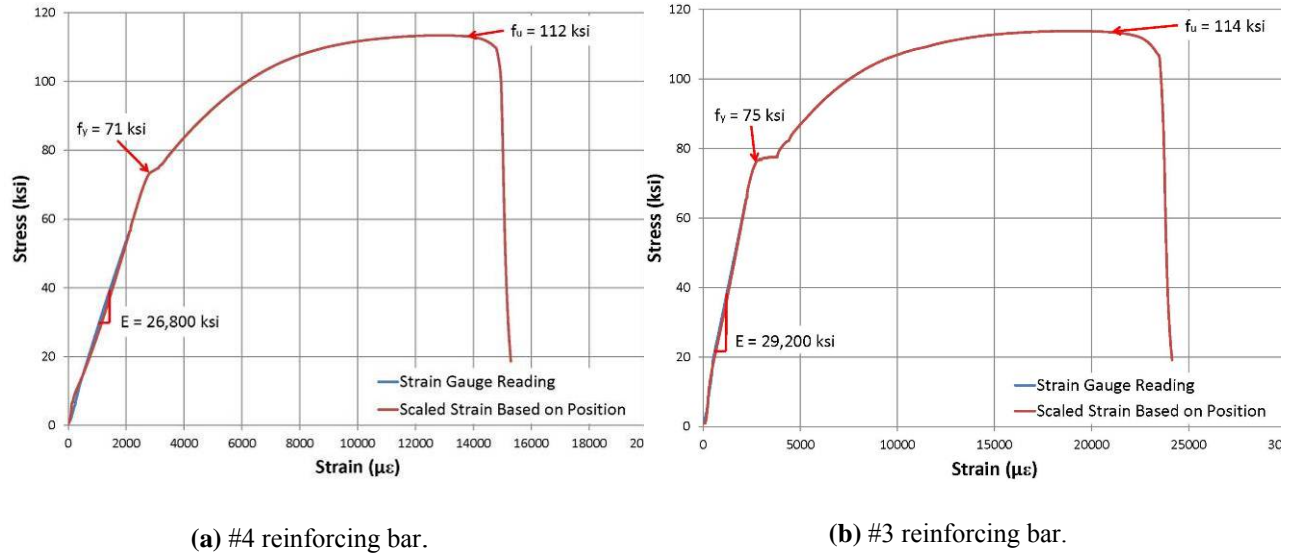
Figure 2.8 Representative results from reinforcing bar tests.

#4 primary reinforcing bars	#3 compression bars
Samples tested	n = 2	n = 2
Yield stress	$f_y = 71$ ksi (490 MPa)	$f_y = 75$ ksi (517 MPa)
Ultimate stress	$f_u = 112$ ksi (772 MPa)	$f_u = 114$ ksi (786 MPa)
Experimentally determined modulus	E = 25600 ksi (177 GPa)	E = 29500 ksi (203 GPa)

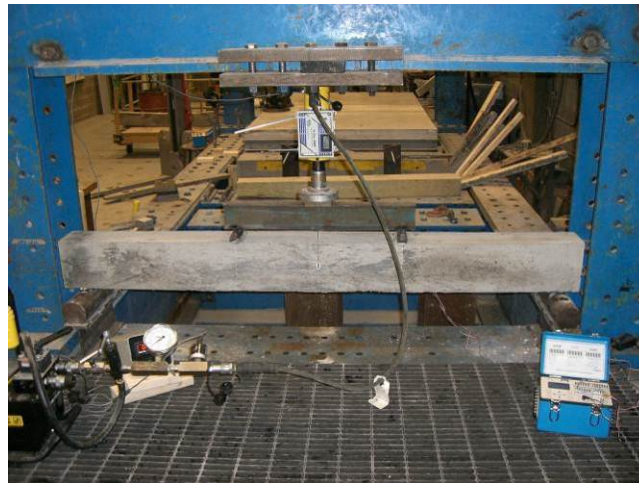
(a) Schematic diagram of beam test set-up.

(b) Photograph of beam tests set-up.

Figure 2.9 Beam test set-up.

All beams were subject to four-point flexure to failure. The shear spans and constant moment regions were each 26 in. (660 mm) long as shown in Figure 2.9. Load was applied using a 40 kip (178 kN) capacity hydraulic ram and spreader beam. The ram was equipped with a ball-joint connection at the spreader beam and both load points at the beam were 0.5 in. (12.7 mm) radius steel rollers on 0.5 in. (12.7 mm) thick steel plates. Support conditions had 0.5 in. (12.7 mm) steel plates resting on 2 in. (50.8 mm) radius rollers. All four steel plates (two load points and two supports) were ‘capped’ onto the beams using a high-strength plaster compound. Vertical displacements at midspan were measured using a draw wire transducer (DWT) whose wire was attached to the beam at its mid-depth at midspan. Load was initially applied in 200 lb (890 N) intervals until large midspan deflections resulted following apparent yield of the reinforcing steel. Following yield, data was recorded at deflection increments of 0.1 in. (2.5 mm) until the end of the test. At each interval, loading was held for approximately 10 seconds to provide time for manual recording of strain gauge readings and displacement.

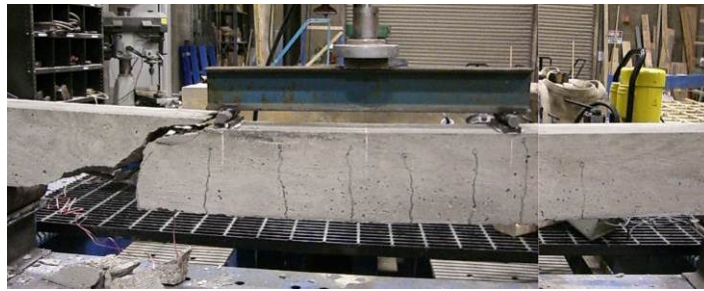
Figure 2.11 Photograph of beam C cracking after failure (collage of two images).

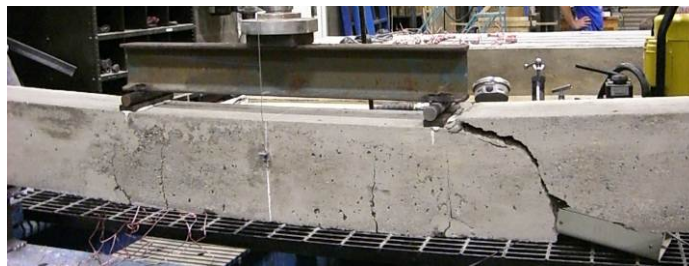
Figure 2.14 Photograph of beam C-S-18 cracking after failure.

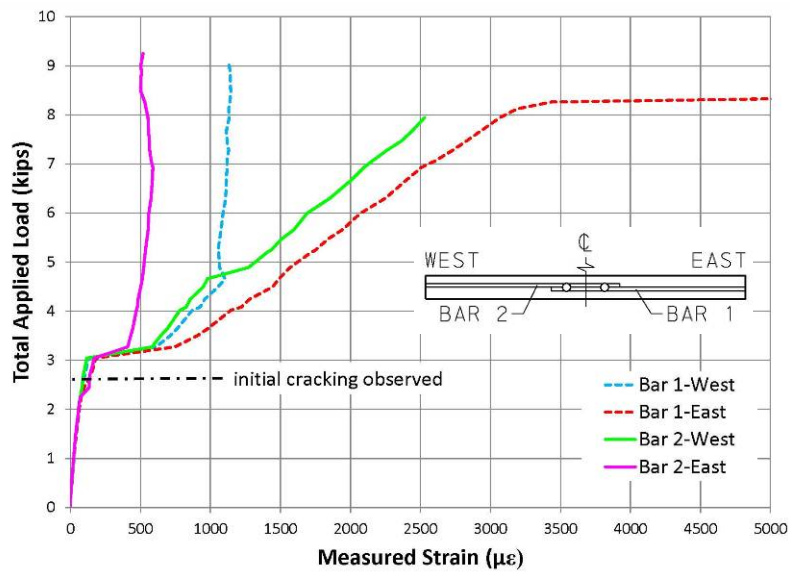
Figure 2.15 Beam C-S-18 strain response of primary reinforcement.

Beam C-S-18 was designed to have an equal capacity to beam C. This was observed in the test data as the beams demonstrated essentially identical behavior. Strain gauge data for beam C-S-18 illustrates the theoretical behavior of lapped bars well. The observed strains near the bar ends (Figure 2.15; bar 1 West and bar 2 East) appear to plateau with increasing loads, indicating that the bar has a limited ability to develop stress at the strain gauge location due to the bar's limited development length at this location. The strain gauges farther from the bar ends (bar 1 East and bar 2 West) observed higher strains and corresponded well with strains observed in beam C (Figure 2.12). The results from beam C-S-18 indicate that the 18 in. (457 mm) conventional lap splice behaved as expected and was adequate to fully develop the #4 bar provided. As shown in Figure 3.1, beam C-S-18 exhibited slightly stiffer behavior and had an ultimate capacity 4.4% higher than beam C. Generally speaking this is an anticipated variation, which is likely due to the marginally stiffer region in the area of the splice. Although the bars are not necessarily fully developed within the spliced region, the provided splice was longer than the required development length of the bars. This means that there are regions along the splice where the lapped bars have greater ability to resist flexure than that of a single continuous bar, hence the marginally stiffer behavior. The first observed cracking in both beams occurred at relatively

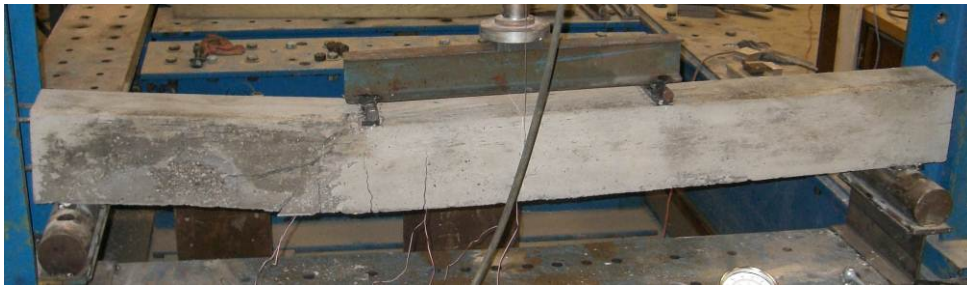
Figure 2.17 Photograph of beam S-18 cracking after failure.

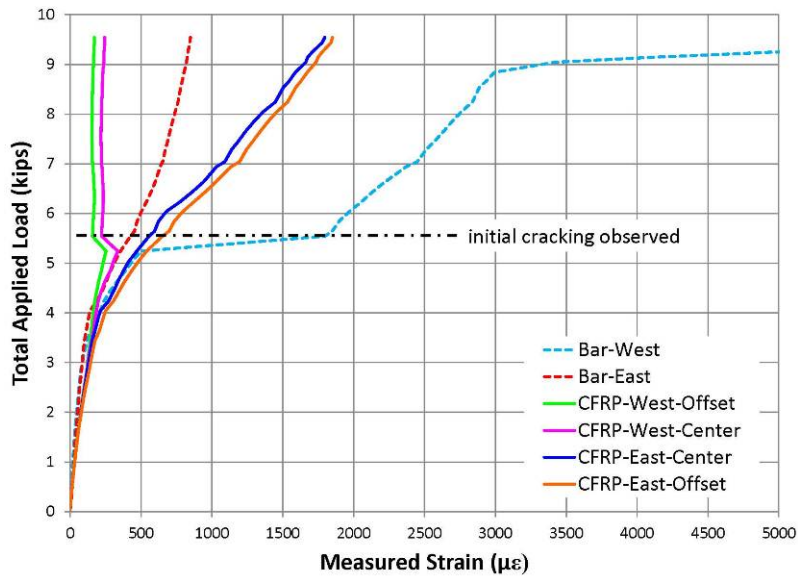
Figure 2.18 Beam S-18 strain response of primary reinforcement.

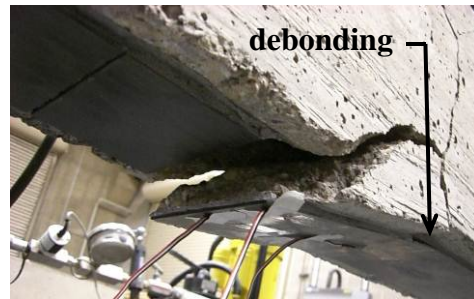
(a) Photograph of S-6 cracking.

(b) Photograph of debonding failure.

Figure 2.23 Photograph of beam S-6 cracking after failure.

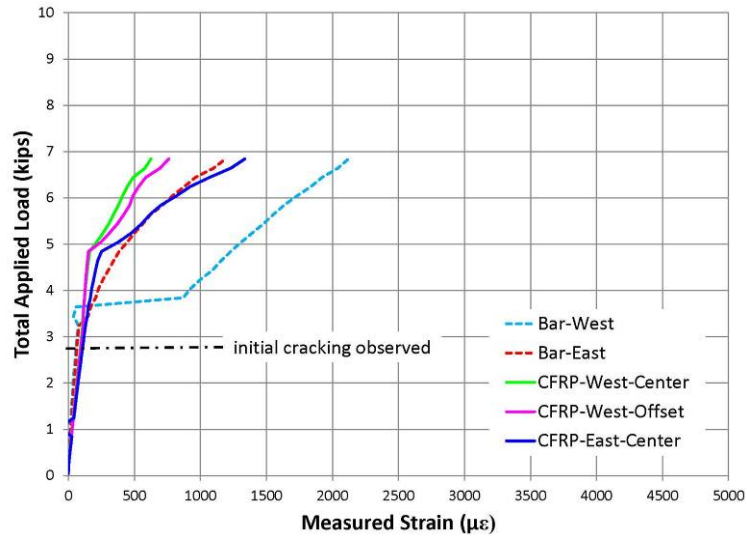
Figure 2.24 Beam S-6 strain response of primary reinforcement.

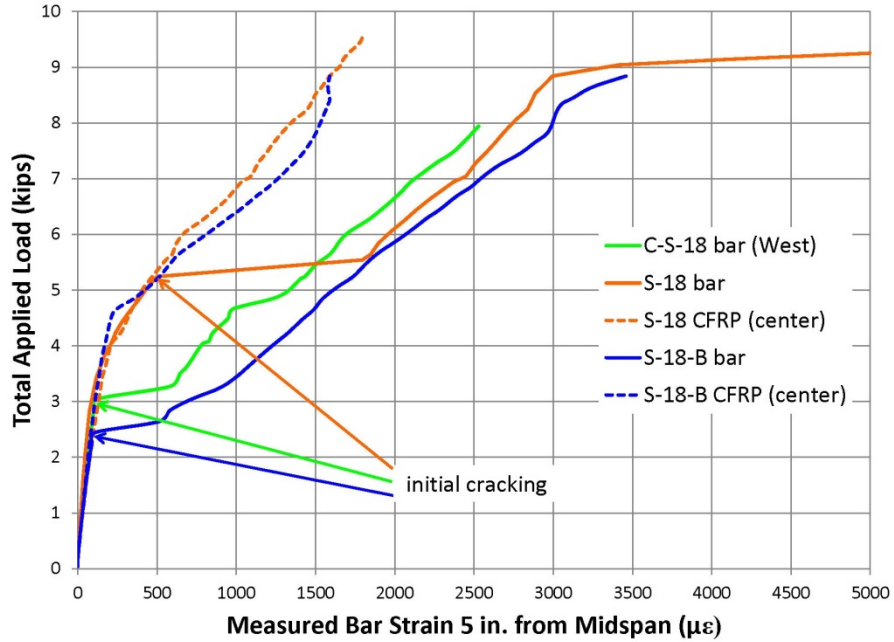
Figure 3.2 Observed reinforcement strains in beams S-18, S-18-B and C-S-18.

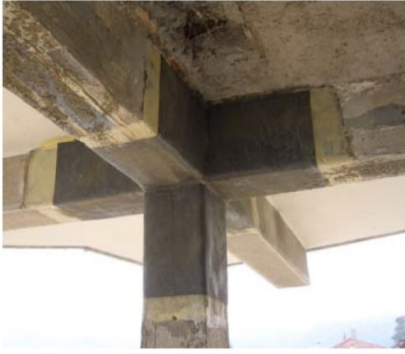
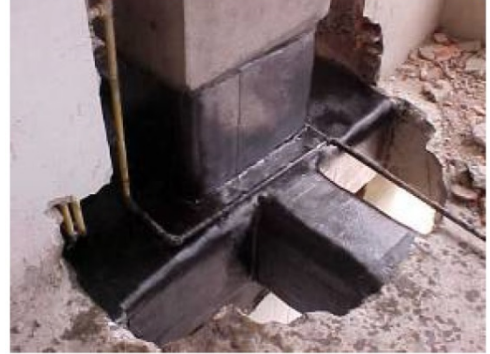
(a) Shear reinforced beam-column joint.

(b) Wrapping CFRP strips through slab.

(c) Removal of concrete volume.

Figure 4.3 *In situ* beam-column CFRP shear reinforcement details (Silva et al., 2009).

thickness of the overlaying slab in order to wrap the CFRP strips around the entire beam (Figure 4.3b), or even removal of the entire slab to expose the beam to be retrofitted. The proposed detail (Figure 4.4) eliminates the need to drill through the slab or remove any significant volume of concrete to construct, once again reducing construction and design efforts. An additional disadvantage of the *in situ* details shown in Figure 4.3 is that they may increase the stiffness of the beam-column joint, which may affect stress distribution and performance of the structure particularly under seismic loading conditions. Such reinforcement may require additional retrofit elsewhere along the load path.
