**STRUCTURAL EVALUATION OF SLAB REHABILITATION BY METHOD OF
HYDRODEMOLITION AND LATEX MODIFIED OVERLAY**

Master of Science in Civil Engineering

University of Pittsburgh

2013

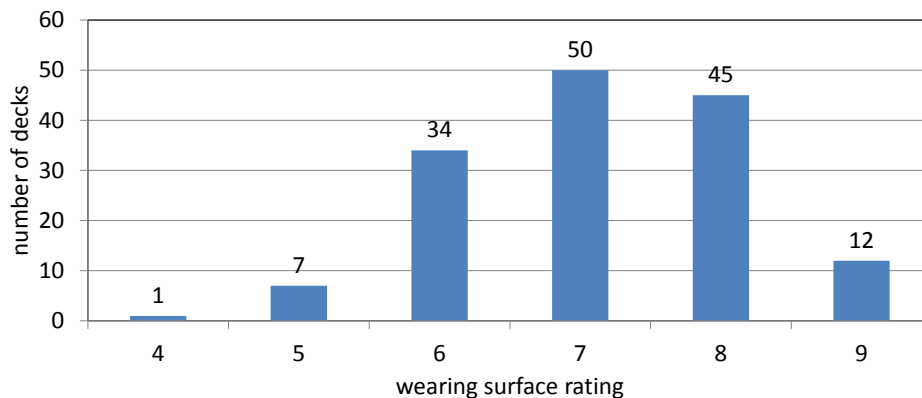
Figure 5: Distribution of wearing surface ratings for LMC-Overlaid Bridge Decks

A review of available inspection reports and construction documents was carried out to assess the condition and performance of latex modified concrete (LMC) overlays in the local PennDOT district (District 11). The review was carried out in February 2013. Initially, the bridge management system (BMS) was queried to identify bridges within the district that had a LMC overlay applied. This search returned 149 bridges (8% of those in D11) representing over 3 million square feet (280,000 m²) of deck area (20%). Overlays (based on ‘year of reconstruction’) range from less than one year to 40 years old. Wearing surface thicknesses of up to 3.5 in. (8.9 mm) were reported. Wearing surface ratings range from 4 to 9 with the majority of ratings at or above 6 as shown in Figure 5. Figure 6 plots the wearing surface ratings against the reported year of reconstruction. As one would expect, bridges repaired more recently had slightly better wearing surface ratings than those with older repairs (as shown by trendline in Figure 6).

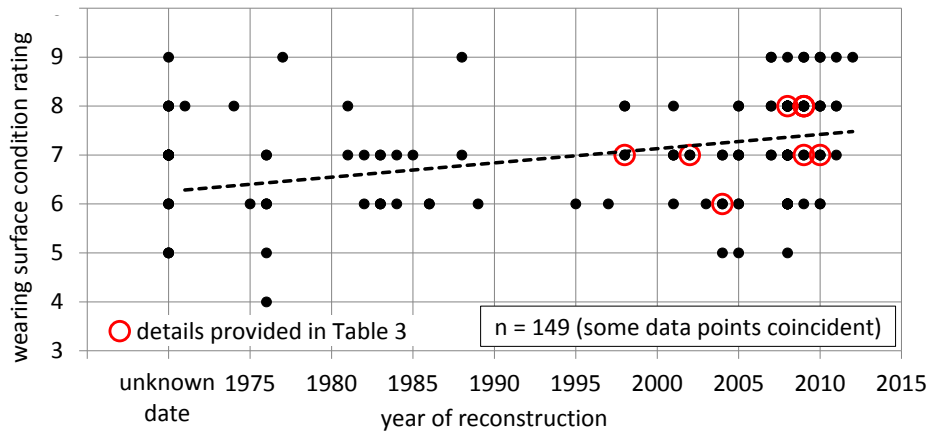
Figure 6: Wearing Surface Condition vs. Year of Reconstruction for LMC-Overlaid Bridge Decks

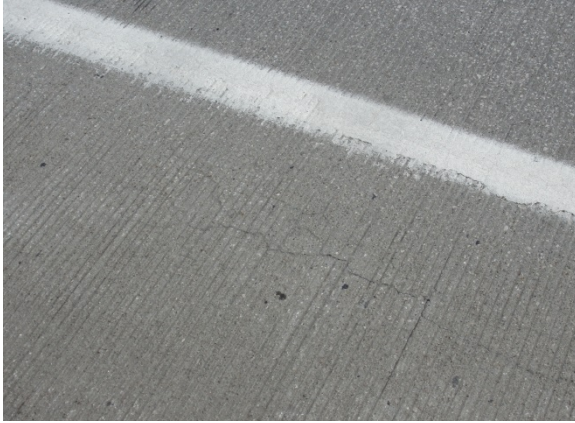
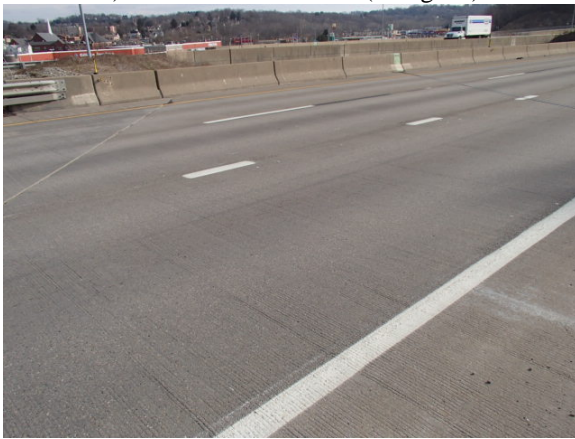
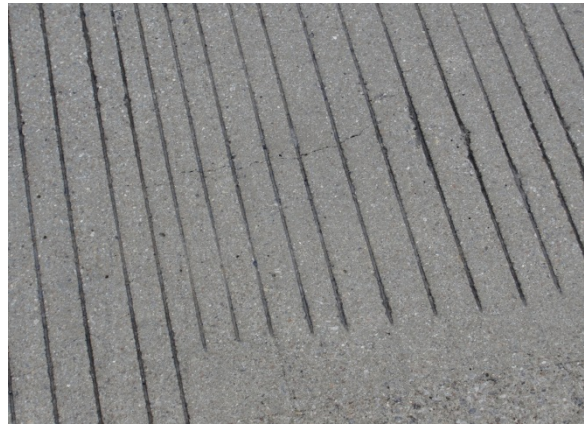
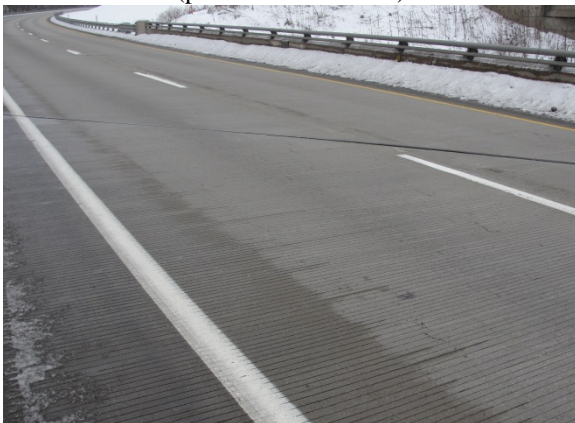
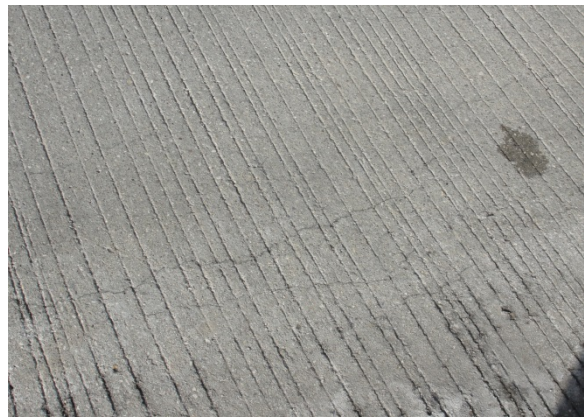
a) Minor hairline cracks (Bridge A)

b) Minor hairline cracks (Bridge B)

c) LMC Overlaid Deck of Bridge C
(photo taken 1.14.13)

d) Minor Hairline Cracks (Bridge D)

e) LMC Overlaid Deck of Bridge E

f) Hairline Longitudinal Cracks (Bridge F)

Figure 7: Photos Reflecting Inspection Notes For Bridges Reported in Table 3

- I. The Latex Modified Concrete (LMC) wearing surface is in overall good condition. Areas of moderate density hairline mapcracking are present in the northbound right lane and shoulder areas throughout. Multiple longitudinal hairline cracks are present throughout the northbound right lane for the full length of the bridge. Random transverse hairline cracking is present throughout. Span 10 Northbound deck right lane exhibits a 6 inch (152.4 mm) diameter by 3/4 inch (19.1 mm) deep shallow spall. The deck wearing surface at Pier 12 is chipped along the sawcut paving joint with missing joint filler. No significant change in the wearing surface has been noted since the 2011 Deck Wearing Surface cracking inspection.

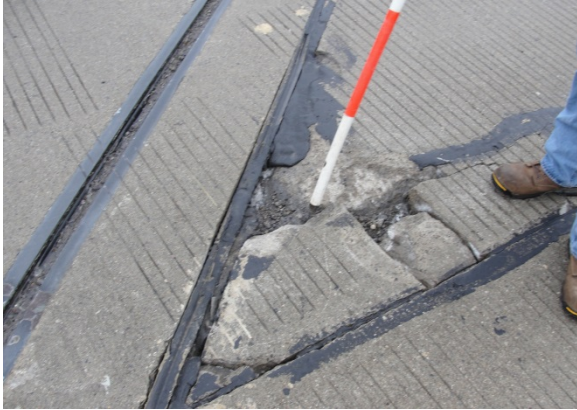
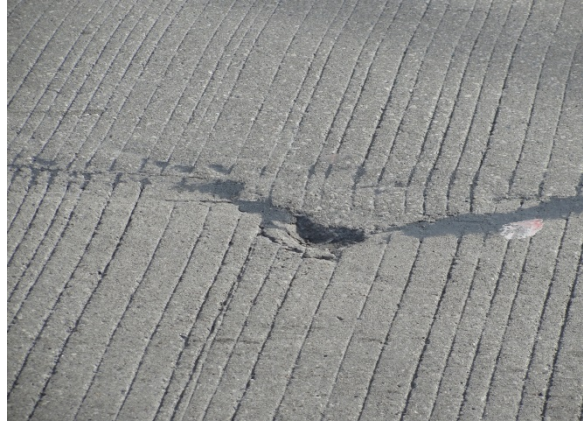
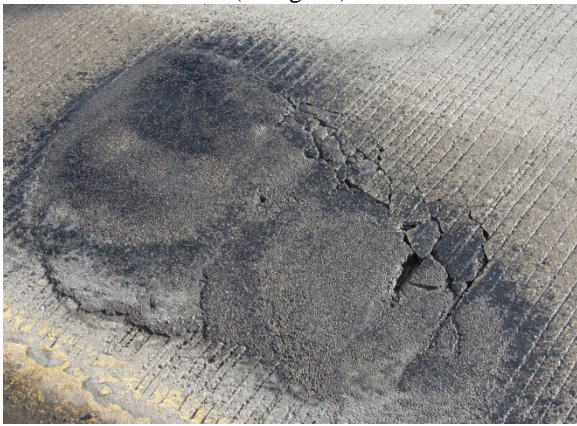
a) Damage to LMC overlay at location of acute skew (Bridge D)

b) Apparent Pop-out of LMC (Bridge F)

c) Mortar Patch of LMC (Bridge F)

Figure 8: Observed Local Damage to LMC Overlays

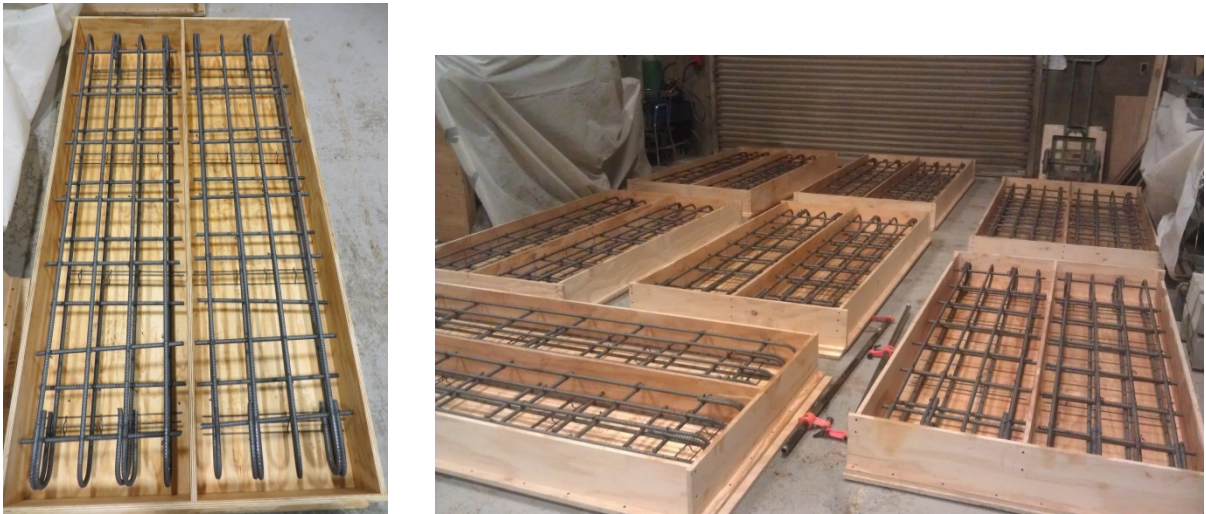
Figure 10: Laboratory Slab Forms Prior to Placing Concrete

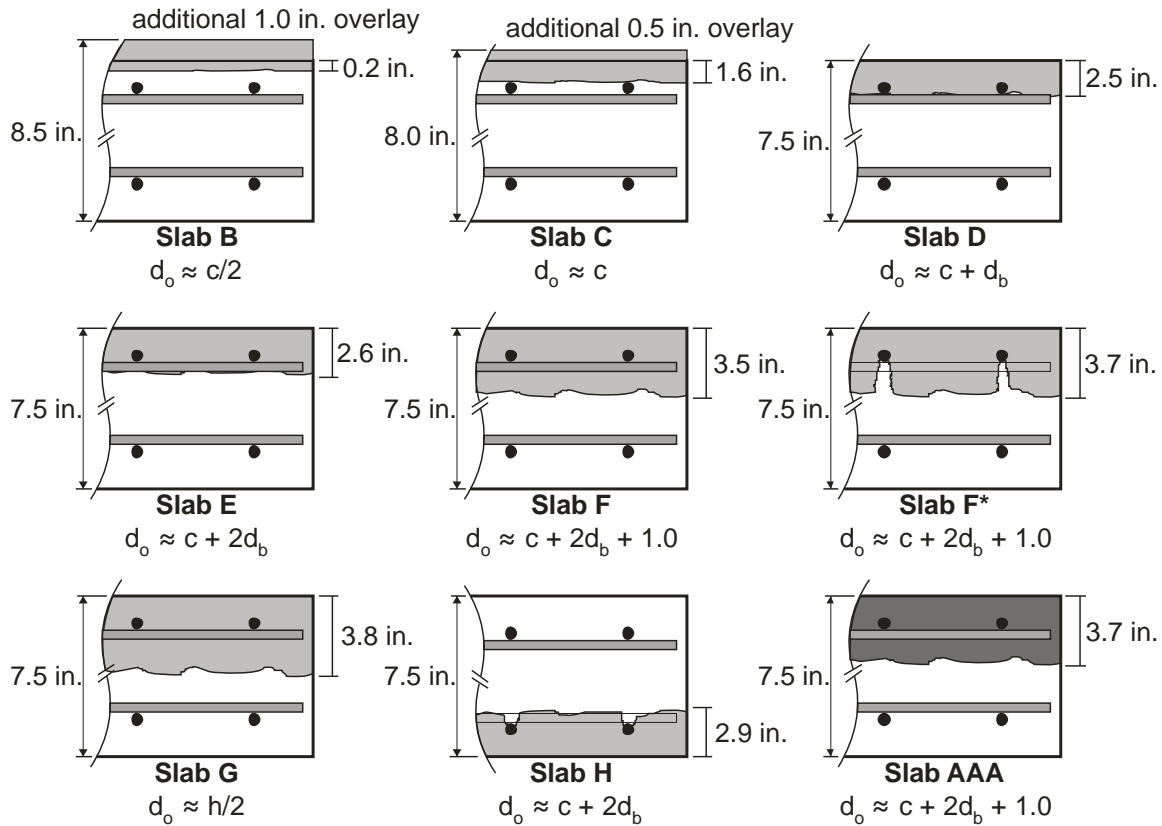
Figure 12 indicates the average measured depth of LMC calculated from the recorded depths from six measurement points across the approximately 66 x 22 in. (1676 x 559 mm) extent of HD (Figure 11) as recorded in Table 4. These depths were measured perpendicular to a level placed across the top of the formwork prior to LMC placement. This method is similar to that used by PennDOT to record such depths in the field. In order to be consistent with field practice, a minimum depth of LMC was provided; this required increasing the overall depth of Slabs B and C to 8.5 and 8 in. (216 and 203 mm), respectively.

Figure 12: Schematic Details of all Laboratory-cast LMC Slabs

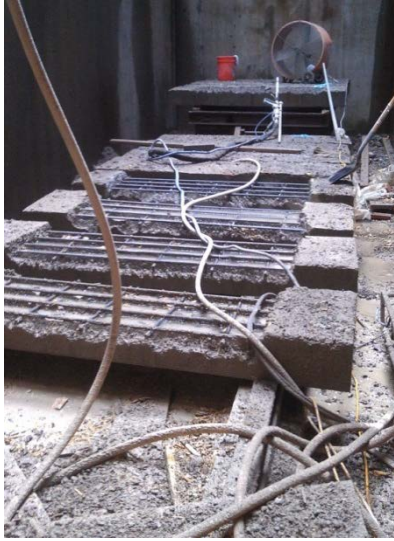
a) Slabs During Hydrodemolition

Finally, the LMC overlays were applied on March 29, 2013 by a PennDOT-approved contractor (Figure 15d). Following LMC application, the slabs were kept under wet burlap for 7 days and then allowed to cure in ambient laboratory conditions.

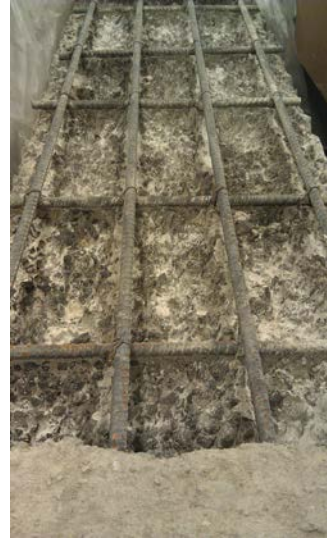
b.) Hydrodemolished Surface Profile

Figure 15: HD and LMC Installation Process

The laboratory slabs were cast on January 16, 2013. Conventional hydrodemolition – using a manual wand – was carried out by an approved contractor from March 18, 2013 to March 20, 2013 when the laboratory slab concrete was at least 63 days old (Figure 15a). Marshall Ave. slabs M3 and M4, were prepared at the same time.

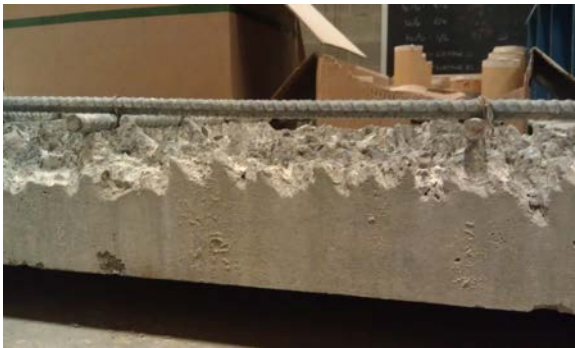
c.) "Shadows" Removed

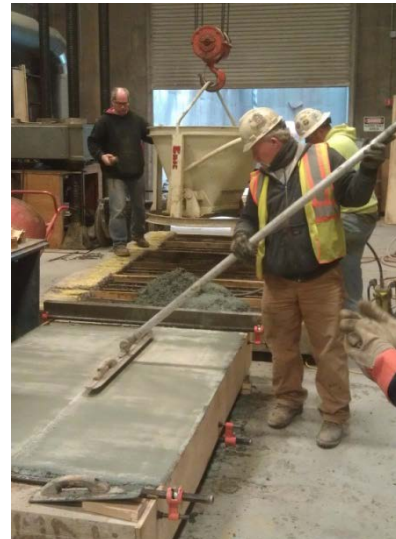
d) Installing LMC Overlay

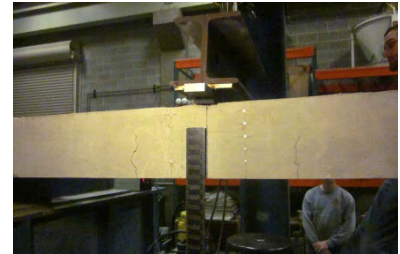
b) DEMEC and Vertical deflection instrumentation

Figure 16: Test Set-Up and Instrumentation

DEMEC targets having an 8 in. (203 mm) gauge length are applied at mid-span on both sides of the slab. The DEMEC instrument used (Figure 16c) has a resolution of 8 microstrain. Target locations vary vertically for each slab but were selected to capture at least the following:

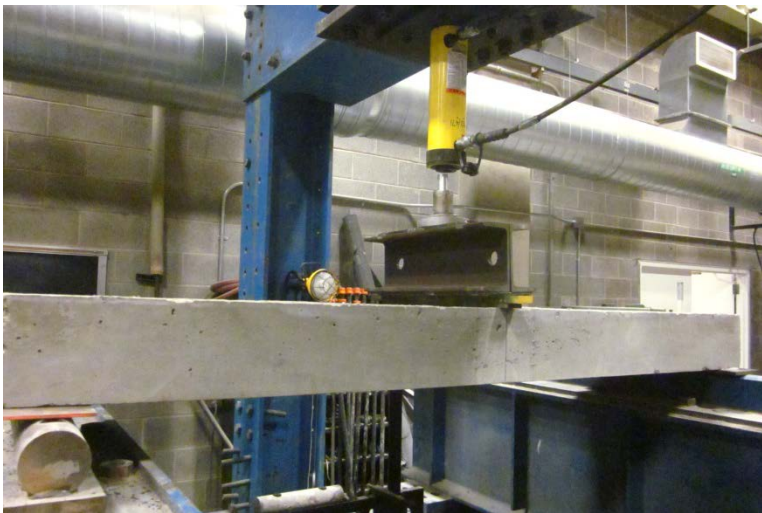
a) Test Set-up (Slab A shown)

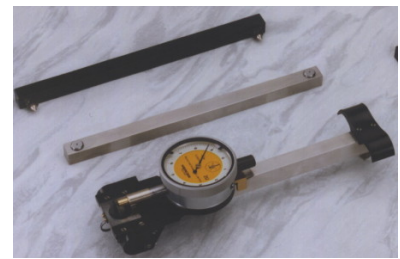
c) DEMEC Reader
 (wexham-developments.co.uk)

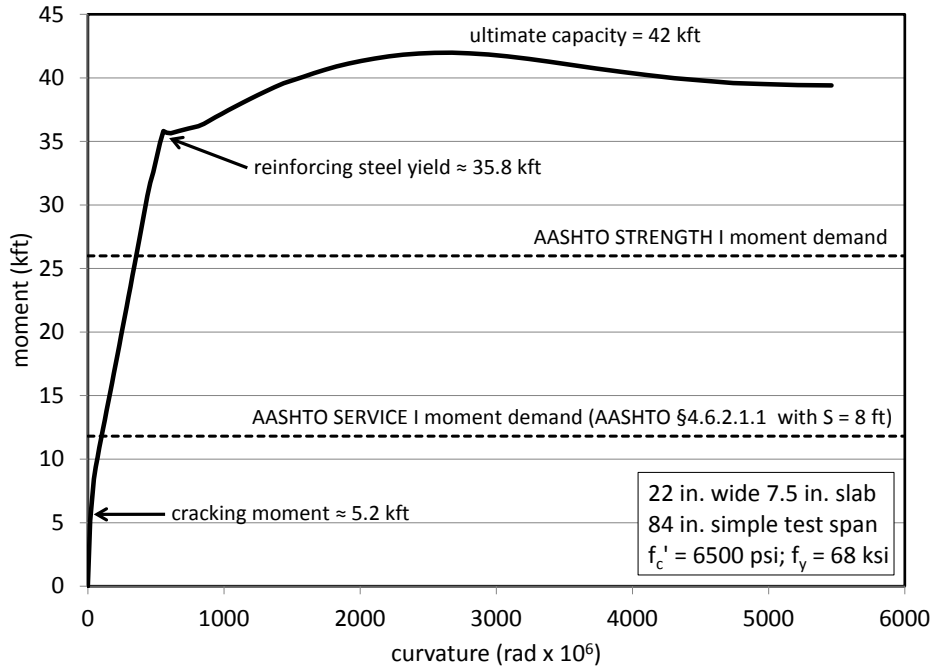
Figure 17: Predicted Moment-Curvature Behavior of Laboratory Control Slab

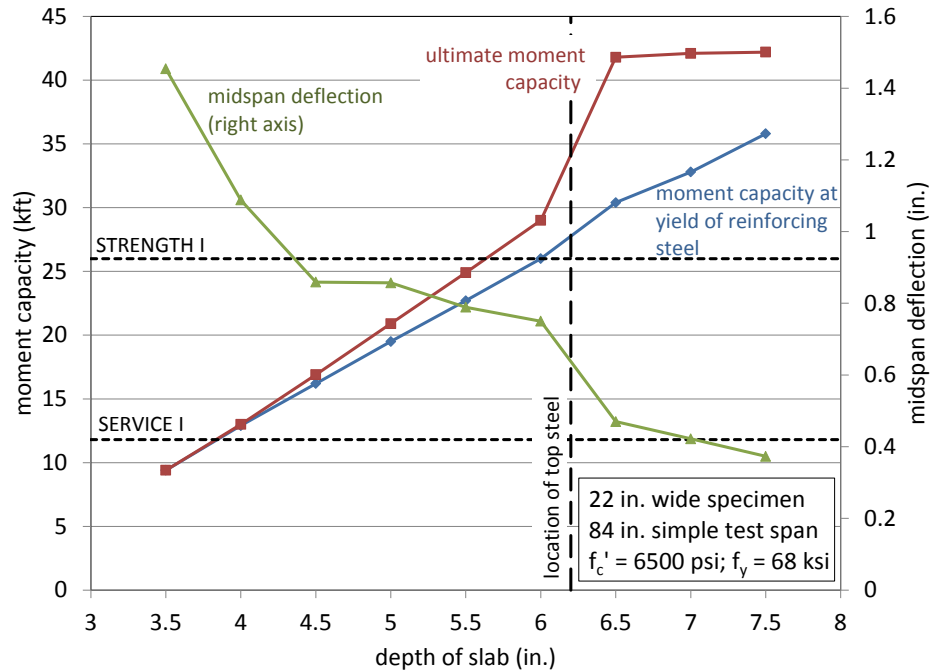
Figure 18 presents the slab moment capacity with decreasing concrete depth as concrete is removed from the top of the slab; essentially the capacity of the slab as it is subject to HD. The data shown represents a series of plane sections analyses conducting using program RESPONSE. The slab depth is measured from the soffit. Once the slab depth falls below the layer of the top reinforcing steel (at 6.2 in. (157 mm)), the contribution of the top steel is neglected (hence the step in the ultimate capacity curve). In terms of capacity, Figure 18 demonstrates that a slab of 6.0 in. (152 mm) is required to resist the factored load demand (STRENGTH I) while a 4 in.(102 mm) slab is adequate to resist the nominal demand (SERVICE I). The predicted ultimate deflection for a 7.5 in.(191 mm) slab is $s/225$; this falls to $s/112$ and $s/77$ for the slabs having a thickness of 6 and 4 in.(152 and 102 mm), respectively. The slab span is $S = 84$ in. (2134 mm).

Figure 18: Predictions of Laboratory Slab Behavior if LMC does not contribute to Slab Capacity

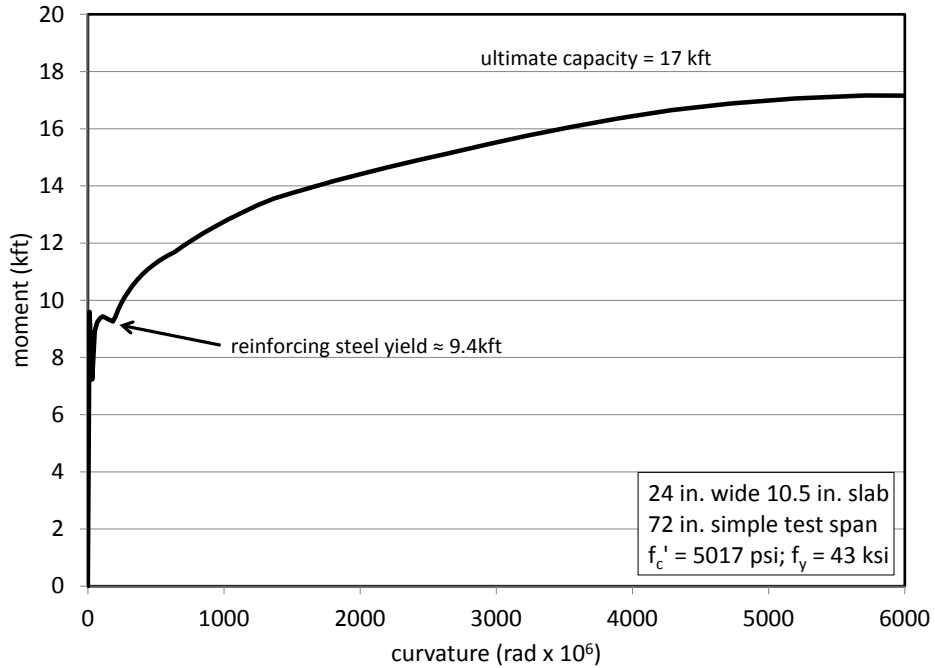
A RESPONSE model was also used to establish a baseline for the Marshall Ave. specimens. The moment curvature response is shown in Figure 19. This model was generated for measured material properties and geometry of the cross-section depicted in Figure 13. In these very lightly reinforced slabs, the pre-cracking behavior is not noticeable, since steel yields at approximately the same time as cracking occurs. Additionally, since the slabs were cut transverse to their principle directions, AASHTO design moments are not applicable.

Figure 19: Predicted Moment-Curvature Response of Marshall Ave. Specimens (No Overlay)

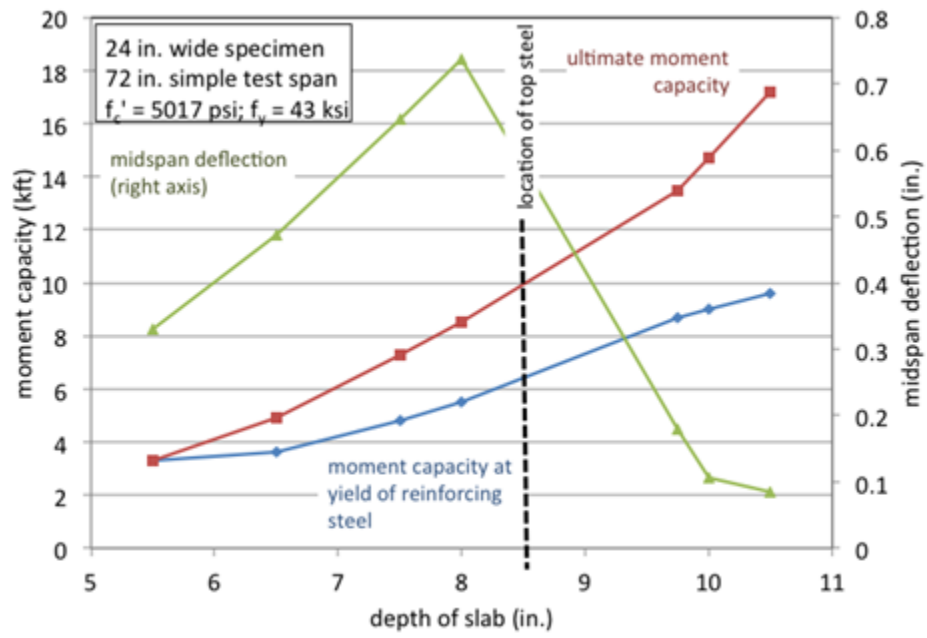
Figure 20 shows the moment capacity and deflection predictions of Marshall Ave. specimens assuming that the overlay had no contribution to the slab capacity. Once the depth of hydrodemolition was beyond the depth of the top mat of reinforcement steel, the top steel was neglected. Moment capacities exhibited similar behavior in both Marshall Ave. and laboratory specimens. Marshall Ave. slabs exhibited different deflection predictions when compared to the laboratory predictions. Deflections increase as depth is decreased to a point at which the ultimate capacity of the slab is no longer high enough to result in large deflections at which point, ultimate deflections decrease as the slab depth is reduced further.

Figure 20: Predictions of Marshall Ave. Slab Behavior if LMC does not Contribute to Slab Capacity

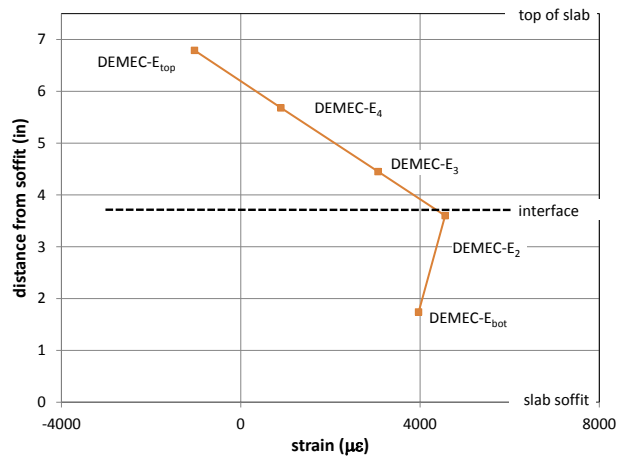
were a crack passes from outside the gage length to inside the gage length between gages – as shown in the circled region of Figure 21a – the DEMEC reading between adjacent gages is affected as shown in Figure 21b. In the case shown in Figure 21, three cracks are included in the top four gages. The right-most crack passes outside the gage at the bottom DEMEC gage; the associated crack width (strain) is therefore not captured in the reading and the apparent bottom strain falls. In this case, the curvature is calculated over the linear section from the top gage to the fourth gage.

a) Crack pattern on Slab AAA (gages enhanced)

b) Strain Profile of Slab AAA (at 35.4 k-ft)

Figure 21: Example of the Effect of Crack Location on Strain Profiles (Slab AAA shown)

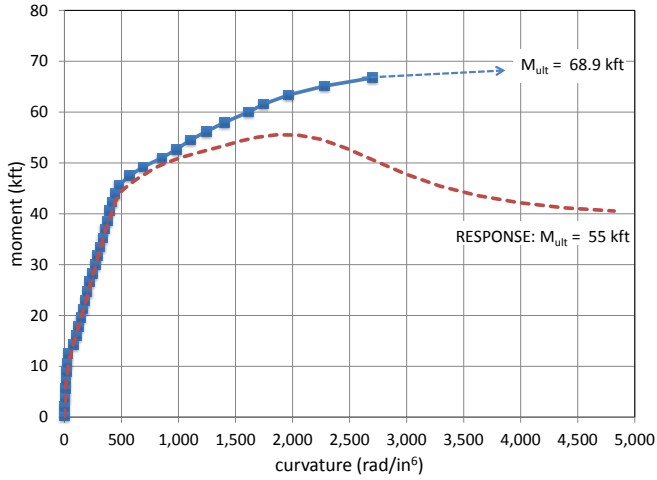
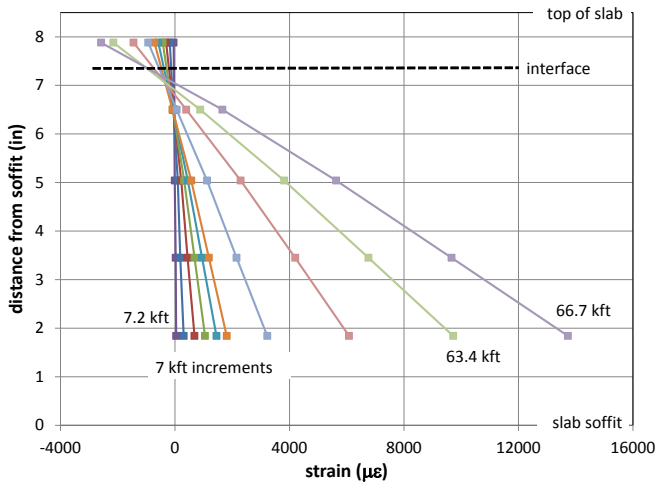
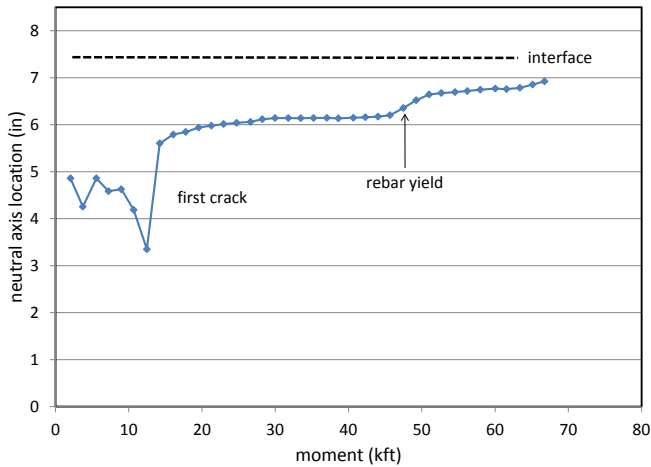
a) Moment-Curvature Plot

b) Strain Profiles

c) Location of Neutral Axis

Figure 23: Slab B Results

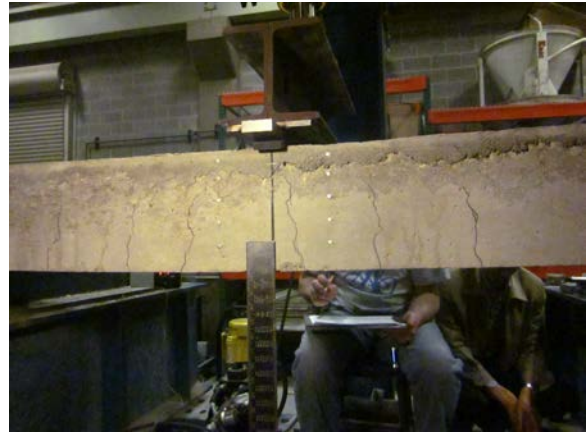
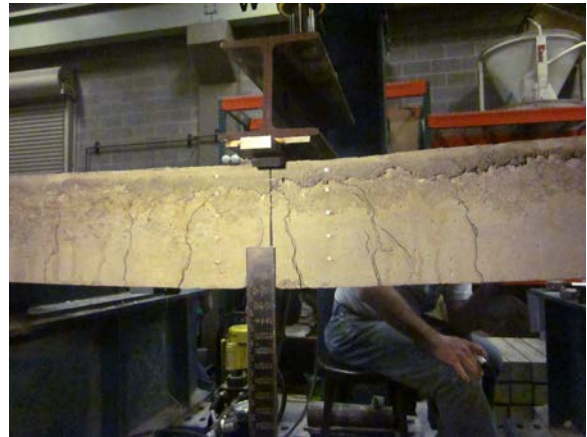
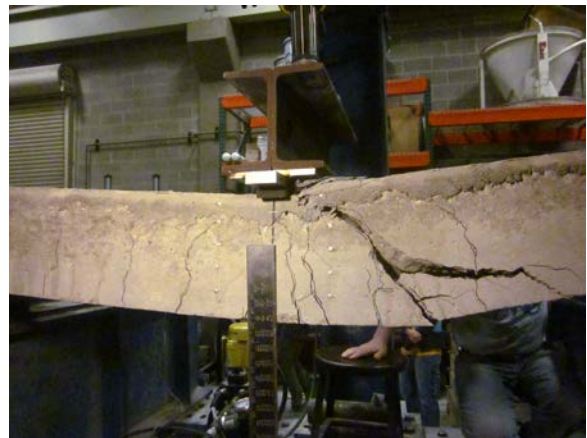
d) Reinforcement Yield (47.5 kipft)

e) Final DEMEC Reading (66.7 kipft)

f) Ultimate Load (68.9 kipft)

Tables 8 and 9 summarize key results from the laboratory and Marshall Ave. specimens, respectively, while Figures 22 through 34 provide details of each slab test. Due to significant existing cracking in slab M2, reliable strain profiles and moment curvature could not be obtained; therefore only observed loads are reported in Table 9. The data shown in Figures 22 to 34 is described as follows:

Figures b show the strain profiles determined directly from DEMEC readings plotted at their appropriate vertical locations. For clarity, profiles at all loading intervals are not shown. Although DEMEC readings were recorded from both sides of each test slab, results from only one side are shown. The results shown are from the side capturing uniform cracking. The location of the LMC interface is also shown in each instance.

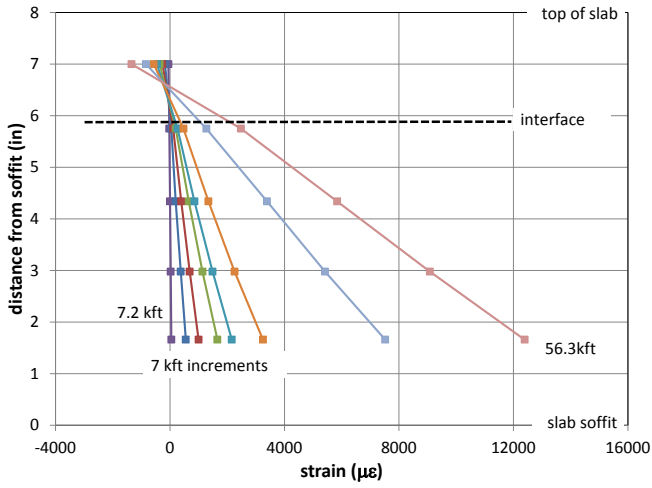
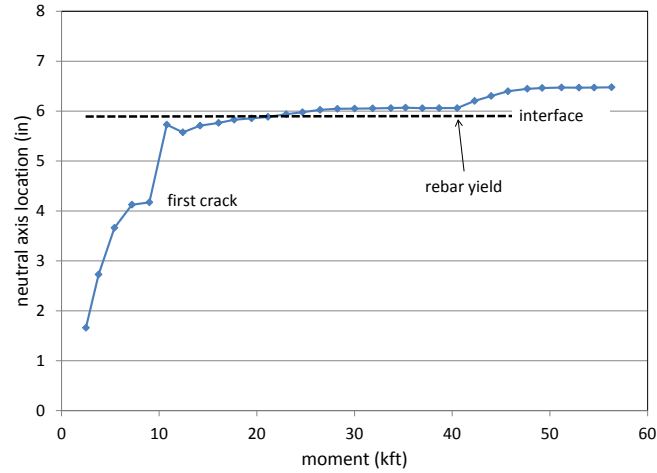
a) Moment-Curvature Plot

b) Strain Profiles

c) Location of Neutral Axis

Figure 24: Slab C Results

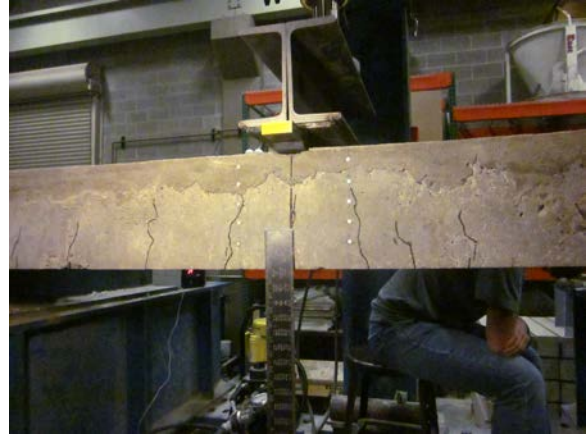
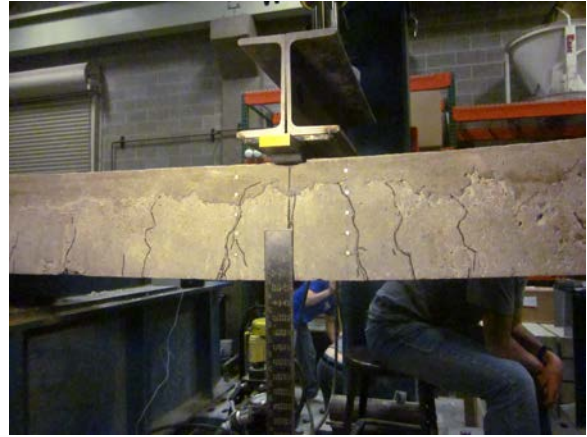
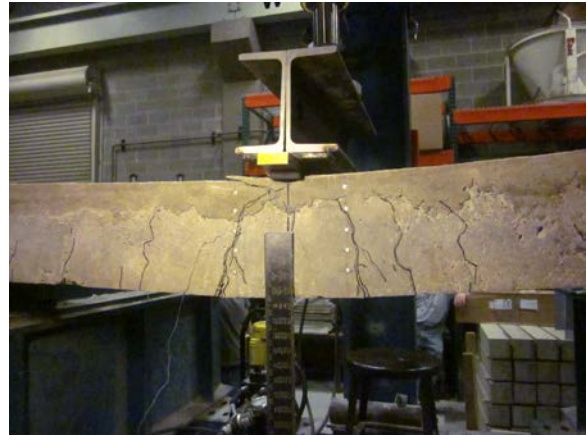
d) Reinforcement Yield (40.5 kipft)

e) Final DEMEC Reading (56.3 kipft)

f) Ultimate Load (59.7 kipft)

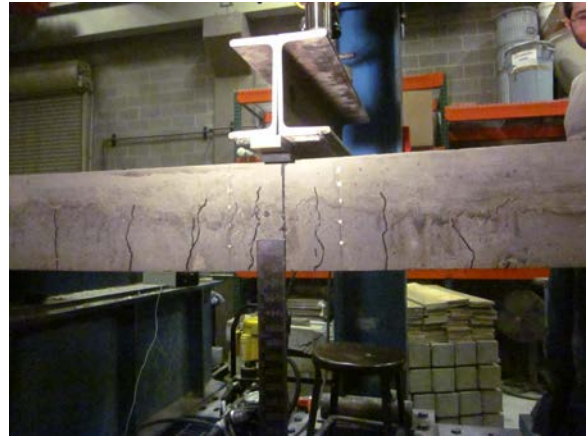
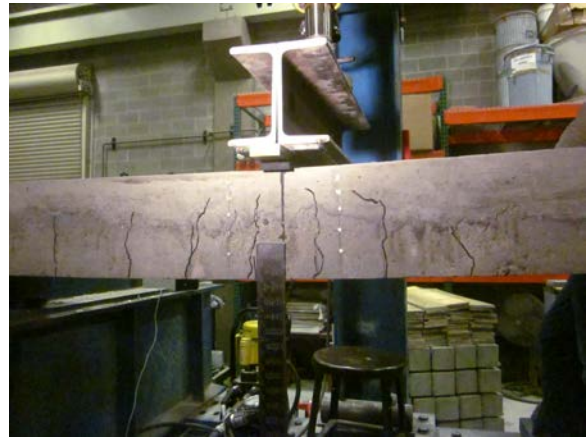
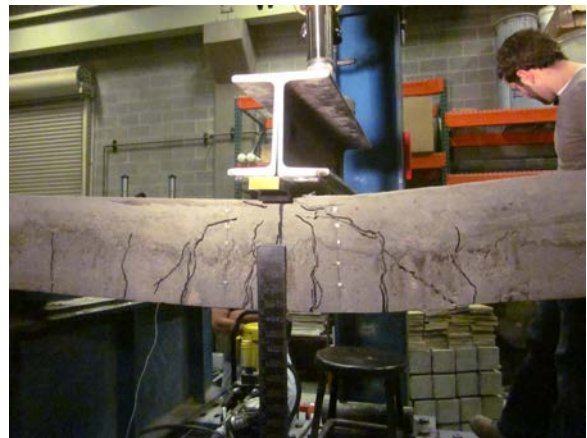
Figure 25: Slab D Results

d) Reinforcement Yield (35.3 kipft)

e) Final DEMEC Reading (49.3 kipft)

f) Ultimate Load (52.8 kipft)

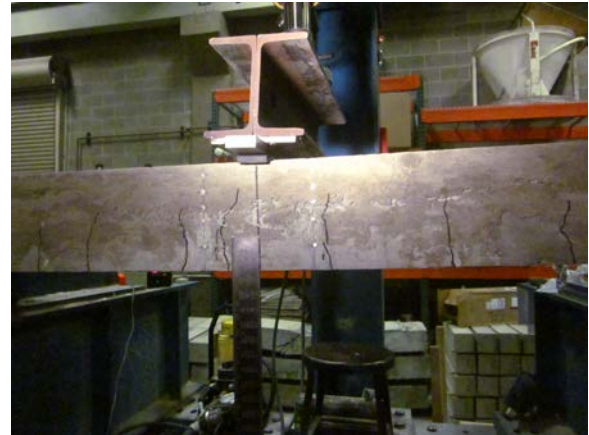
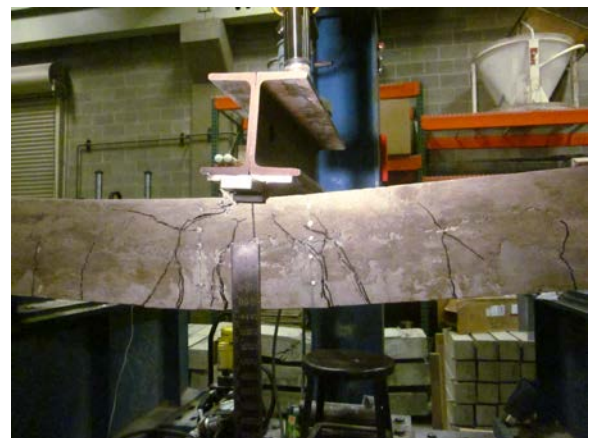
Figure 26: Slab E Results

d) Reinforcement Yield (35.3 kipft)

f) Ultimate Load (51.2 kipft)

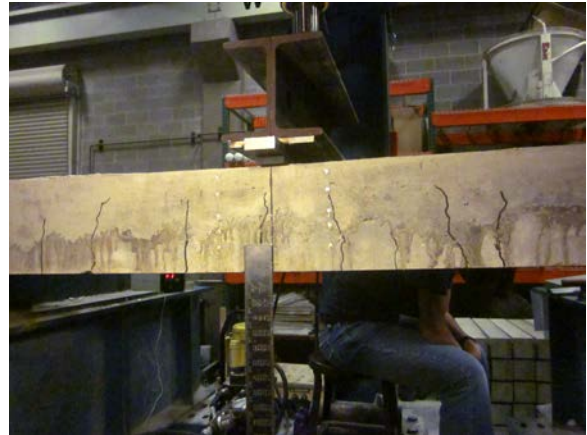
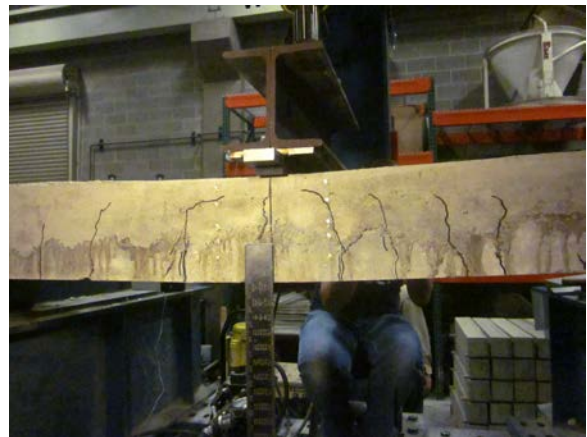
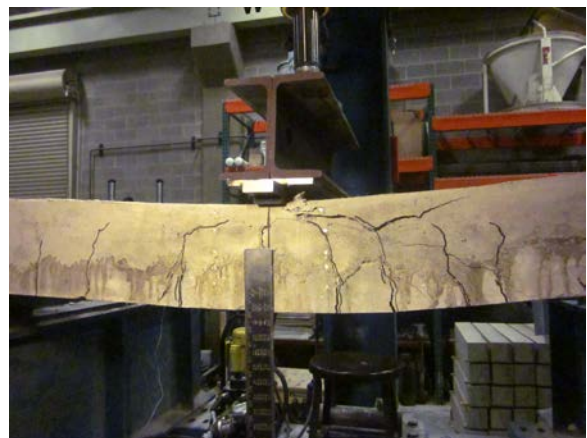
Figure 27: Slab F Results

d) Reinforcement Yield (35.1 kipft)

e) Final DEMEC Reading (47.5 kipft)

f) Ultimate Load (51.0 kipft)

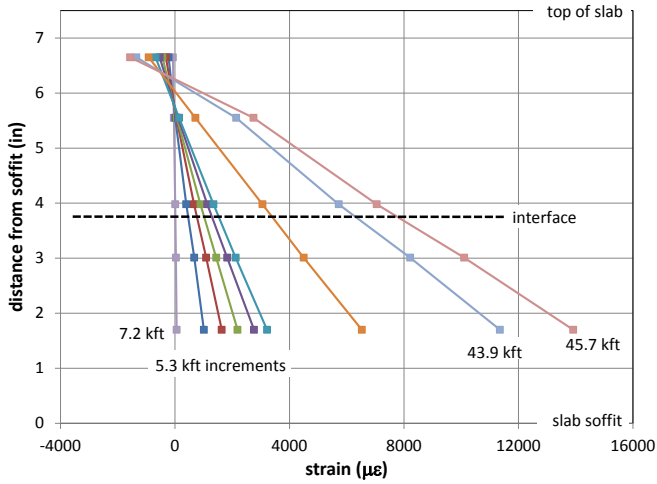
a) Moment-Curvature Plot

b) Strain Profiles

c) Location of Neutral Axis

Figure 28: Slab F* Results

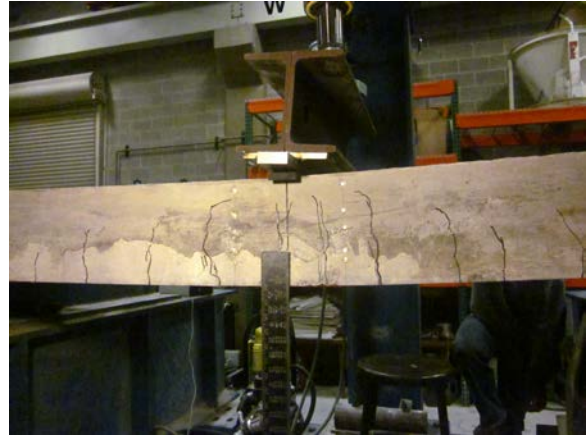
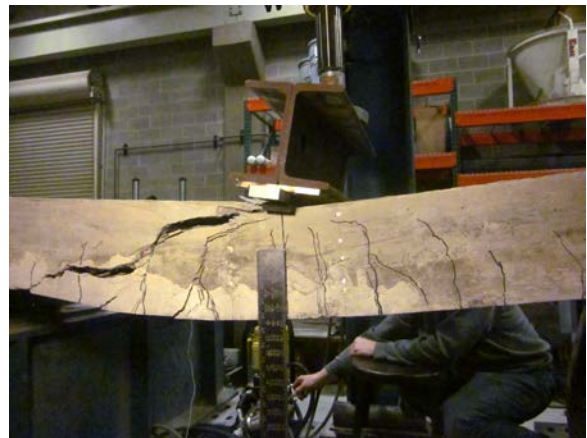
Figure 29: Slab G Results

e) Final DEMEC Reading (49.1 kipft)

f) Ultimate Load (54.4 kipft)

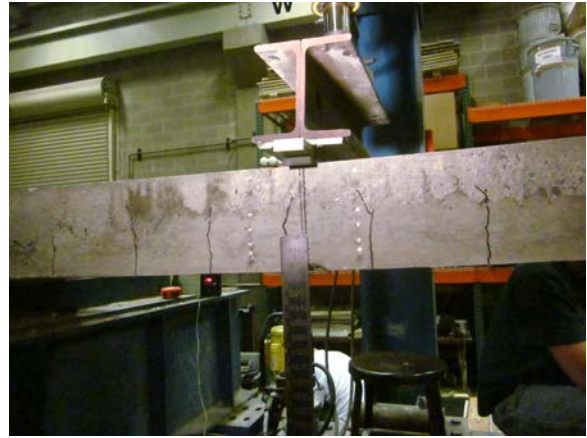
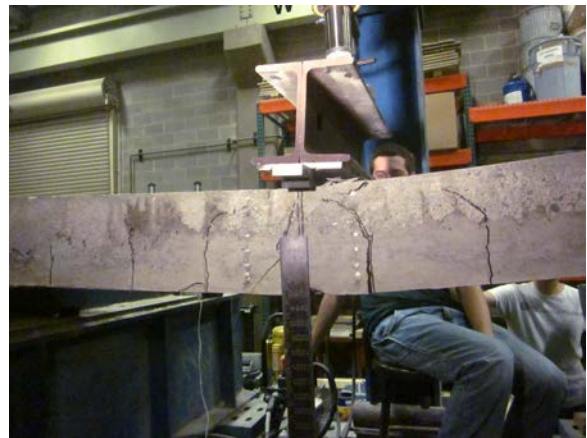
Figure 30: Slab H Results

d) Reinforcement Yield (35.3 kipft)

f) Ultimate Load (51.1 kipft)

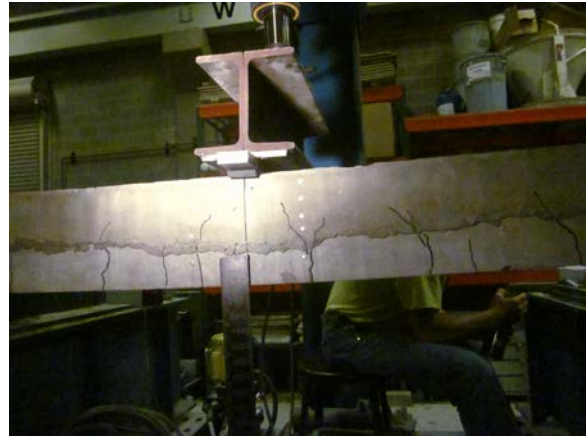
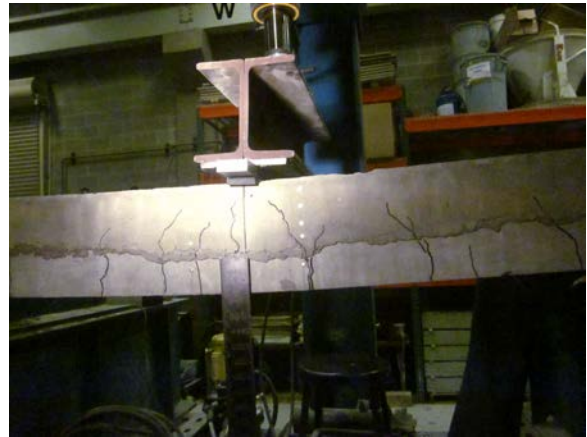
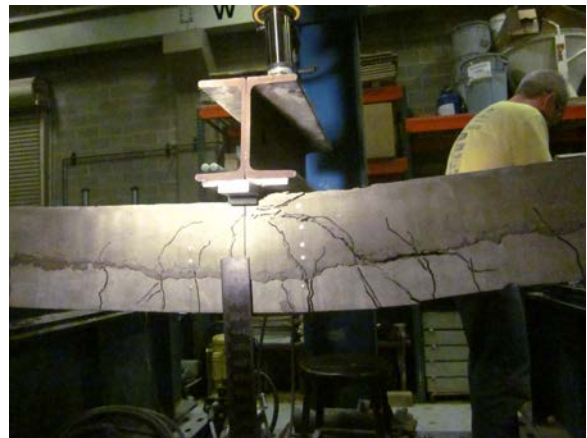
Figure 31: Slab AAA Results

d) Reinforcement Yield (35.3 kipft)

e) Final DEMEC Reading (42.3 kipft)

f) Ultimate Load (44.0 kipft)

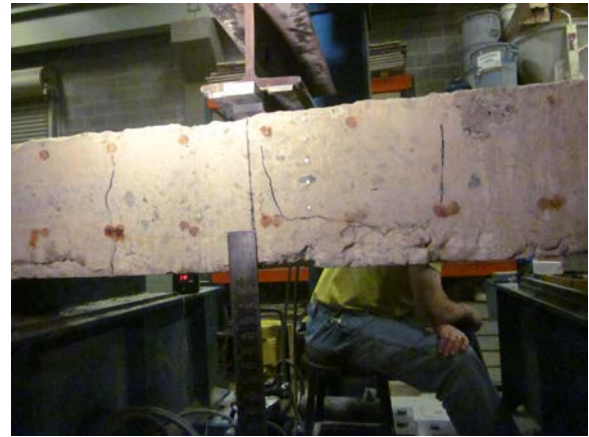
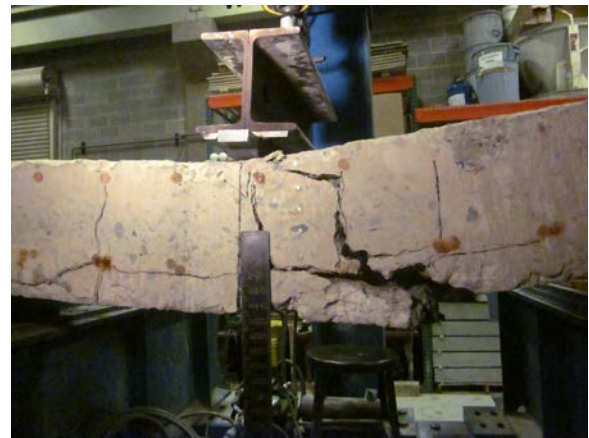
Figure 32: Slab M1 Results

e) Final DEMEC Reading (16.7 kipft)

f) Ultimate Load (21.2 kipft)

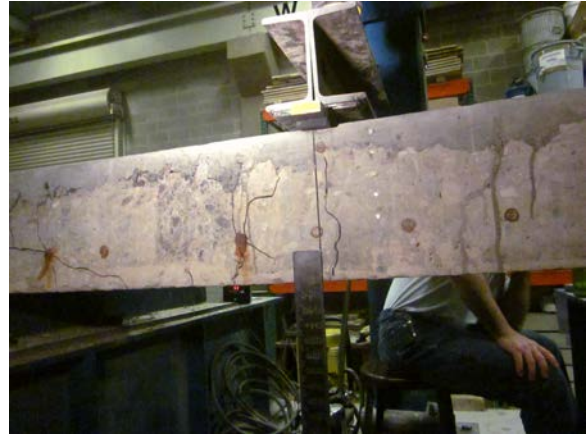
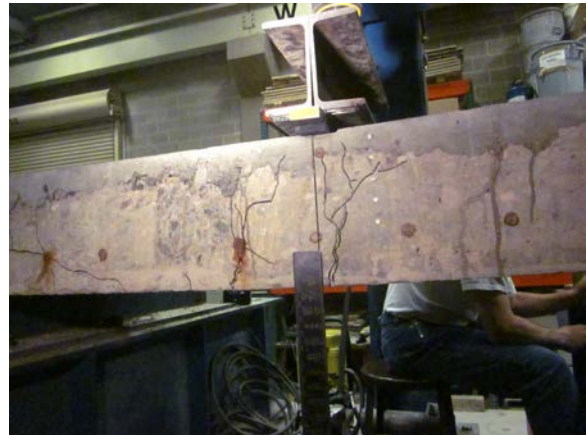
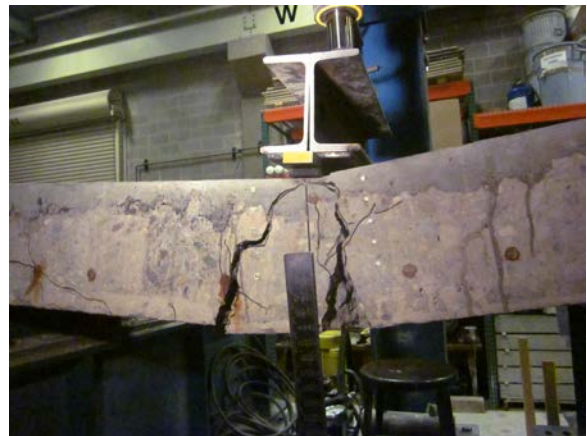
Figure 33: Slab M3 Results

d) Reinforcement Yield (14.3 kipft)

e) Final DEMEC Reading (17.3 kipft)

f) Ultimate Load (22.7 kipft)

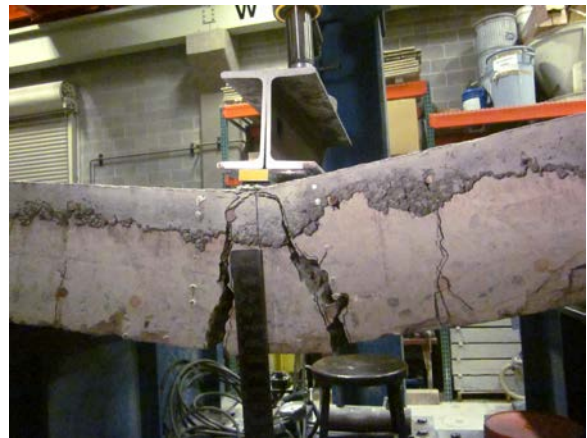
Figure 34: Slab M4 Results

f) Ultimate Load (26.9 kipft)

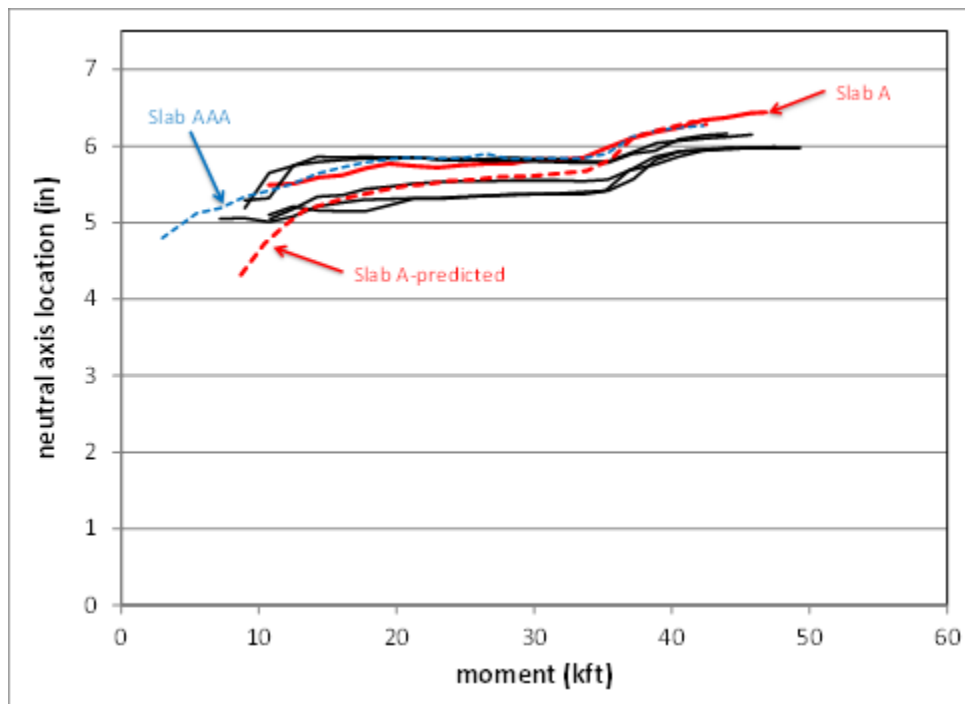
Figure 39 shows the calculated post-cracking neutral axis depth for all laboratory slabs along with the predicted values for Slab A. Data for individual slabs is provided in Figures 22 through 31. Experimental values tracked each other and the predicted values very well. Once

The most important observation in Figure 39 is that there is no obvious effect on the LMC interface. For most slabs, the interface is below the cracked section neutral axis (see Figures 22-31) and above the uncracked neutral axis (approximately 3.75 in. (95 mm) above soffit) and has no obvious effect on slab behavior.

Figure 39: Post-Cracking-Height of Neutral Axis vs. Moment of Laboratory Slabs
