STRUCTURAL REPAIR OF PRESTRESSED CONCRETE BRIDGE GIRDERS

Jarret Lee Kasan

Submitted to the Graduate Faculty of the
Swanson School of Engineering in partial fulfillment
of the requirements for the degree of
Master of Science

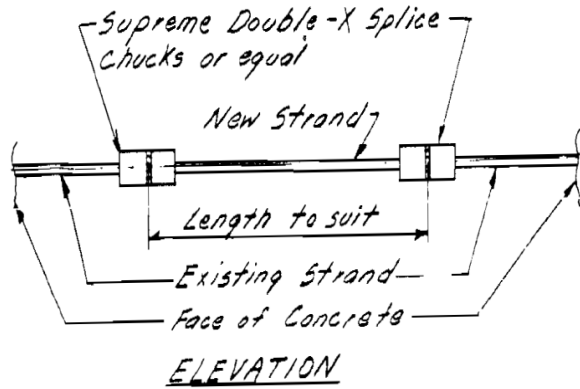
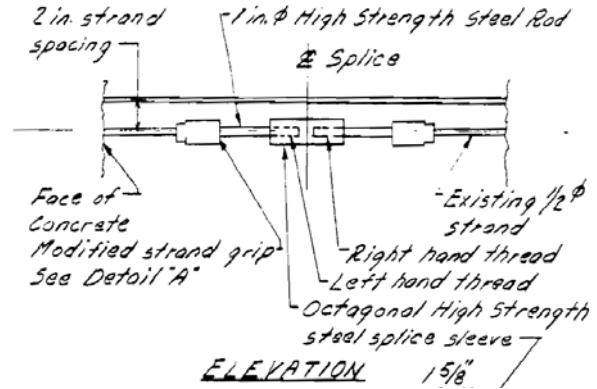
Figure 2-4 Strand splicing methods (Shanafelt and Horn 1980).

(a) Splice 6: Strand chucks used to splice strand. Prestressing reintroduced by heating strand during installation

(b) Splice 7: 'Turnbuckle' style strand splice. Coupler draws strand ends together.

(c) Splice 8: Multiple strand 'turnbuckle' style strand splice.

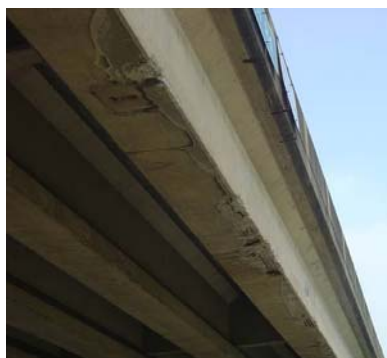
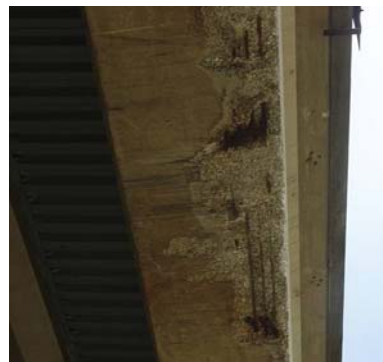
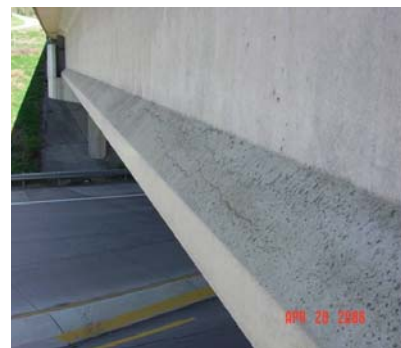
Figure 3-3 Impact damage to I beam (PennDOT).

(a) damage to girder soffit.

(b) close up view of (a) showing severed strands.

(c) longitudinal cracking resulting from impact.

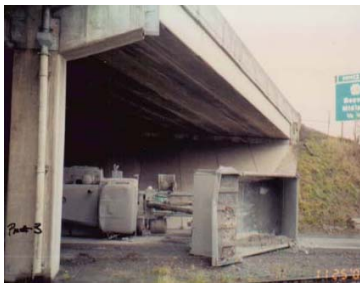
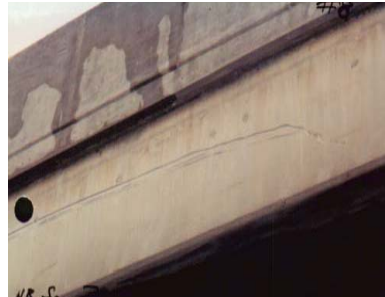
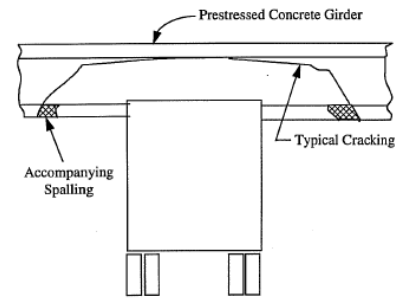
Figure 3-5 Vehicle impact due to collision.

(a) following vehicle impact (PennDOT).

(b) typical impact damage pattern (PennDOT).

(c) typical impact damage due to side impact (Feldman et al. 1996).

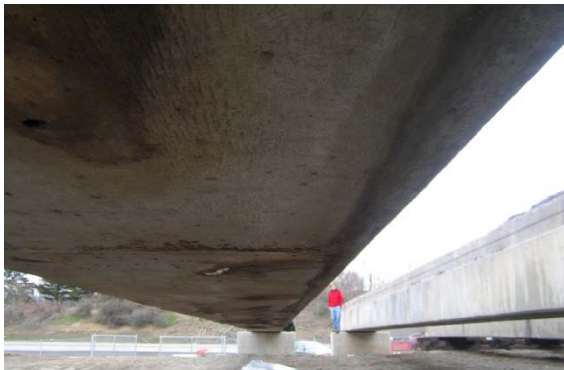
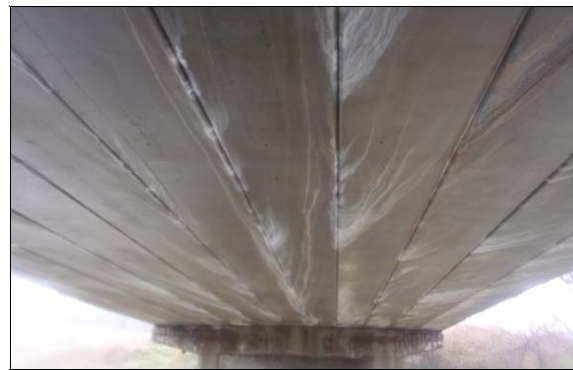
Figure 3-6 Evidence of water on soffits of adjacent box girders.

(a) water coming down exterior face of adjacent box girder (Harries 2006).

(b) water leaking between adjacent box girders (PennDOT).

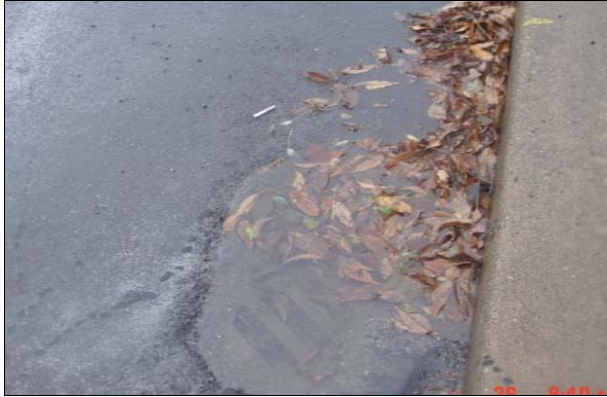
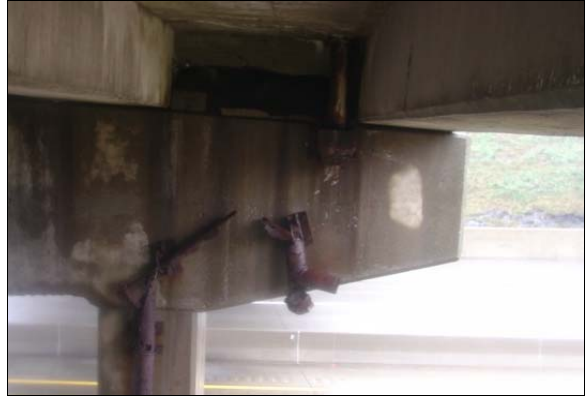
Figure 3-7 Water from unanticipated sources.

(a) water pooling due to clogged deck drain (PennDOT).

(b) damaged drain system resulting in water affecting superstructure (PennDOT).

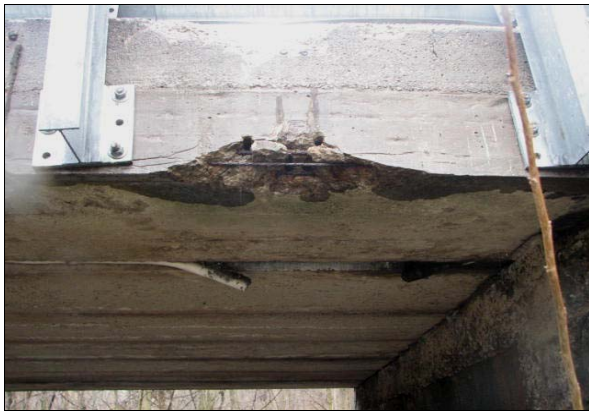
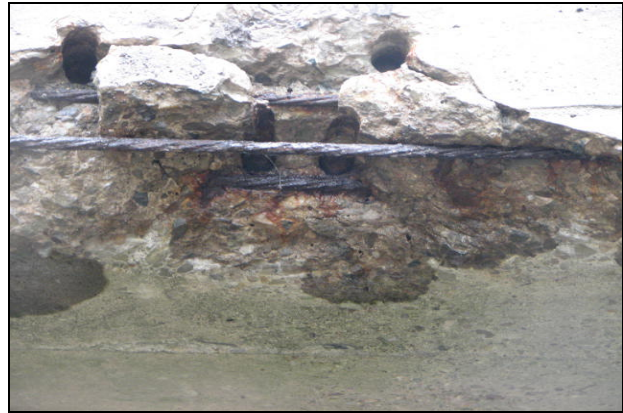
Figure 3-8 Damage to strands caused by relocating barrier supports (PennDOT).

(a) spalling at original attachment and possible future damage at sight of new attachment.

(b) unpatched holes at sight of original attachment result in exposed strands.

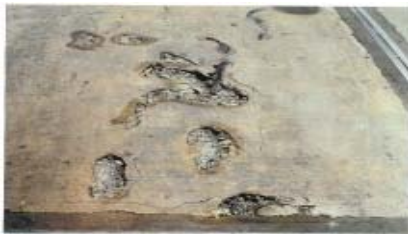
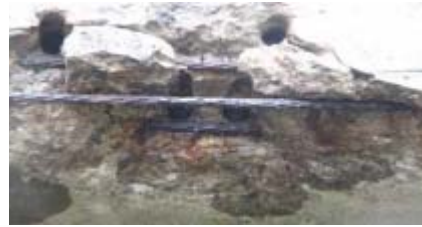
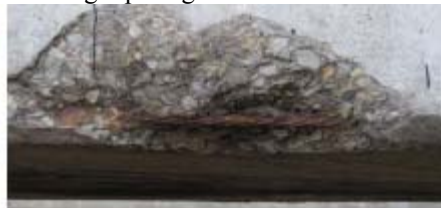
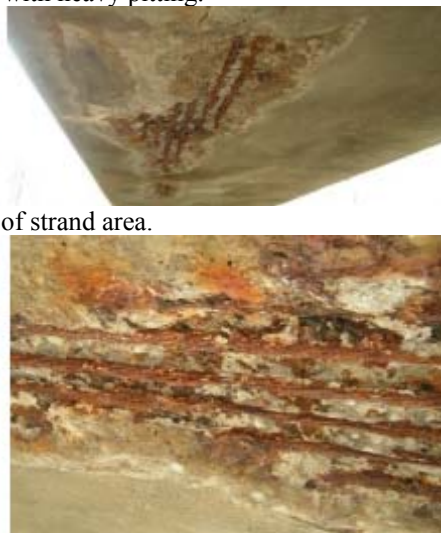
Figure 3-11 Continuum of corrosion damage (Naito et al. 2006; Harries 2006).

(a) concrete spalling.

(b) exposed strands without corrosion (Fig. 3-8b).

(e) corroded strand with heavy pitting.

(f) partial loss of strand area.

(g) complete loss of strand area.

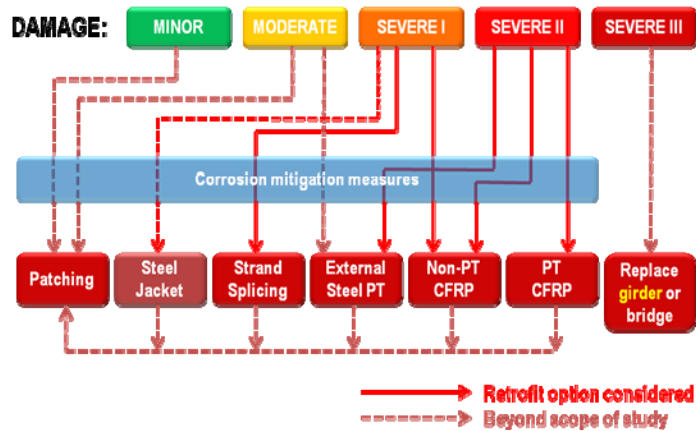
Figure 4-4 Flow charts illustrating viable retrofit techniques based on level of damage.

(c) I-beam

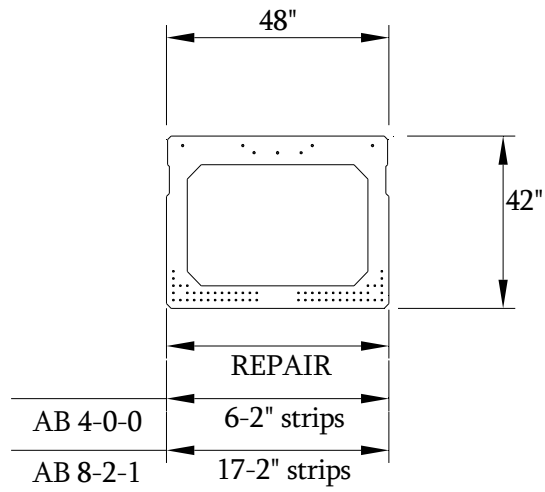
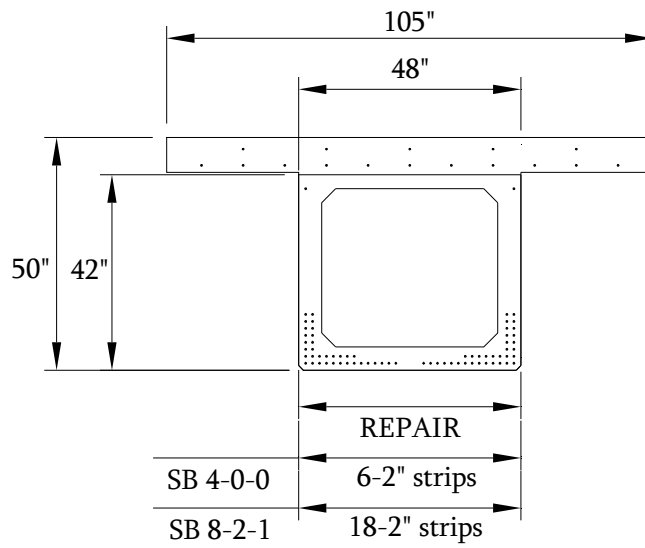
Figure 5-2 Preformed CFRP strip repairs.

(a) AB CFRP strip repair.

(b) SB CFRP strip repair.

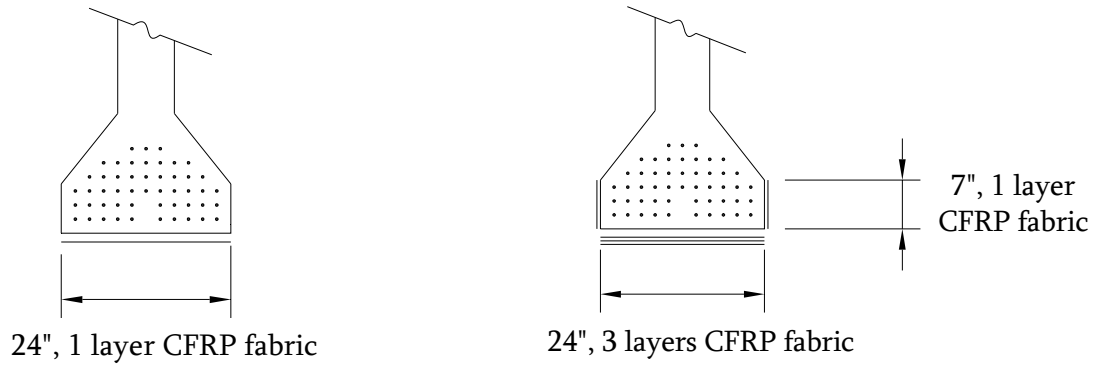
Figure 5-7 CFRP fabric repairs.

(a) IB 4-0-0 CFRP fabric repair.

(b) IB 6-2-1 and 10-2-1 CFRP fabric repair.

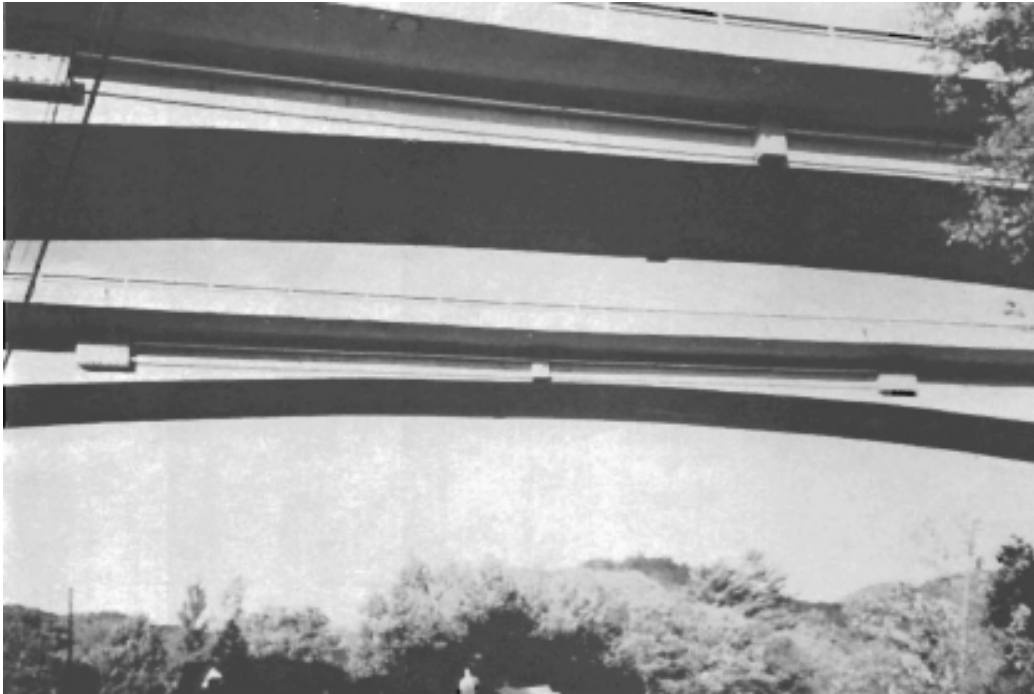
(a) Post-tension tendon retrofit with concrete bolsters (Collins and Mitchell 1997).
