EVALUATION OF TITANIUM ULTRALIGHT MANUAL WHEELCHAIRS USING
ANSI/RESNA STANDARDS

Submitted to the Graduate Faculty of
School of Rehabilitation Science and Technology in partial fulfillment
of the requirements for the degree of
Master of Science

University of Pittsburgh

2008

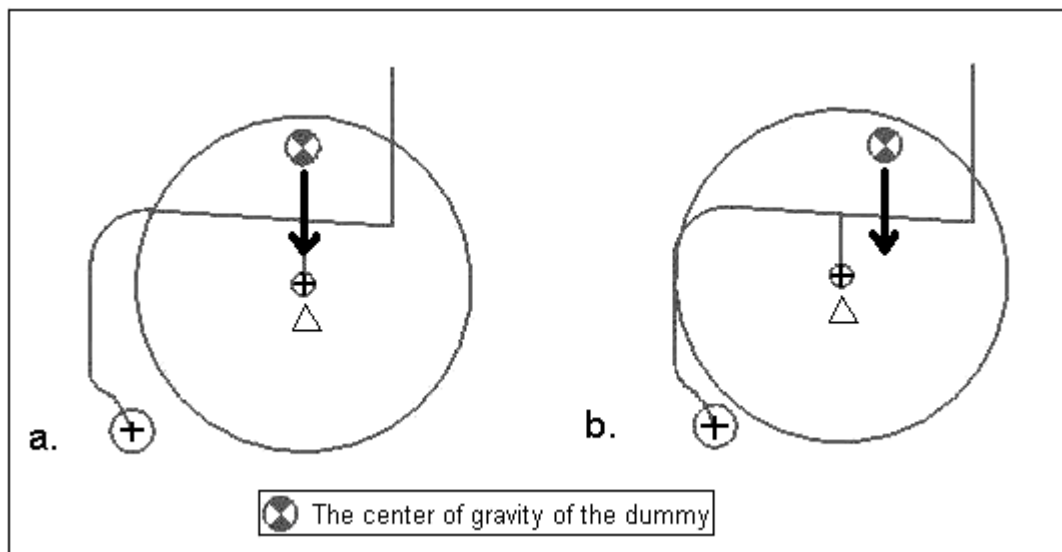
Figure 4. Position of the rearwheel axle in the forward stability tests. The mid-position of the rear wheel axle was considered the least stable setting (a) since the wheelchair would tip “backwards” if we moved the axle further forward (b).

The ANSI/RESNA wheelchair standards indicate to move the rear wheel position forward when conducting the forward stability test with least stable setting. When testing this group of titanium wheelchairs, the mid-position of the rear wheel axle was considered the least stable setting (a. in Figure 4) since the wheelchair would tip “backwards” if we moved the axle further forward (b. in Figure 4).
