BRIDGE WATERPROOFING DETAILS

Submitted to the Graduate Faculty of
Swanson School of Engineering in partial fulfillment
of the requirements for the degree of
Master of Science

University of Pittsburgh

The objective of this research is to improve the safety margin and redundancy of current waterproofing details used for bridge substructures in PennDOT practice. Based on a literature review, inspection reports, and field visits, the key components of the waterproofing system are studied. Using software analysis and experimental tests, their strength and robustness is analyzed and evaluated based on the damage development and failure mode. The inadequacy in the key components of current waterproofing system is substantiated and remedies to mitigate water leakage are proposed. Executable recommendations are suggested to strengthen the waterproofing details at critical locations and to provide ease of construction and inspection.

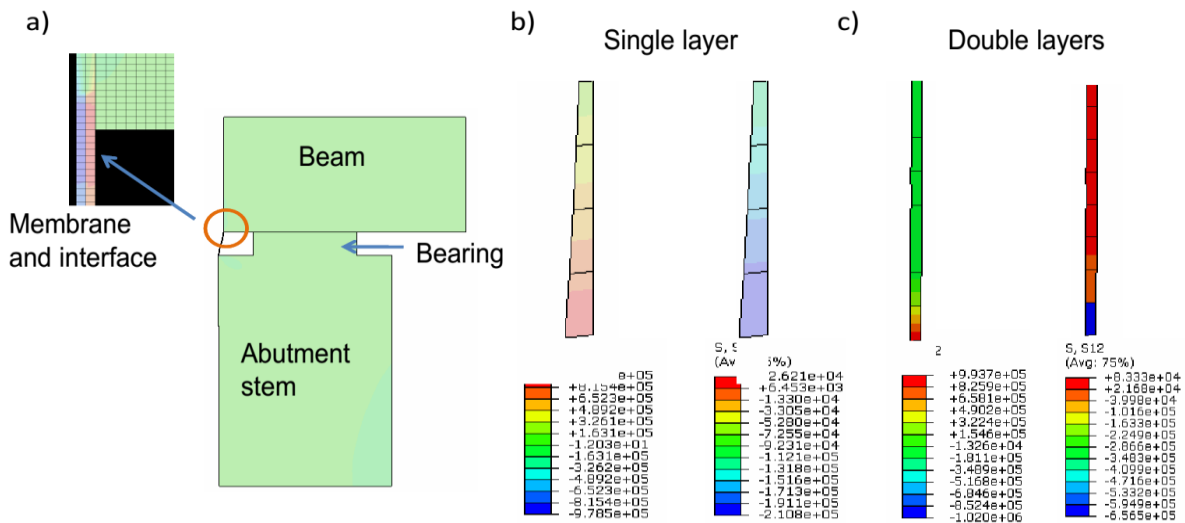
Figure 3.7: ABAQUS model of membrane peeling off

To investigate the strength distribution in the adhesive interface between concrete and waterproofing membrane, a computational model is built by using Abaqus (Figure 3.7a). In the model, the interface between membrane and concrete is typical in PennDOT practice: 12 in. long

In figures 3.7b and 3.7c, the stress distribution along the membrane-concrete interface is plotted when a contraction equal to 0.6 in. happens in the deck in winter. From the plots, it can be seen that severe stress concentration exists in the interface adjacent to the two concrete corners. This stress concentration is caused by the *material mismatch* and *geometry irregularity* and can be explained by nonlinear fracture mechanics, which is beyond the scope of this investigation although widely studied in fiber composite materials for metal-composite hybrid joint.

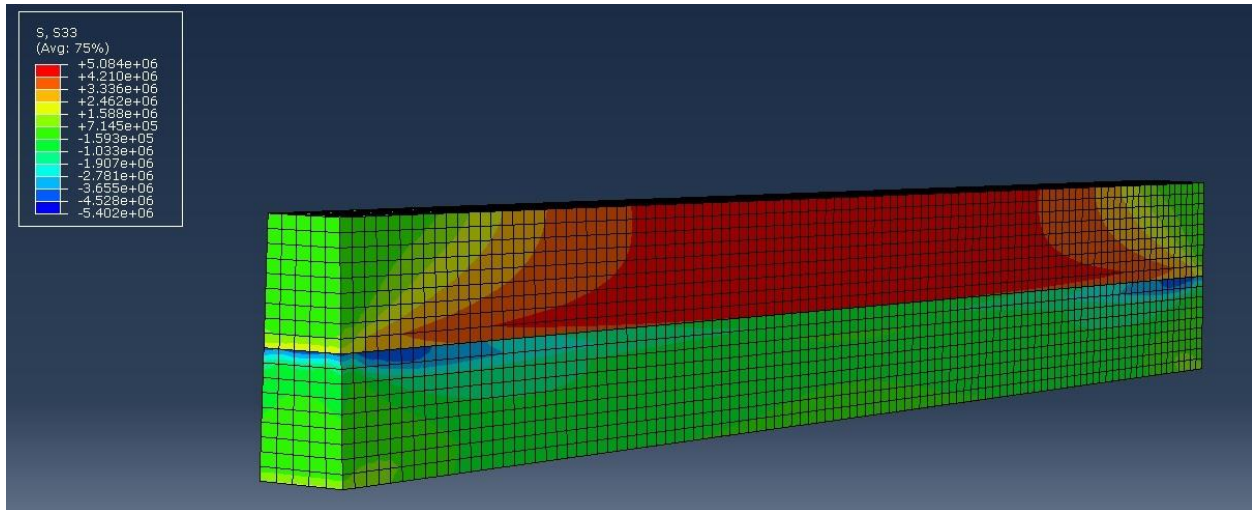
Figure 3.8: Stress distribution in rehabilitated abutment

For projects where the abutment is rehabilitated, property and age of the concrete on the opposing sides of the old-new concrete interface differ significantly. Substantial shrinkage in the young concrete will lead to cracking at the interface, and thus cause water leakage. This is evident in the Boydstown Bridge and Beechton Bridge, even though the latter one had a waterproofing membrane applied at the interface.

A finite element analysis was carried out using Abaqus. The American Concrete Institute shrinkage model is used. The Beechton bridge abutment is used as the sample abutment. The analysis simulates stresses at the old-new concrete interface at the end of 365 days. The stresses are shown in figure 3.8. It can be seen that tensile stresses in the new concrete almost reach 740 psi (5.084 MPa) which is higher than the tensile strength of concrete. These stresses are possibly what contribute to the cracks in the abutment wall.

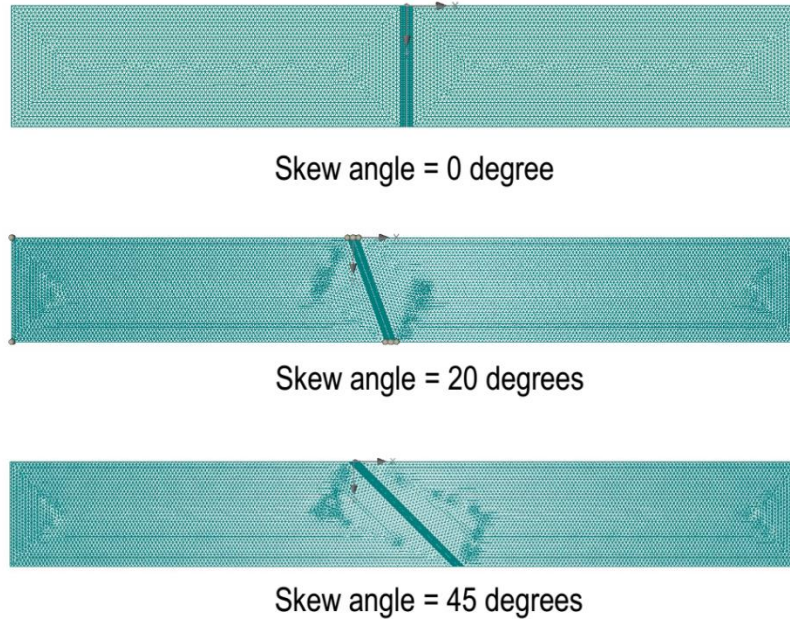
Figure 3.9: Effect of skew angle on the contact surface

When an expansion of 0.4 in. is applied to the concrete deck, the stress on the contact surface is investigated for different skew angles. Here 0.4 in. is selected in that it is equivalent to a 100 ft. long concrete slab undergoing a temperature variation equal to 86°F, which is most common for bridges in Pennsylvania. Under this deformation, stress development on the contact surface will be different for different skew angles.

For all the skew angles, there is only normal stress on the contact surface before thermal deformation. However, as the thermal deformation grows, significant shear stress is developed on the contact surface for non-zero skew angle. For example, at the end of the expansion, the shear stress for a skew angle of 20 degrees is 75 psi, over half of the cohesion strength; and for a skew angle of 45 degrees, it is 139 psi, almost reaching the assumed cohesion strength. Note that traffic loading in accordance to AASHTO specification (AASHTO, 2010) is considered in the simulations, although its effect on contact stress is found to be negligible.

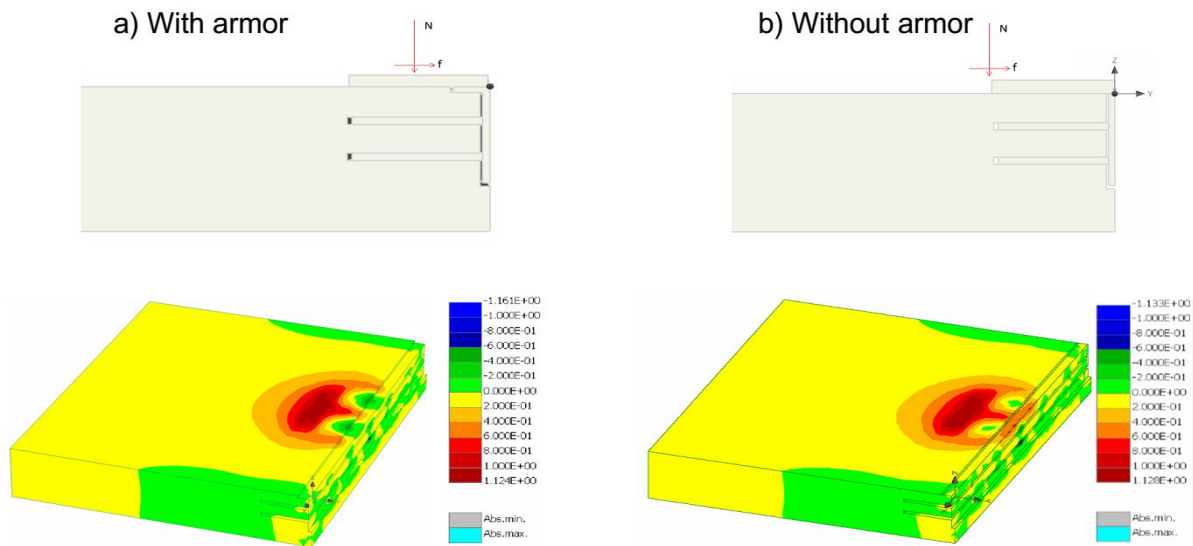
Figure 3.10: Analysis of Strip seal joint in Atena

From the stress distribution obtained, it can be seen the maximum stress in the anchorage stud is about 2118 psi, far less than the yield strength and fatigue strength of steel. The maximum stress in the steel extrusion is only 1336 psi, demonstrating a substantial safety margin. The maximum tensile stress in the concrete block-out is about 163 psi, only around 35 percent of its tensile strength. Therefore, there will be no macro-cracking around the anchorage stud (micro-cracking due to shrinkage may exist but it will not significantly affect the pullout strength).

In current PennDOT practice, 5/8” x 10” stud is generally used as the anchorage member. For concrete without cracks, block-out with strength = 4000 psi (strength of Class AAA-P), its pullout strength is about 16000 lb. according to ACI design code (American Concrete Institute Committee 318, 2011). This is significantly greater than the force obtained in the push-out test for strip seal, which is only about 2700 lb. This means the anchorage of extrusion has a larger safety margin than the strip seal, and thus enables the extrusion to hold the strip seal safely even when significant load is imposed on the strip seal.

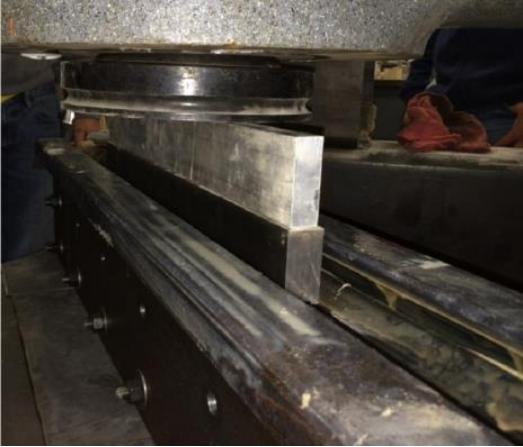
Figure 3.12: Loading of strip seal

The test is conducted on a loading machine by pushing a one-foot long steel rod into the strip seal (Figure 3.12). In the test, the strip seal exhibits strong resistance to the push-out. To avoid the loading piston from touching the steel extrusion, the test is stopped after the load reaches 2700 lb. Under this load, the strip seal does not fail; neither is there a sign of push-out of strip seal from the extrusions (Figure 3.13). Considering that the AASHTO requirement (AASHTO, 2010) for MBEJ is 1600 lb., the strip seal strength is significantly higher, and thus provides sufficient safety margin to the Strip Seal Joint.

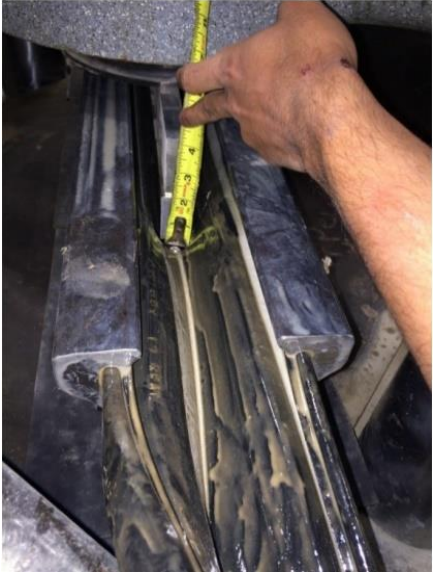
Figure 3.13: Around 4 in. deflection at the end of loading

In addition, the strip seal displays excellent ductility in the test. When the load reaches 2700 lb., the strip seal undergoes a deformation over 4 in. deep without damage. This shows that the strip seal has a high tolerance to debris accumulation. This is a great advantage compared to

Compression Seal Joint, which cannot sustain large vertical deformation and is thus sensitive to debris accumulation.

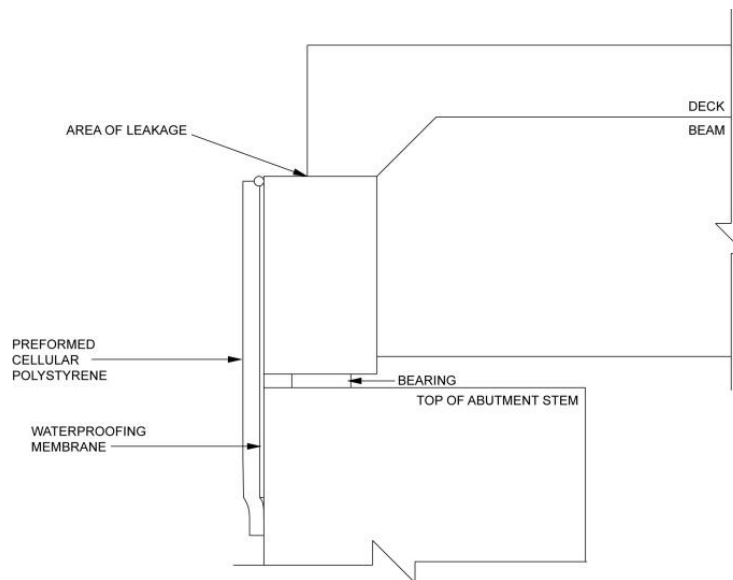
Figure 4.1: Implementation of Waterproofing

Analysis of current design and construction recommendations, observations of in-situ implementation and performance of waterproofing details show that there exists striking inadequacy in current waterproofing details implemented in PennDOT practice, especially for bridges of parapet abutments. This inadequacy is evidenced by severe water leakage found in all 5 bridges visited in Pennsylvania, all of which were built as per PennDOT recommendations after 2008 and were found to have severe water leakage at a much earlier age than expected by design.

Based on findings detailed in previous chapters, the inadequacy in current waterproofing practice in PennDOT may stem from 2 primary sources: 1) insufficient design of key structural components in the subsystems; and 2) lack of redundancy in sub-level and global level systems. The former one causes the damage of waterproofing members in service at an unexpectedly young age, e.g., the dislocation or laceration of waterproofing membrane of the abutment by sharp coarse stones in the backfill (Fig. 4.2) and, damage of the joint edge by impact forces caused by traffic and snowplow (Fig. 4.3). The latter changes the system into a series-coupled chain, with its capacity being dictated by the weakest link. Additionally, poor design of the waterproofing membrane does not provide any redundancy to the expansion joint, thereby substantially reducing the robustness of the expansion joint (Fig. 4.1 and 4.4).

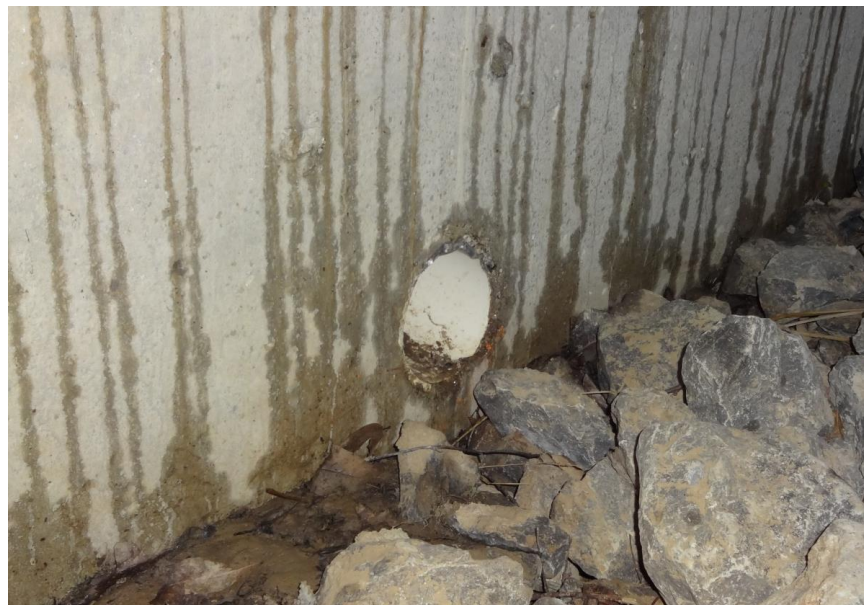
Figure C104: Weep hole on retaining wall

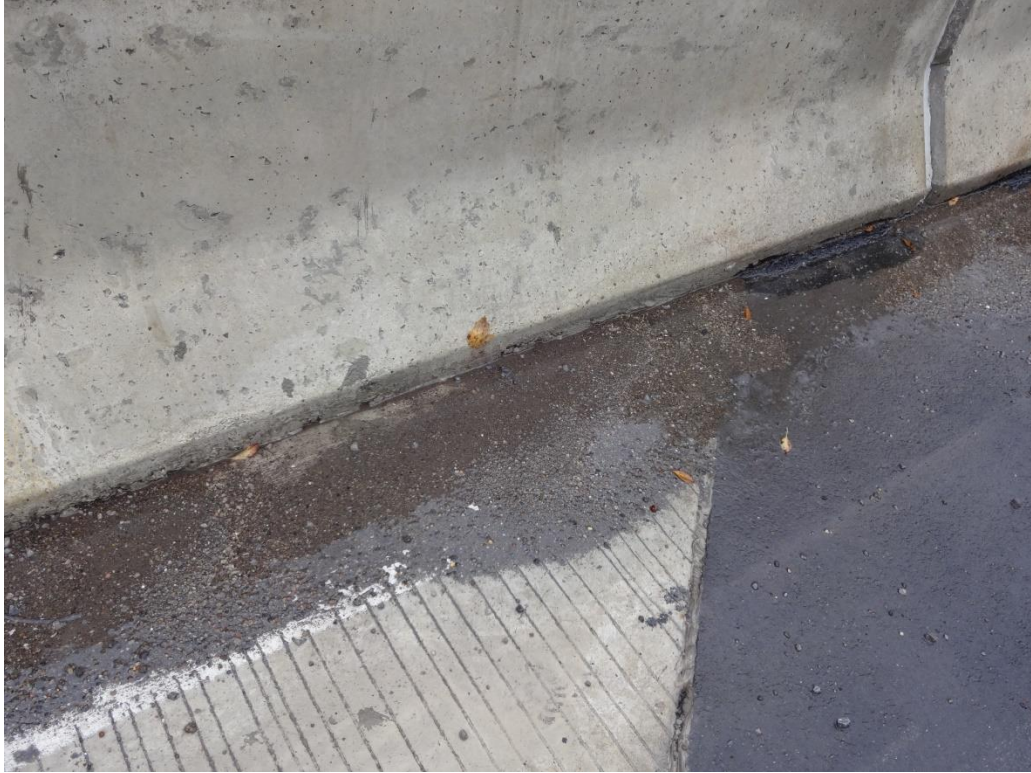
Figure C105: Minor debris accumulation along the edge of the deck

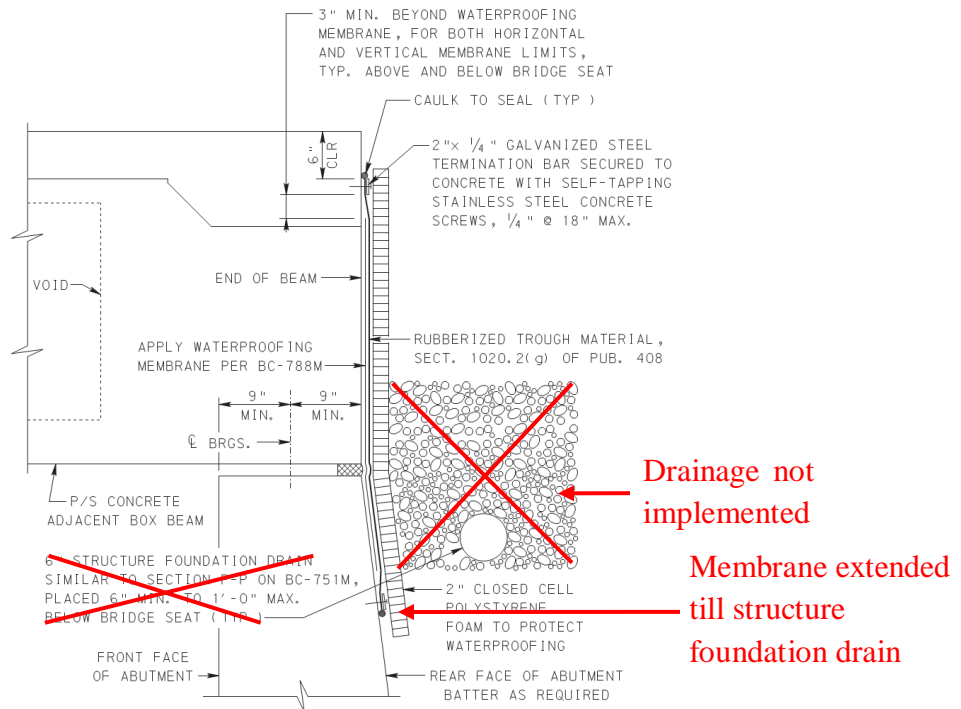
Figure C111: Waterproofing details at abutment-expansion joint interface

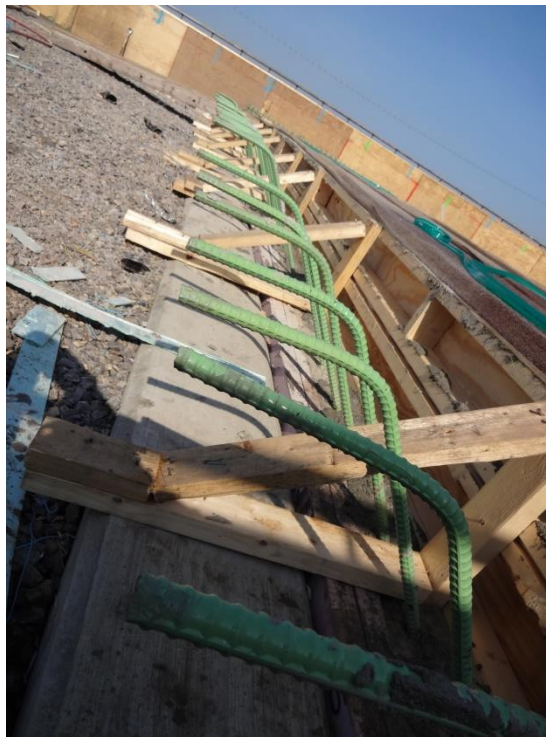
Figure C115: Waterproofing at approach slab – bridge deck interface

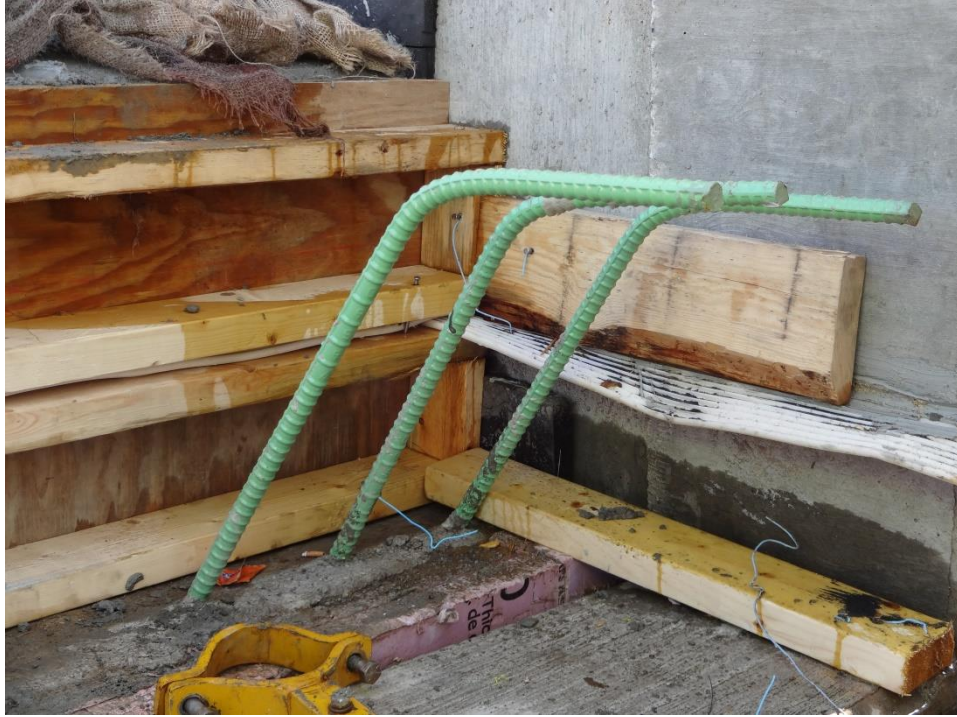
Figure C116: Waterstop extended to curb overlapping on additional piece of waterstop

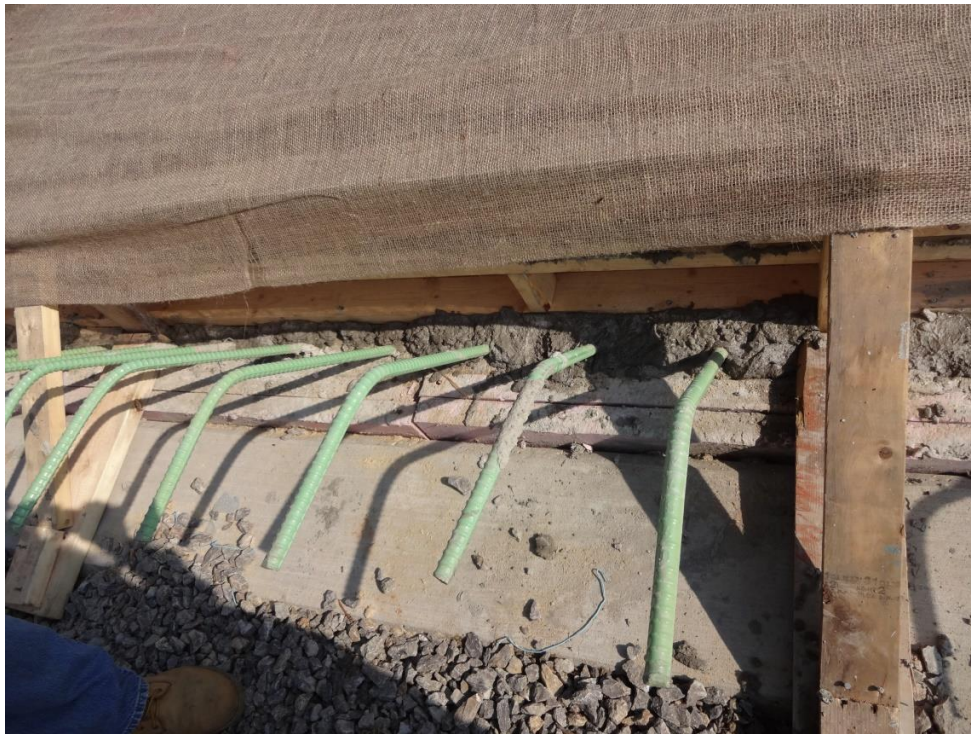
Figure C117: Polystyrene foam fillers in between approach slab and bridge deck
